Framework Plan

The MSP Redevelopment Project

Appendices A, B, C, & D

Observations of the Enclosure Walls

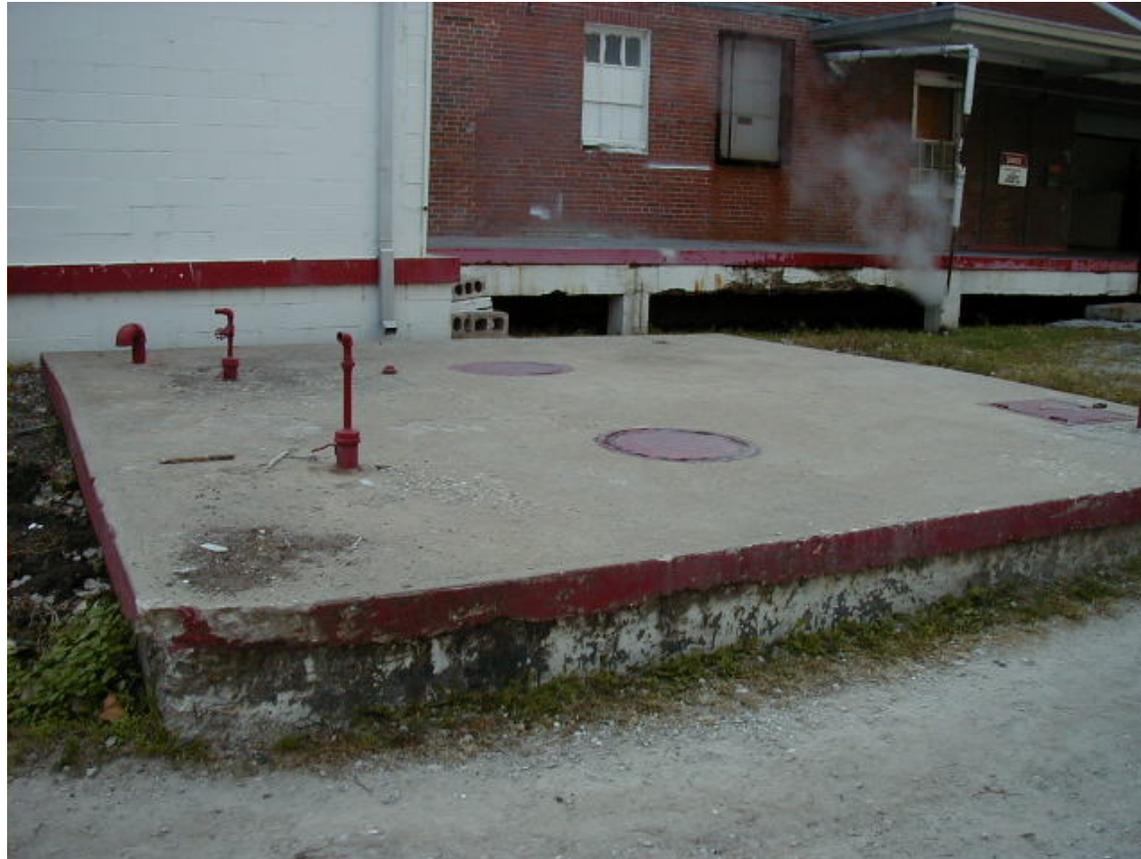
Underground storage for NaOH and POH behind Soap Factory not in use

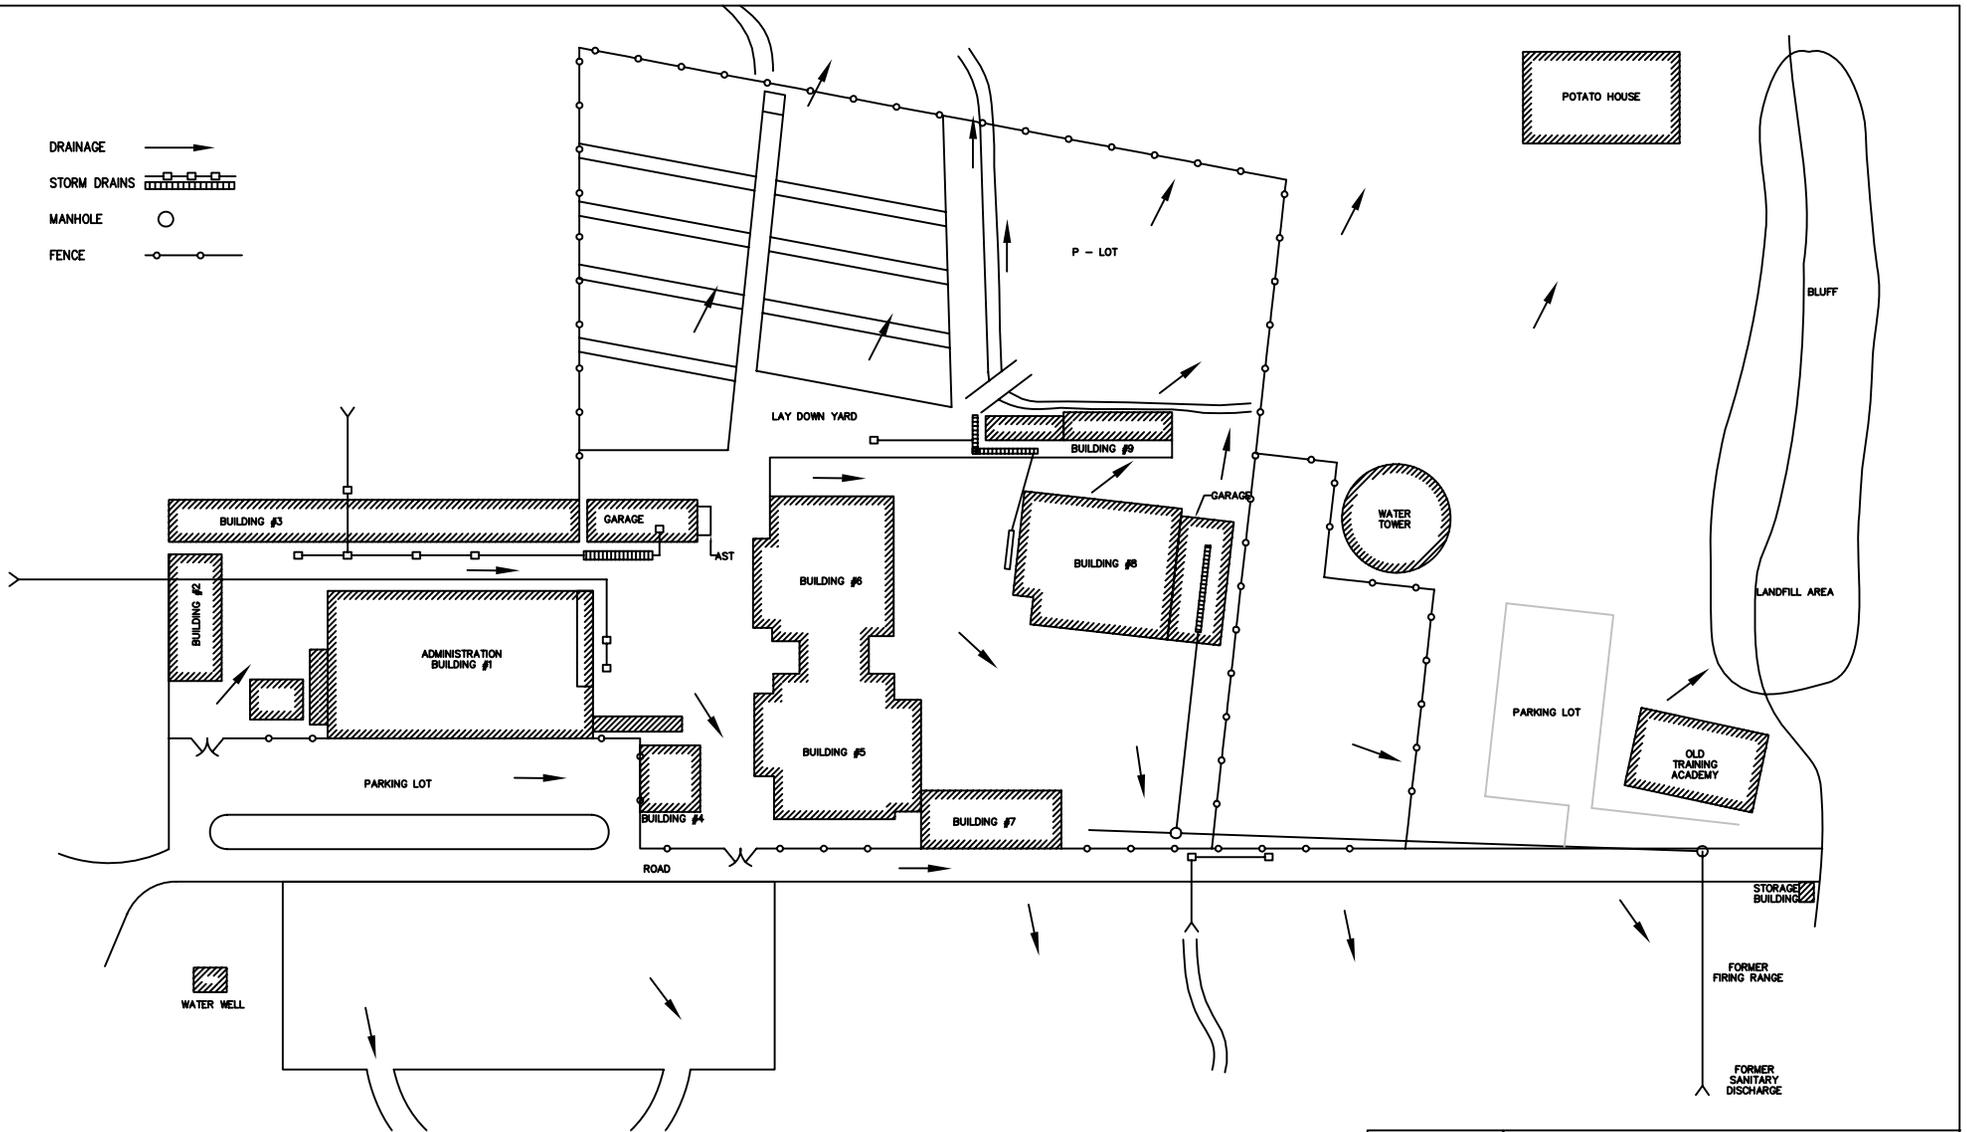
<small>TSI engineers, inc. 6074 AND ARDENAL, BUILDING C 2 CAMPBELL PLAZA ST. LOUIS, MISSOURI 63139</small>	SITE LOCATION AND TOPOGRAPHY		
	SURPLUS PROPERTIES JEFFERSON CITY, MISSOURI		
	Drawn By: EBS	Checked By: RW	
	Project No. 2001026.00	Date: 06/07/01	Figure 2

All current buildings for the Surplus Property are identifiable. Significant drainage erosion is observed on the hillside east of Lay Down Yard (see Figure 2. Site Location and Topography Detail). The Old Training Academy and storage building are present along with the water tower and the shoe factory to the south.

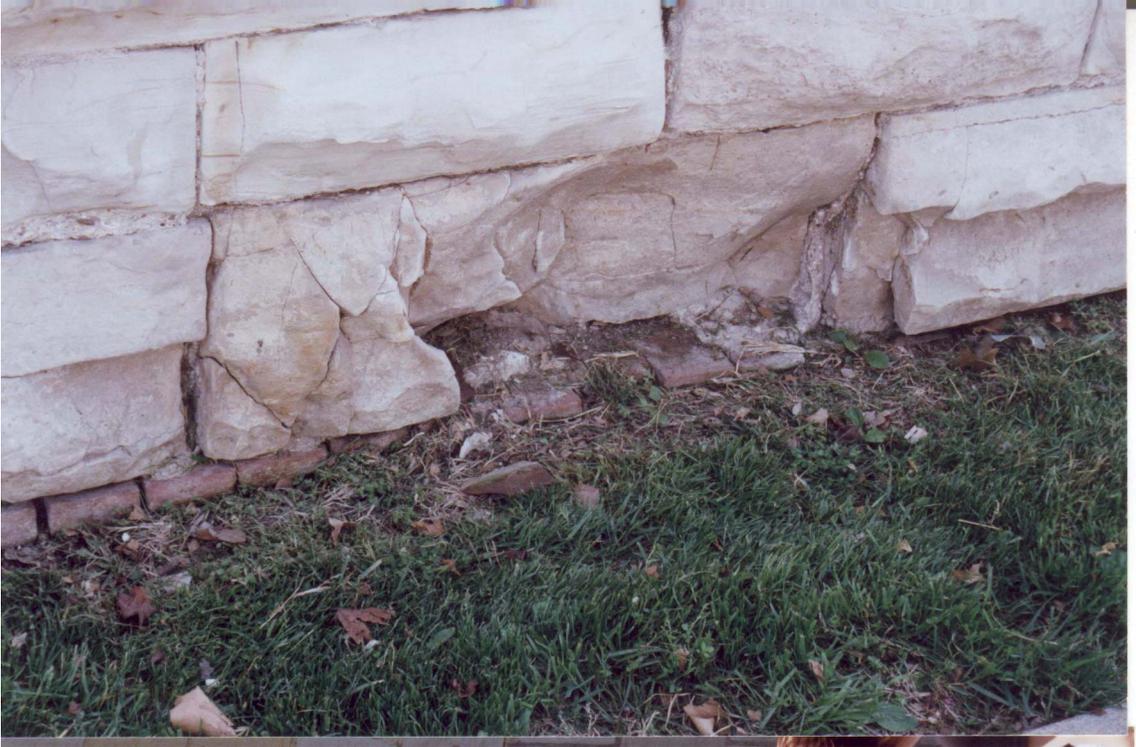
The wall has two areas of concern, water infiltration and horizontal earth pressure. The two types of deterioration can be best exemplified by the damage on the east and south walls. The east wall shows several areas of water infiltration damage. The water infiltration shows up as two distinct types of damage. The stone in several areas have had the faces spalled off. Also, several portions show the entire interior face wythe to be delaminated from the inner wythe. The stone, which is laid with the natural seams running horizontally, shows less distress than those seams laid vertically. This is because the pressure of the wall weight is holding the seams in compression. The water appears to be entering the wall through the cap parging and eroded mortar joints. The water then moves vertically between wythes and is trapped inside and saturates the stone. The water inside the wall will freeze and push the outer wythe away from the inner wythe. Where the stones are spalling, the saturated stone has split at a natural seam where the water has collected and frozen.

Spalled Stone Face

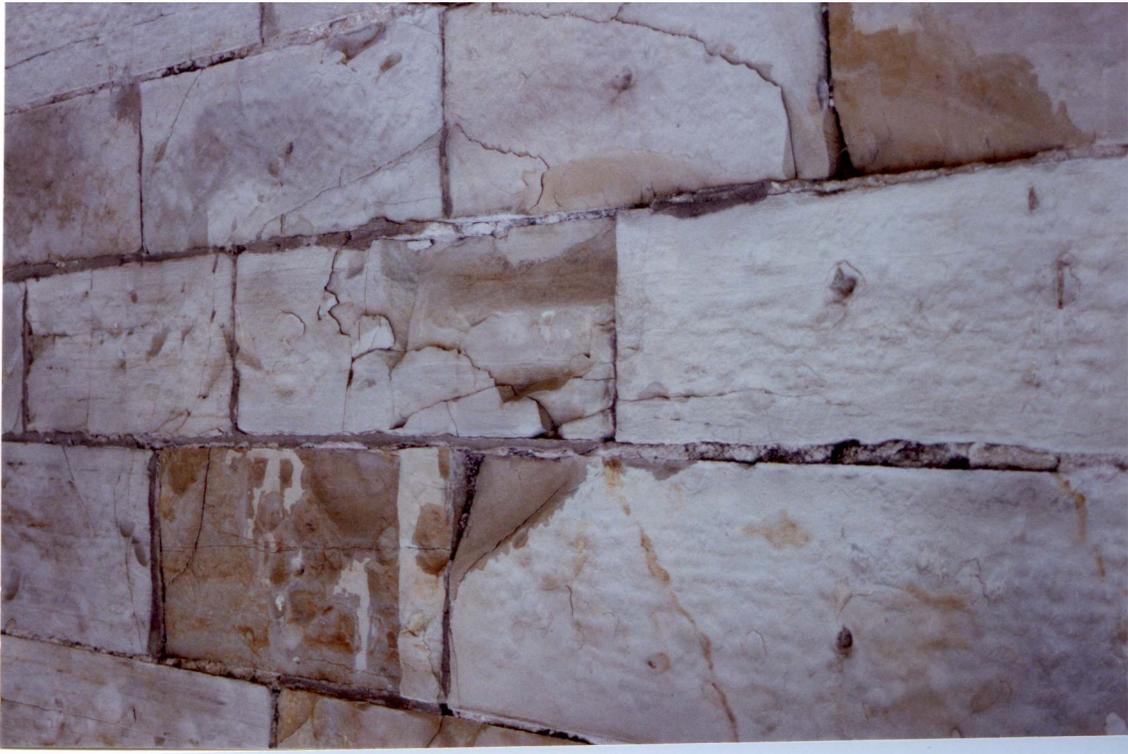
Area of Wall Delamination

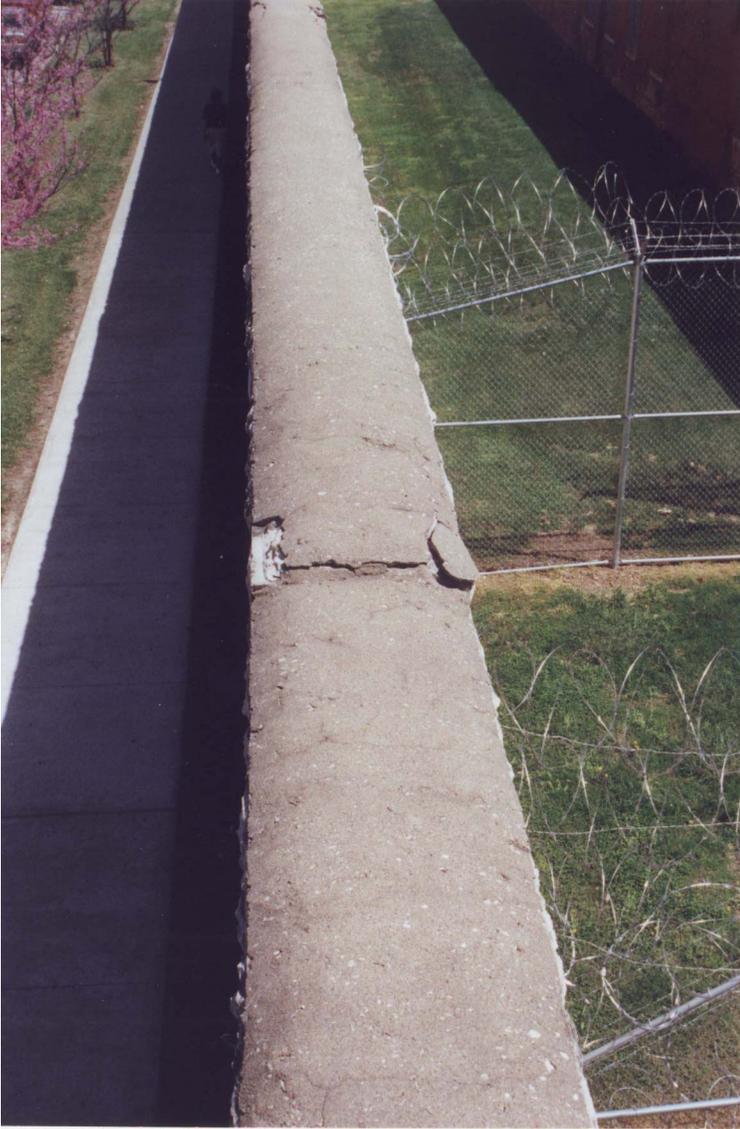
Cracked Concrete Cap

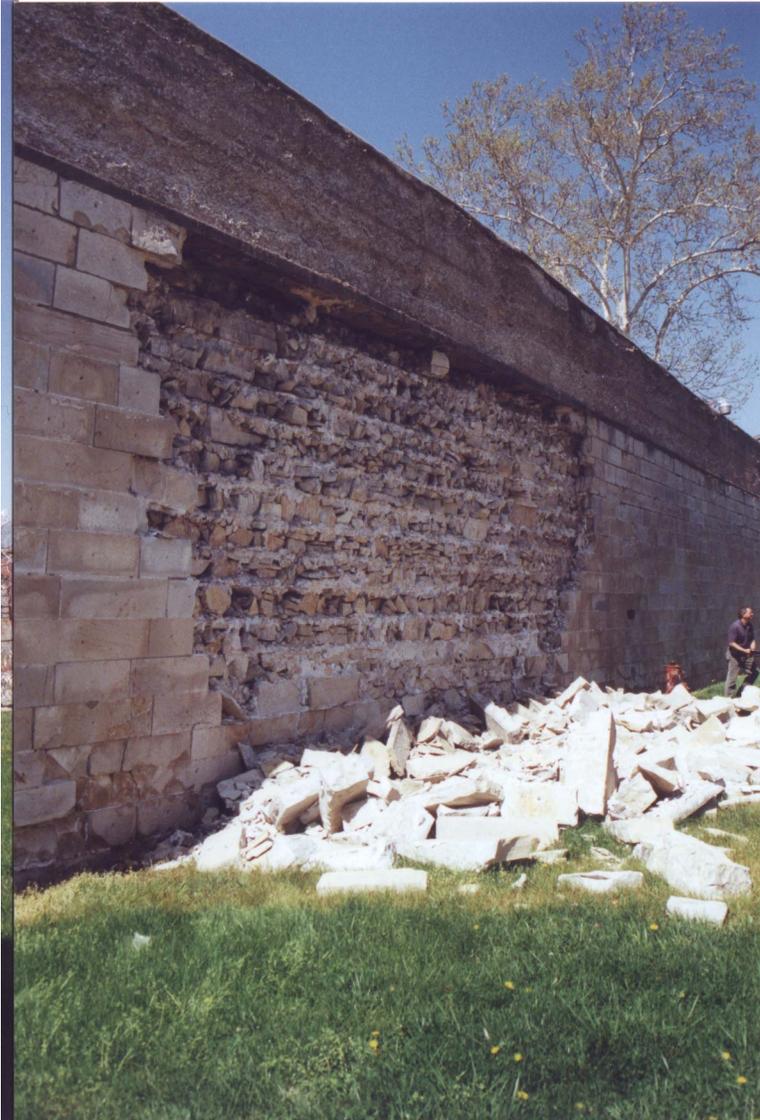
The wall on the south side of the facility has a large area of localized collapse. The collapse is only of the inner wythe of the stone wall. In this area the wall shows both rotation about the axis of the wall footing and a horizontal displacement between the two guard towers in the southwest corner of the facility. The wall is failing in overturning as well as possibly horizontal sliding. The damage appears to have been ongoing for many years. There are cracks associated with this movement which have been tuckpointed several years ago. The wall in this area retains 6 – 8 feet of soil; the grade being higher on the exterior side. There have been several types of utility work on the outside of the wall, which are in the influence zone of the backfill. It is possible that this utility work could have increased horizontal earth pressure on the wall, due to backfill compaction or water entering an open excavation. The wall is currently stable and is being restrained by the reinforced concrete band on the top acting as a tension strut. The portion of the wall,

which fell, appears to have delaminated from the middle and exterior wythes, which are still intact. The delamination would have been a consequence of the water infiltration as discussed in previous portions of this report. After the inner wythe was loose, it became unstable due to the angle of rotation of the entire wall. This wall should have a temporary bracing system installed to prevent overturning and complete collapse.

Collapsed Wall Section with Concrete on Top

To conclude, the primary cause of distress in the wall is water infiltration of the wall. The horizontal earth pressure has caused a section of the wall to rotate to the point where the loose wythe of stone collapsed. The portion of the south wall, which has partially collapsed, should be braced with a temporary frame to ensure public safety until a permanent bracing system is installed and repairs can be made. From the standpoint of economy and site logistics a steel frame on the interior side of the wall would seem to be the optimal solution. Care should be taken during the installation of the bracing to ensure the safety of the construction crew. Work should proceed from the guard towers towards the center and the concrete beam at the top should not be disturbed until the shoring is in place.

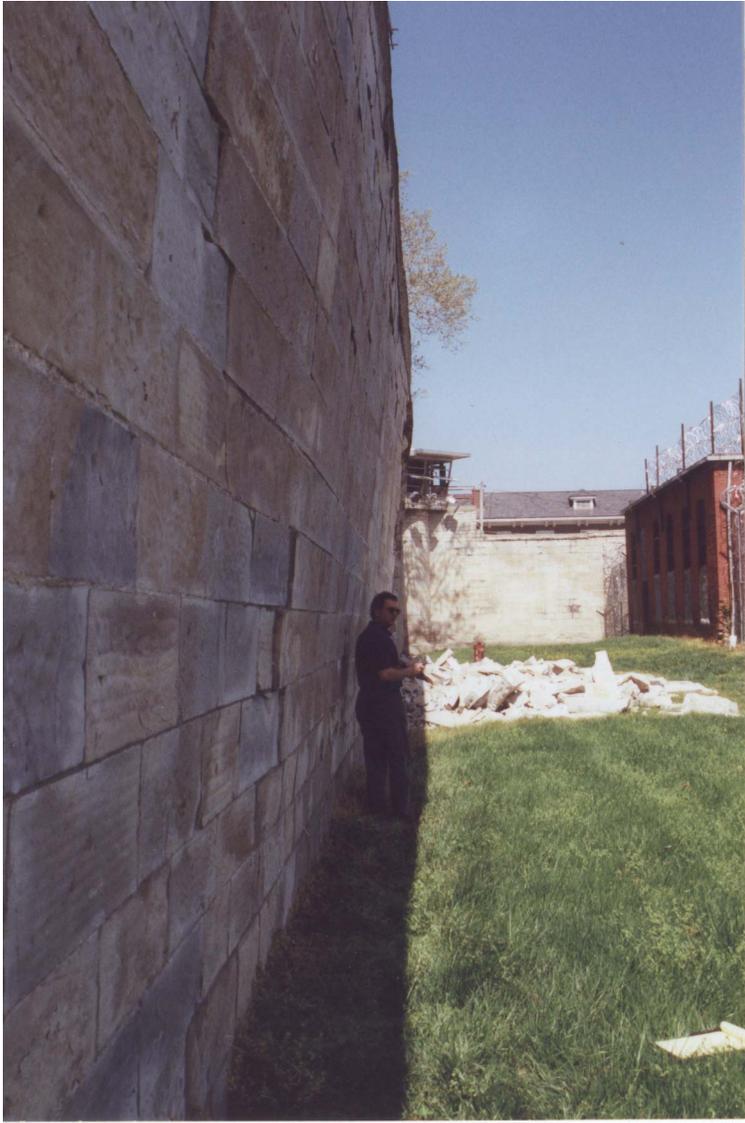
Wall Rotation
