# Architecture

M S P

## Introduction

The Project Team has conducted a redevelopment/reuse overview evaluation of the existing project structures which were identified in the Process Definition Plan (the Consensus Plan) for further consideration and inclusion in the Framework Plan. The structures evaluated included:

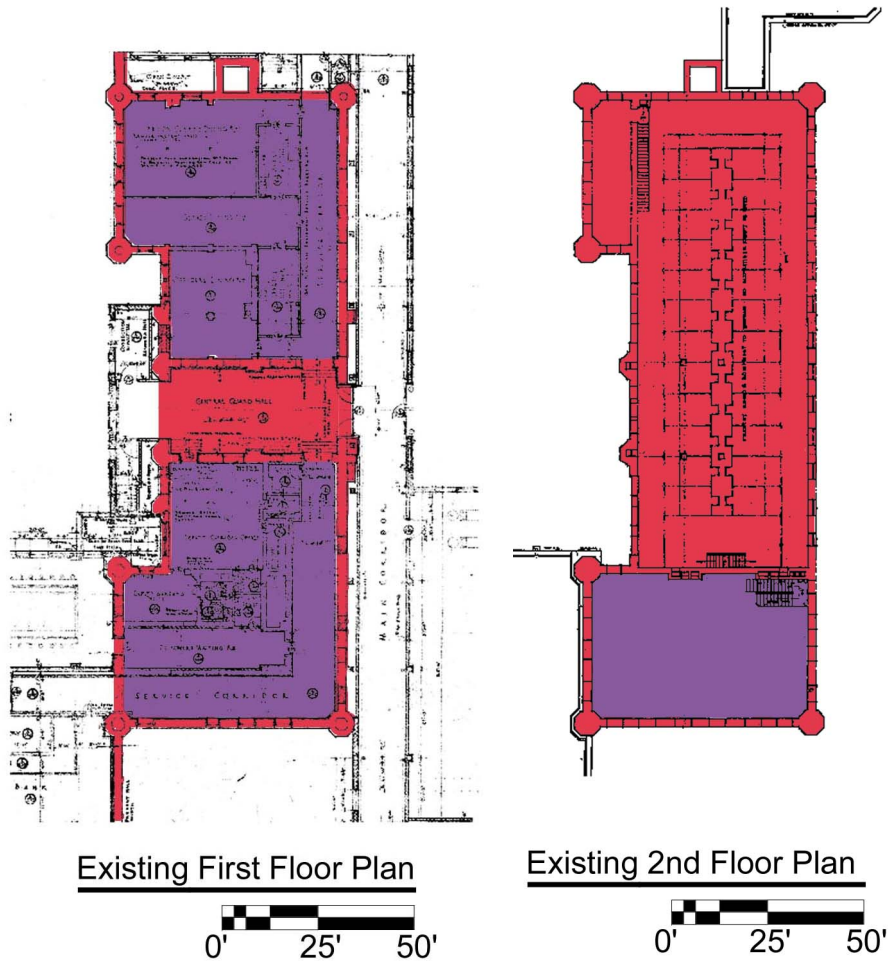
### Preservation Zones

- Level 1 - Preservation Zone**  
The character & qualities of this zone should be maintained & preserved as the highest priority
- Level 2 - Preservation Zone**  
Every effort should be made to maintain and preserve the character and qualities of this zone
- Level 3 - Rehabilitation Zone**  
Undertake all work in this zone as sensitive as possible; However, contemporary methods, materials, & designs may be selectively incorporated
- Level 4 - Free Zone**  
Treatments in this zone, while sympathetic to the historic qualities & character of the building, may incorporate extensive changes or total replacement through the introduction of contemporary methods, materials & designs

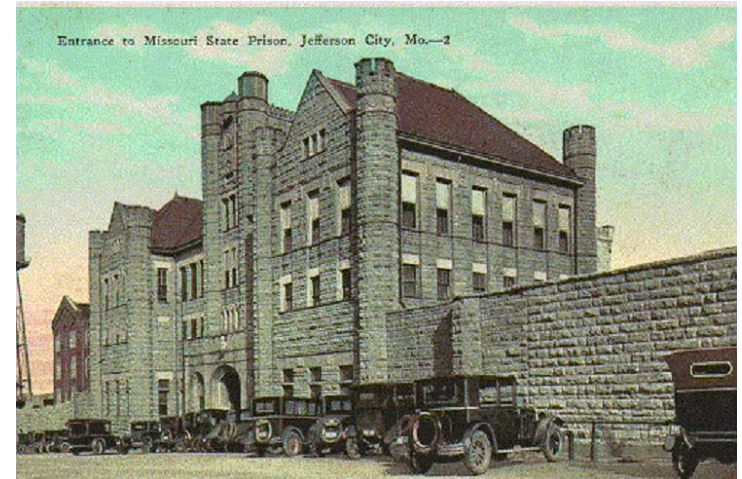
Historic View of West Elevation prior to WPA (1936) additions, the rear pre-1885 structure is barely visible to the right.

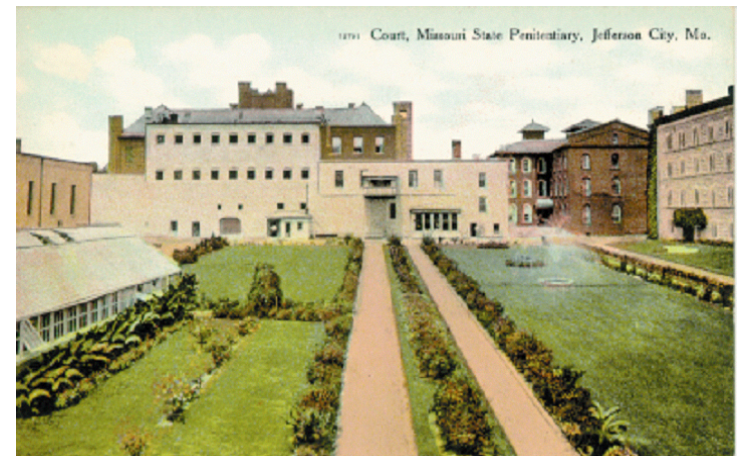
Historic View of East Elevation prior to WPA (1936) additions, the rear pre-1885 structure is shown here.

1. How should the east elevation be restored once the WPA corridor is removed? The brick infill where H.U. #1 attached to the pre-1885 structure is somewhat unsightly. Rebuilding this structure should be considered in redevelopment plans.
2. Major modifications should be reversed for appearance and historic integrity. These include restoring the roof overhang, rebuilding approximately 5’-0” to the tops of the turrets, 7’-0” of the clock tower and restoring window openings that have been bricked in.

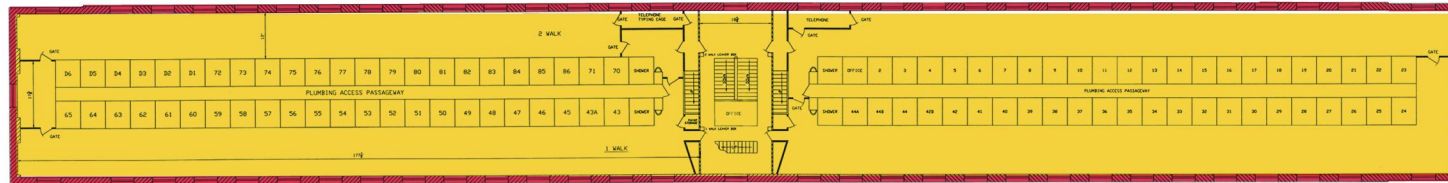
**Preservation Zones over Existing Plan**

**NORTH ELEVATION PRIMARY, FACES HISTORIC QUADRANGLE & SERVES AS BACKDROP TO VIEWS FROM 1868 H.U. #4**

1. The north elevation of this building can serve as the southern backdrop for the historic zone.
2. The steel cells are independent of the building structure, they can be removed without effecting the roof structure.

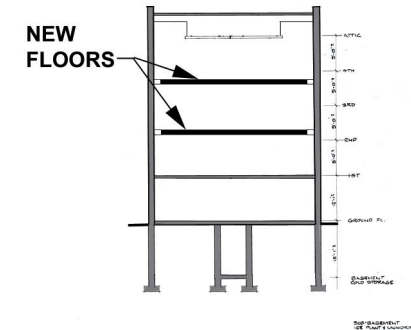
Alternate Section

Redevelopment plan: **Cells to be removed and new floors installed**

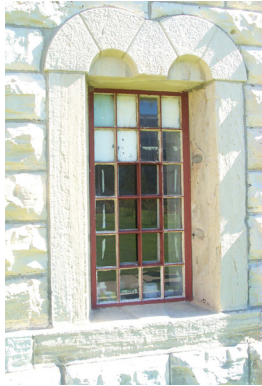
View of typical window

1. To what period should building be restored?
2. Roof overhang was removed.
3. A vertical mullion stone appears to have been removed at each window opening at the north and south elevations. This divided each opening into what was originally two separate windows.
4. Built for post-Civil War criminals.
5. Designed by Warden Horace Swift.
6. Stone was quarried on site by prisoners.
7. Oldest building existing on the site.

1. What period should the building be restored? Many modifications have occurred to the building since it's construction.
2. It appears that the roof overhang and soffits were removed exposing brick backup material above the stone walls, these should be restored.
3. Stone restoration will be necessary. There are crushed stones at various locations and missing stone mullions in the window openings that should be restored.
4. Integrating modern mechanical systems could be completely hidden. The extent to which this is done will be dependant on the interpretive philosophy for this building.

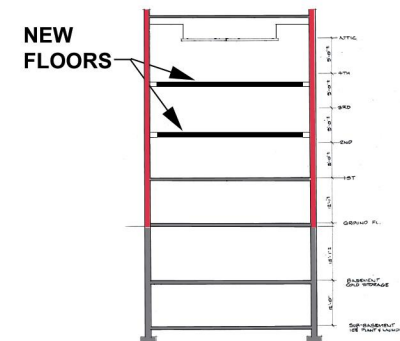
Alternate Section

Cells to be completely removed

1. Hotel – approximately 152 rooms (38 rooms on each floor x 4 floors)
2. Offices

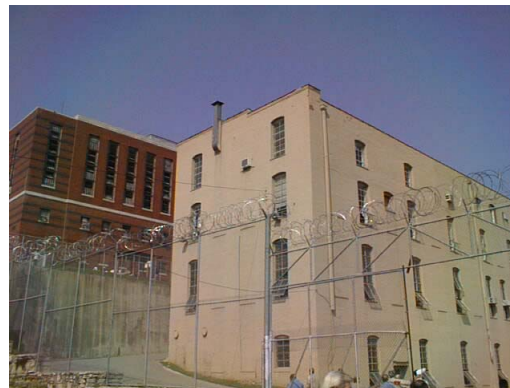
Northeast corner of building, H.U. 5 is in the background

1. A significant amount of the original window openings have been bricked in over the years, these should be re-opened and restored.
2. Paint should be removed from the exterior brick surface.
3. The original window design should be replicated and installed.
4. Existing floor-to-floor height is ideal for redevelopment.

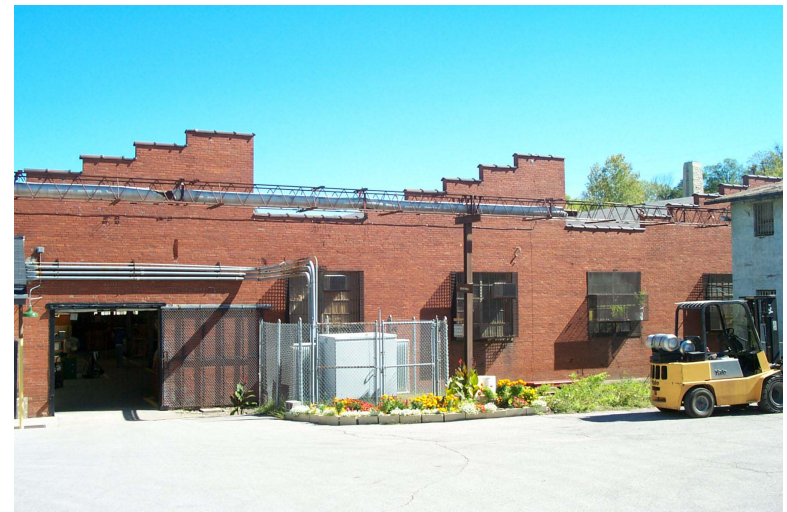
Existing view of South elevation, I-Hall is in the foreground to the right

1. Adjacent to the existing rail line, the prison stone wall should remain around this building as a sound barrier.
2. Early graveyard may be located around and/or under this building.
3. The adjacent Sallyport is an integral part of this building and should remain.
4. The number of columns throughout the space could potentially be reduced with transfer beams.

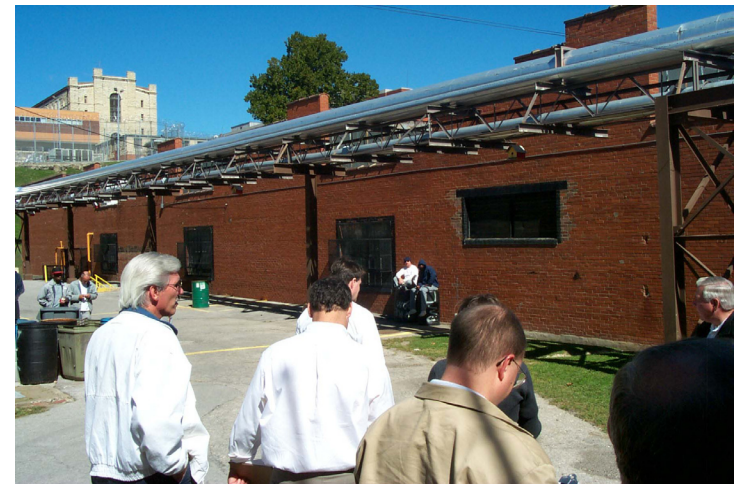
Existing South Elevation, above grade steam pipes are in the foreground

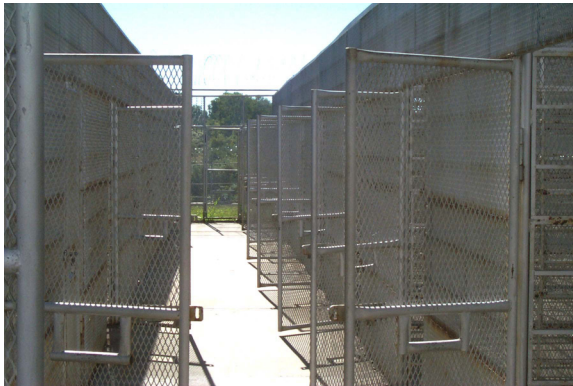
View of secure exercise yards above the Centennial Cells

1. Leave site undisturbed underground, interpret through maps, drawings & other historical information.
2. Excavate and interpret as ruins.

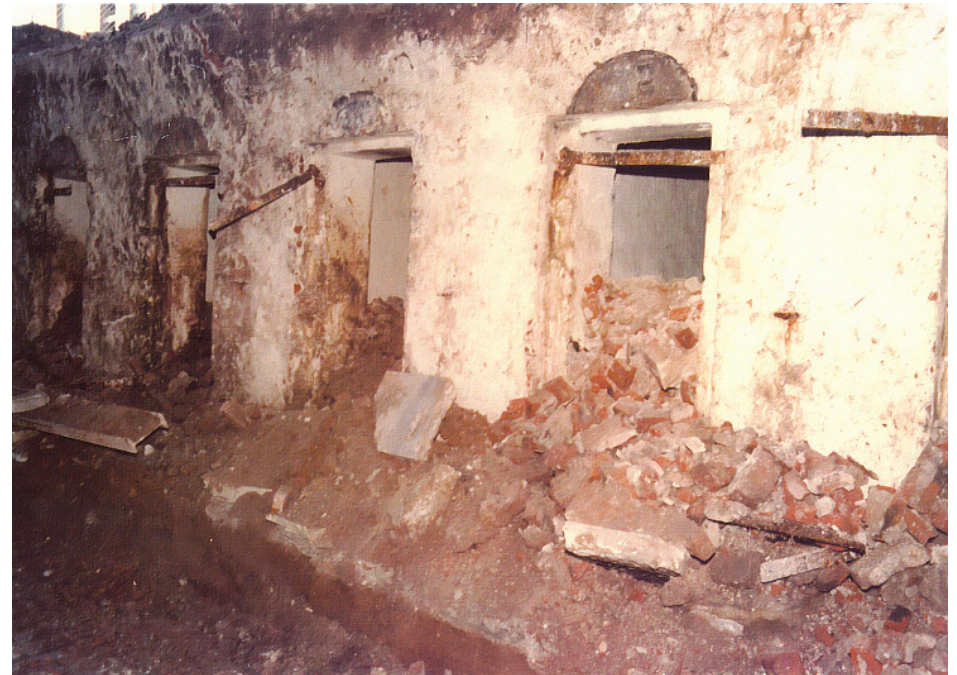
Photograph by Mark Schreiber taken during archeological investigation

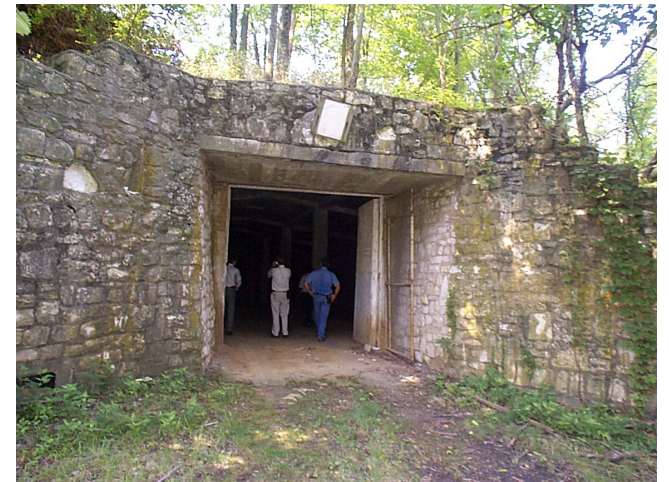
Existing view of North elevation

1. Separated from the historic area by the roadway and stone walls.
2. The structure is buried under an earth berm. Some large trees have grown on top of the structure; the larger trees should be removed in order to maintain the building.

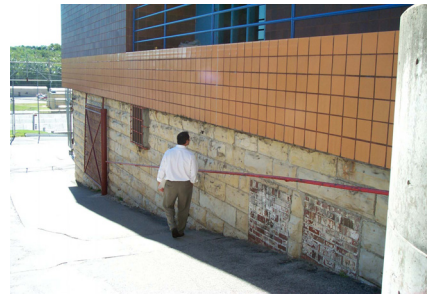
View of the north elevation of the Education Building / Dining Hall

1. Meeting Hall for Convention Center

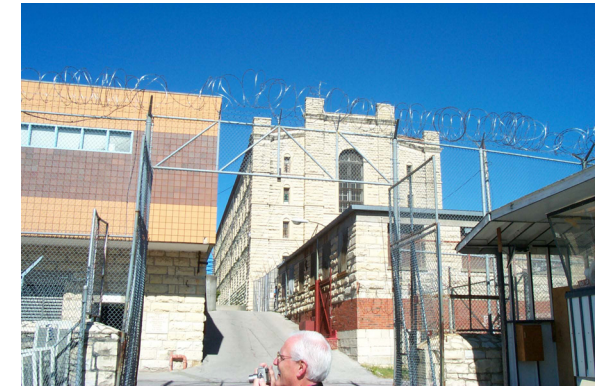
Current photograph looking west with H.U. 4 in the background. The Dining Hall is to the left and the Clothing Factory (currently Maintenance), to the right.

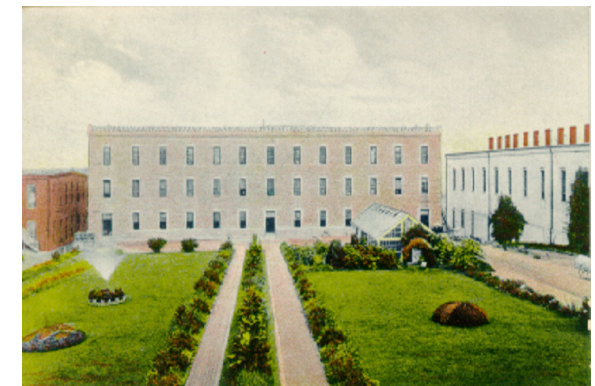
Early photograph / rendering of stone Dining Hall with brick Clothing Factory to the north.

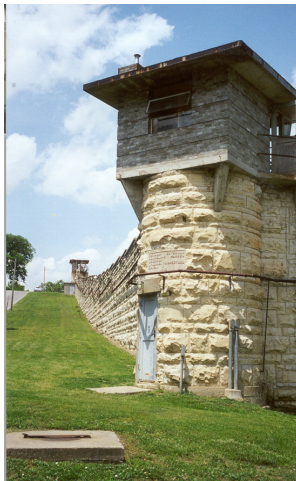
Existing view of typical guard tower.

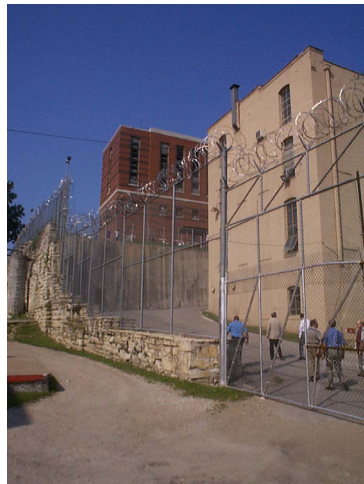
Existing view of Northern end of pre-1885 wall @ Shoe Factory
