Framework Plan

The MSP Redevelopment Project

Appendices A, B, C, & D

Observations of the Enclosure Walls

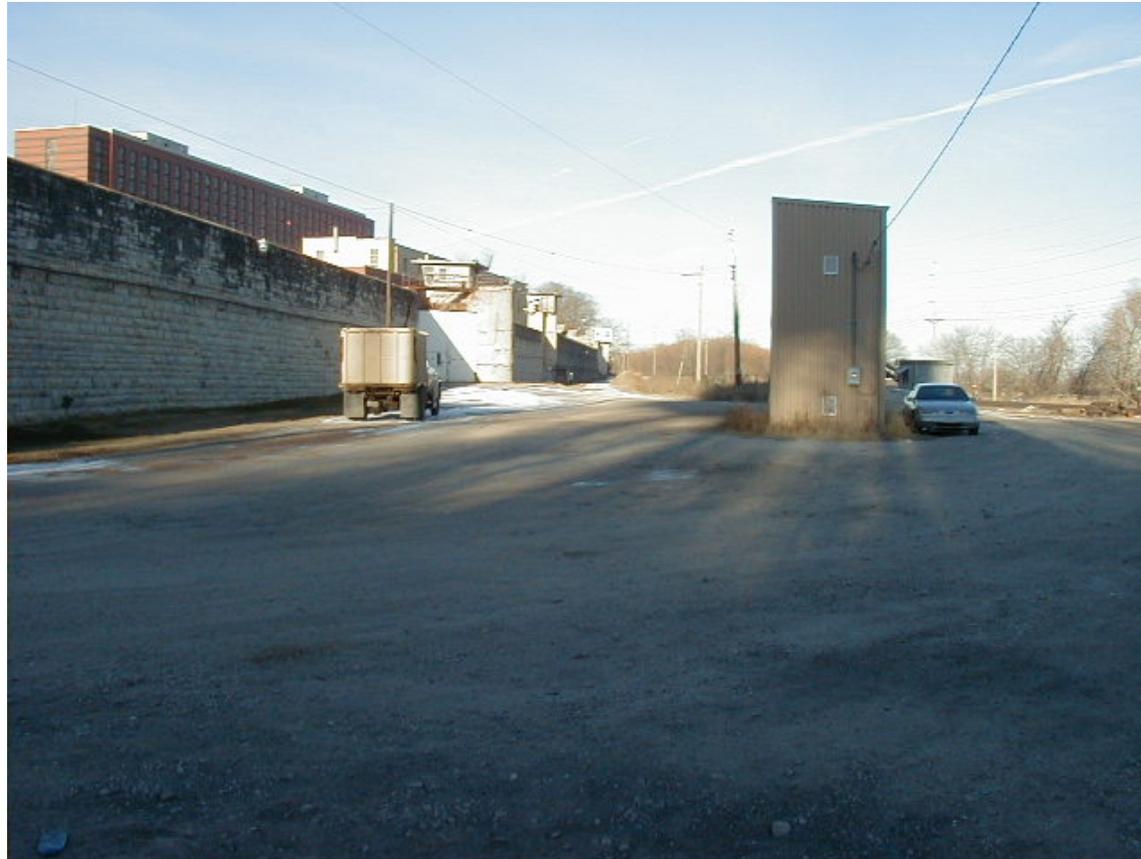
Truck gate northeast wall facing northwest

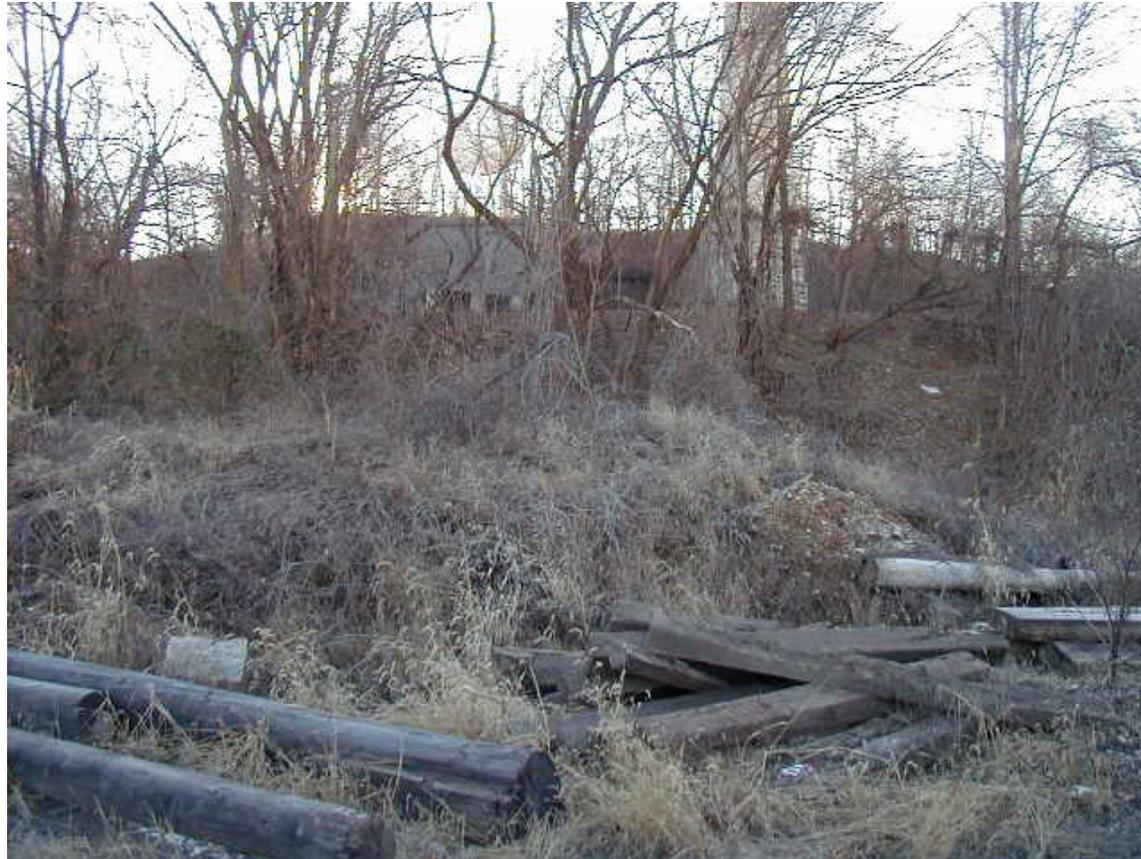
Area below incinerator and slaughterhouse facing south

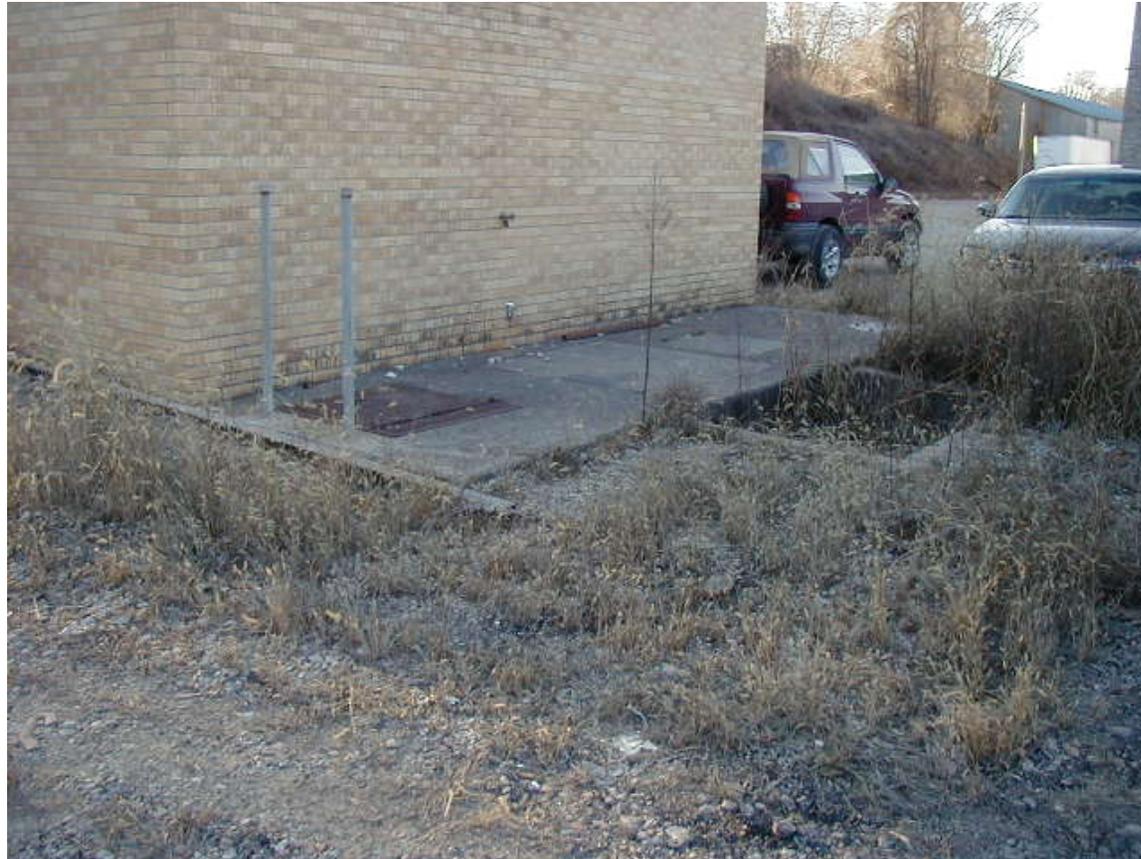
Wastewater treatment plant facing south

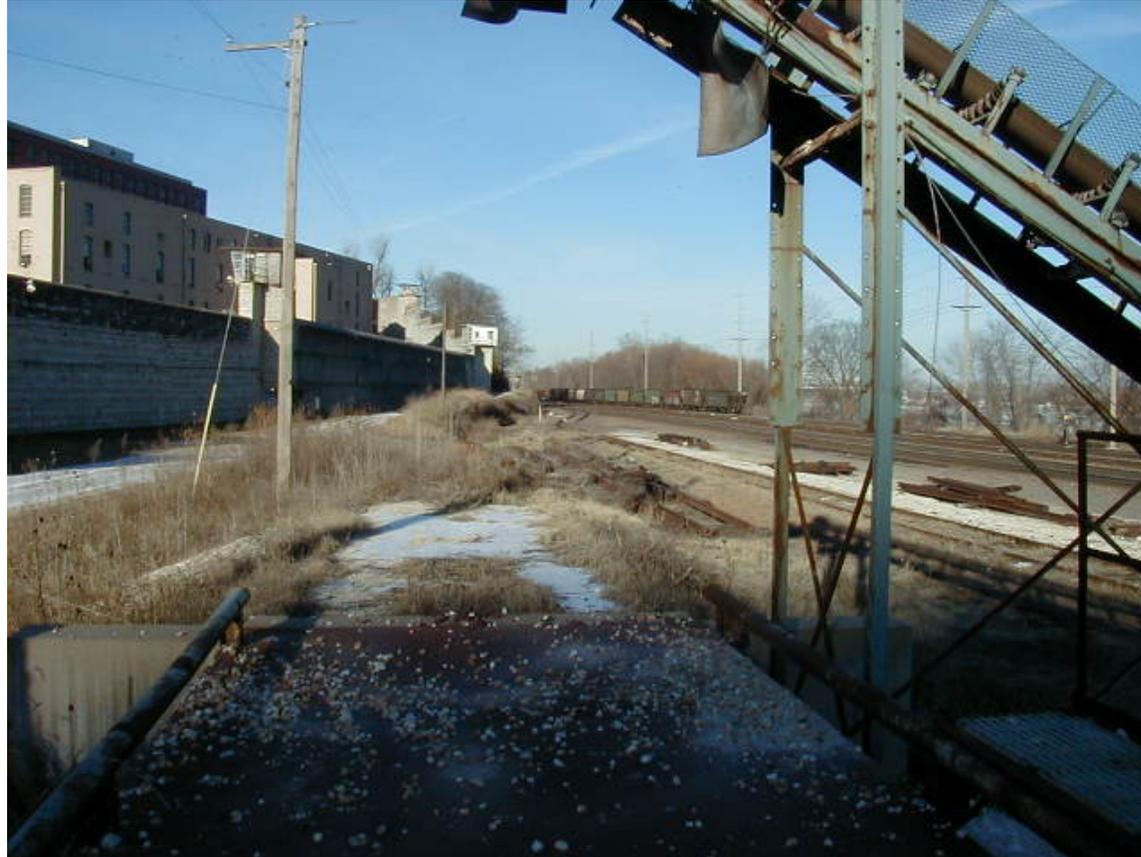
Northeast wall and Union Pacific Railroad facing northwest

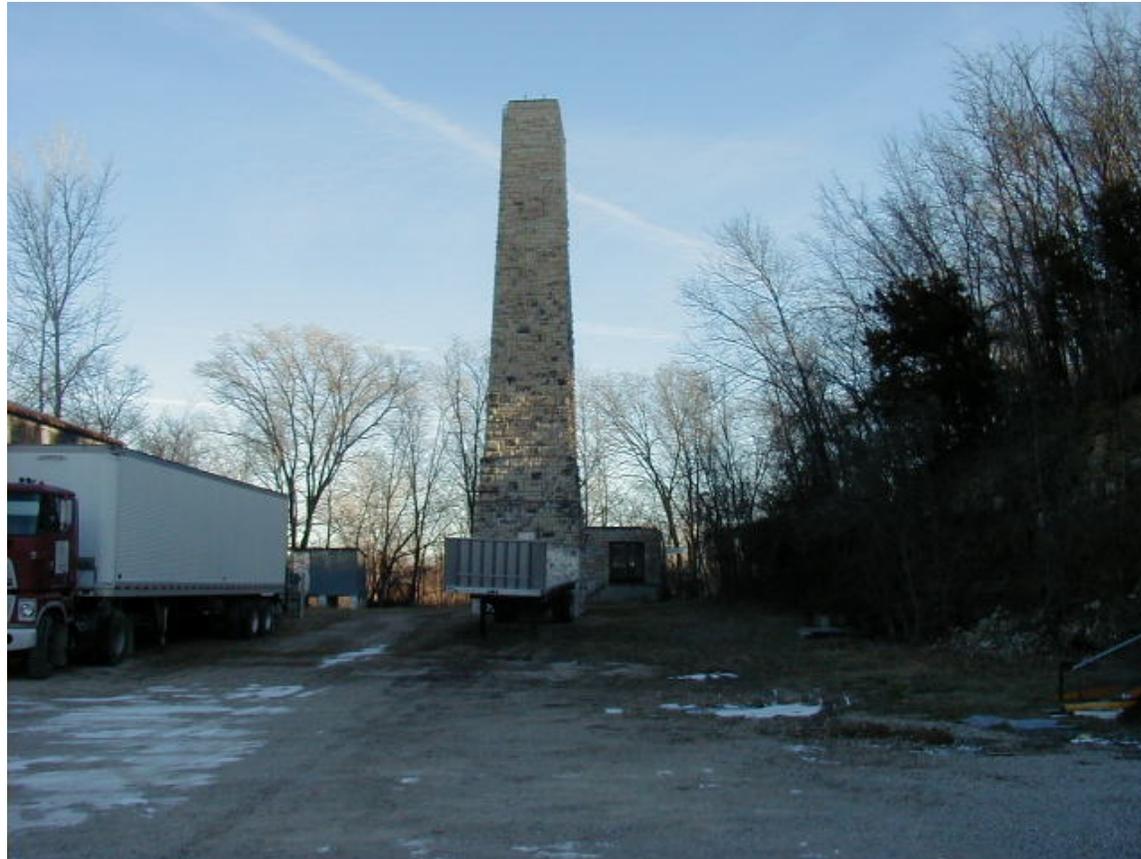
Abandoned incinerator facing north

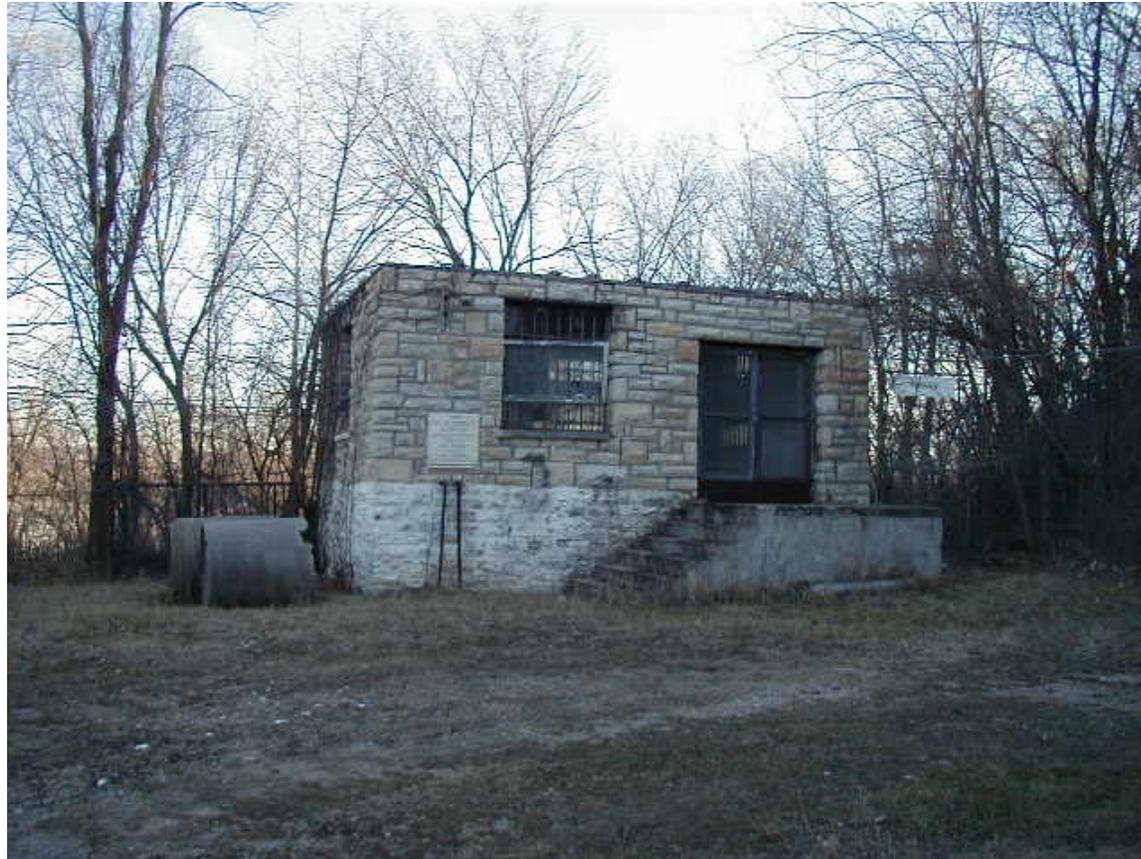
Lard house facing northeast

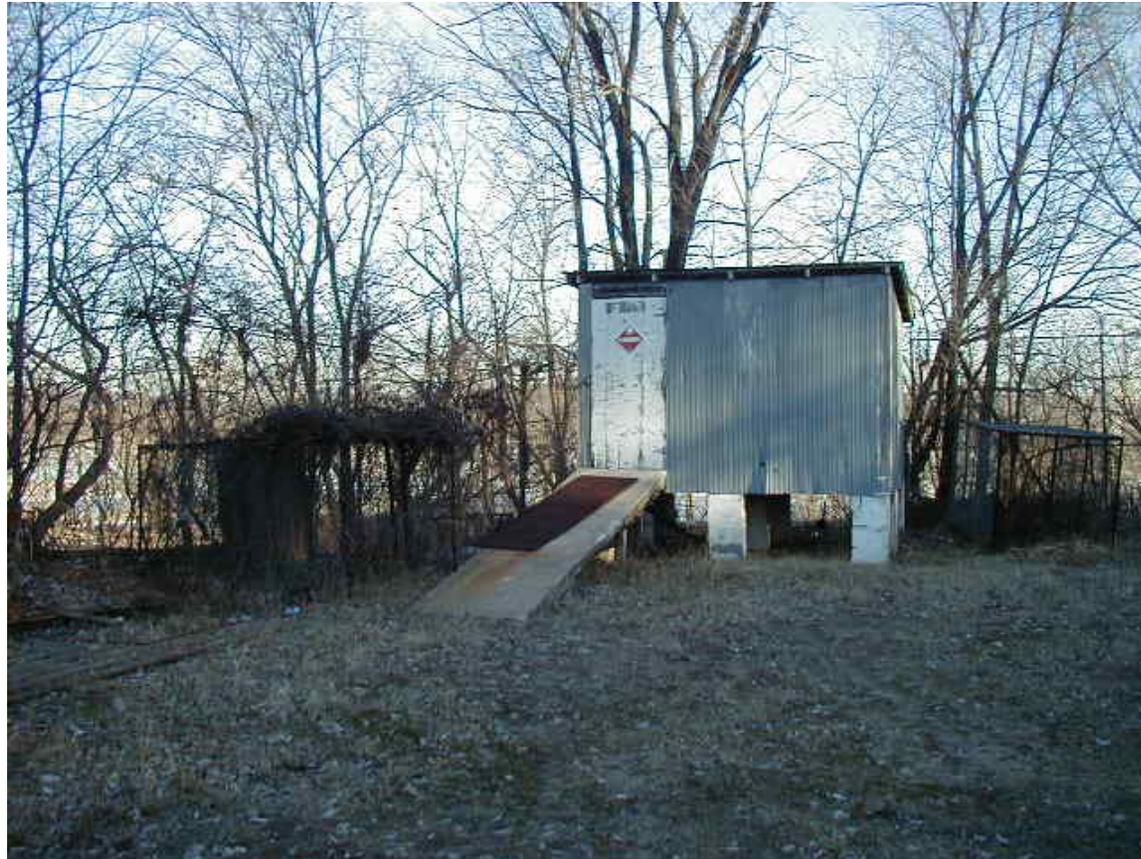
Storage shed facing north

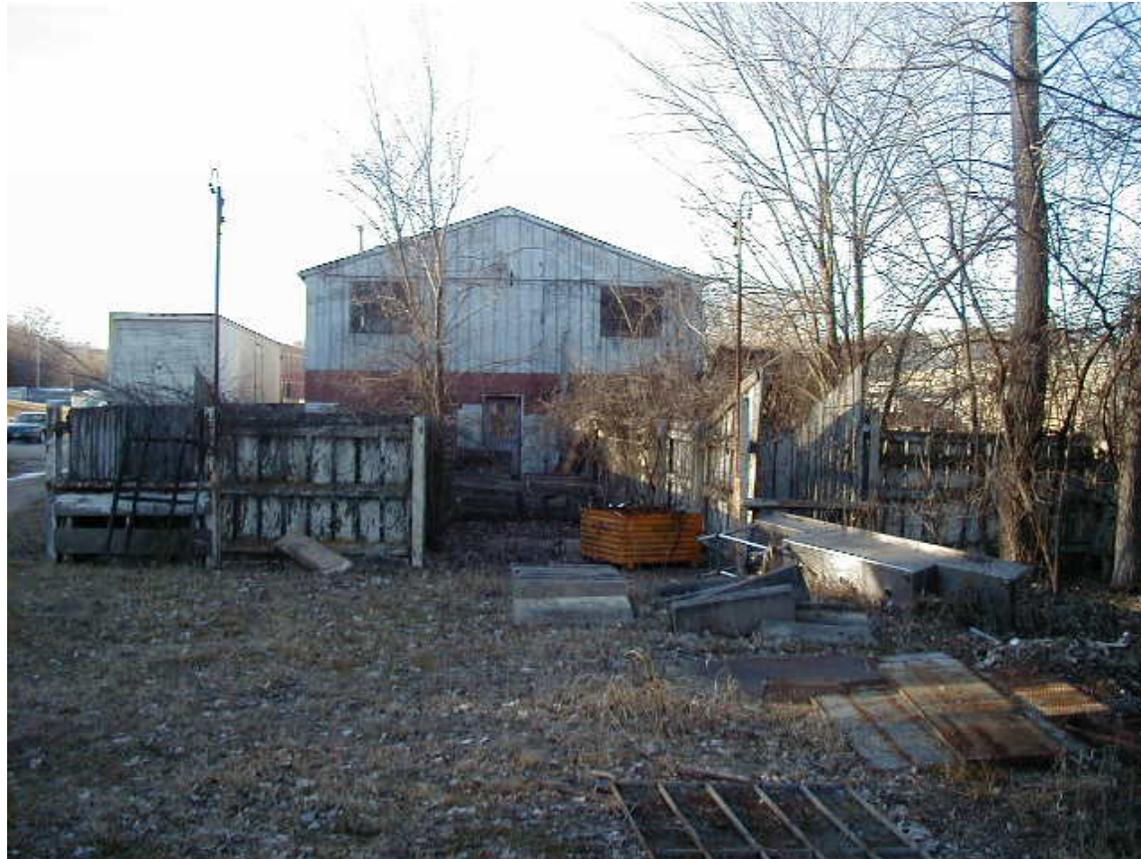
Abandoned slaughterhouse facing southwest

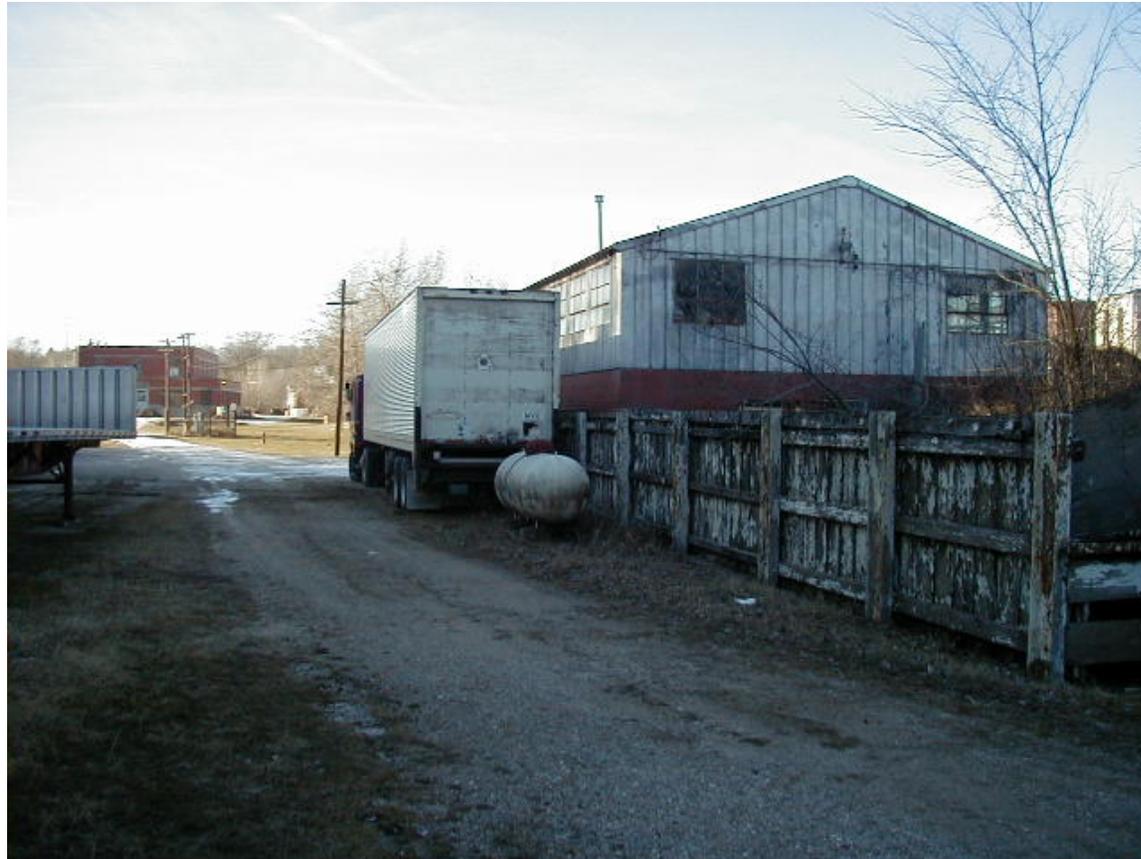
Abandoned slaughterhouse facing west

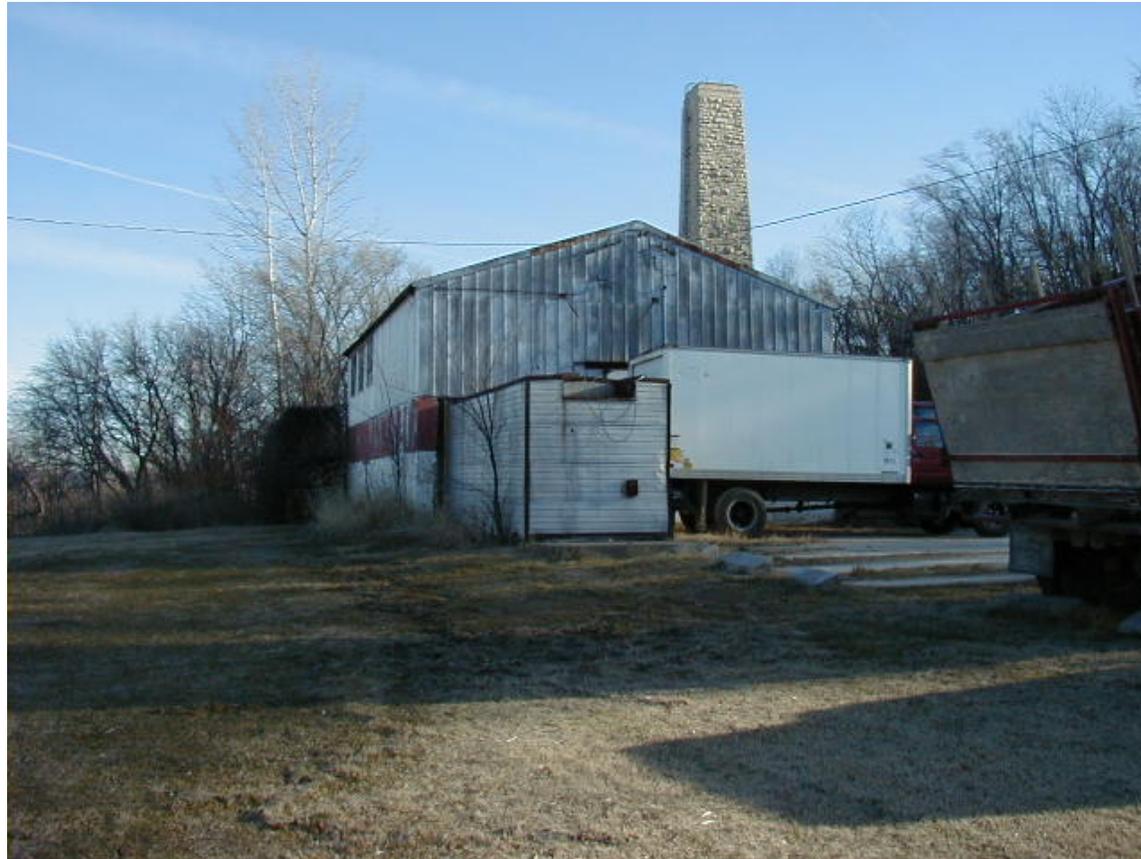
Rear of diesel plant facing southwest

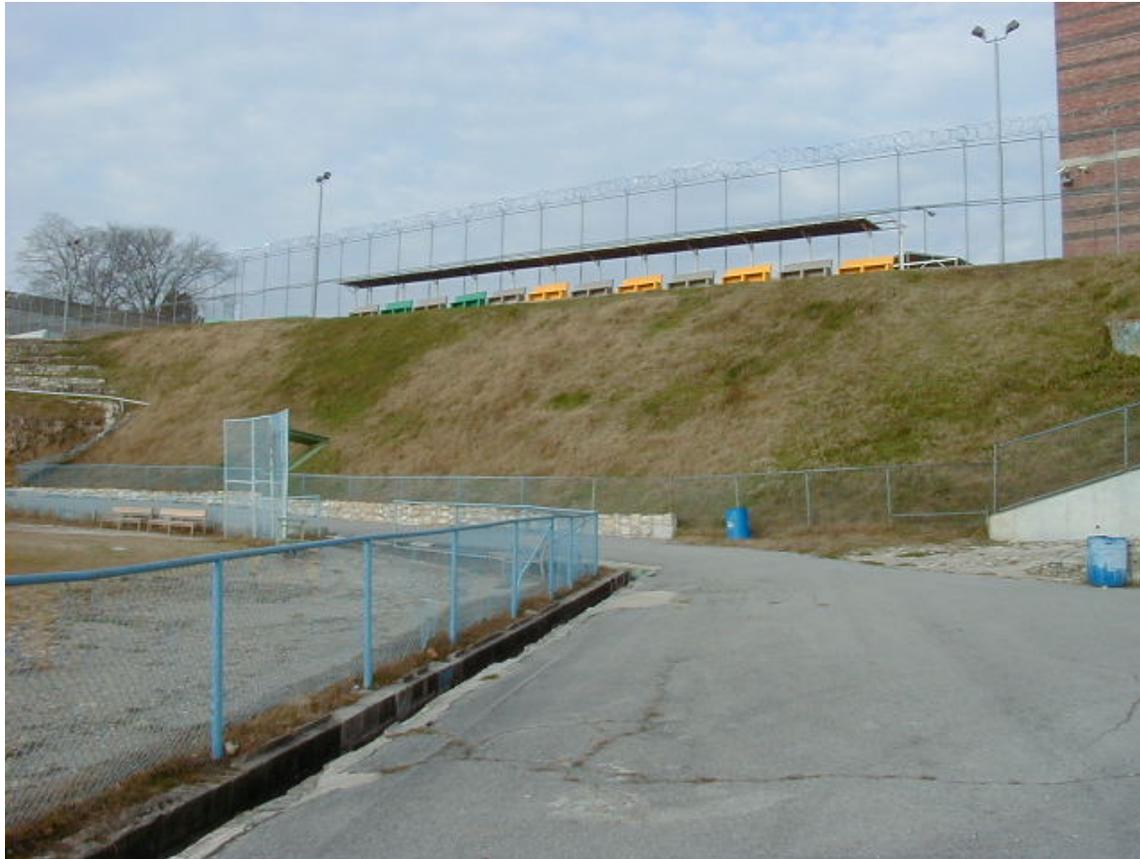
Fill soil bank between Upper and Lower Recreation yard Facing West

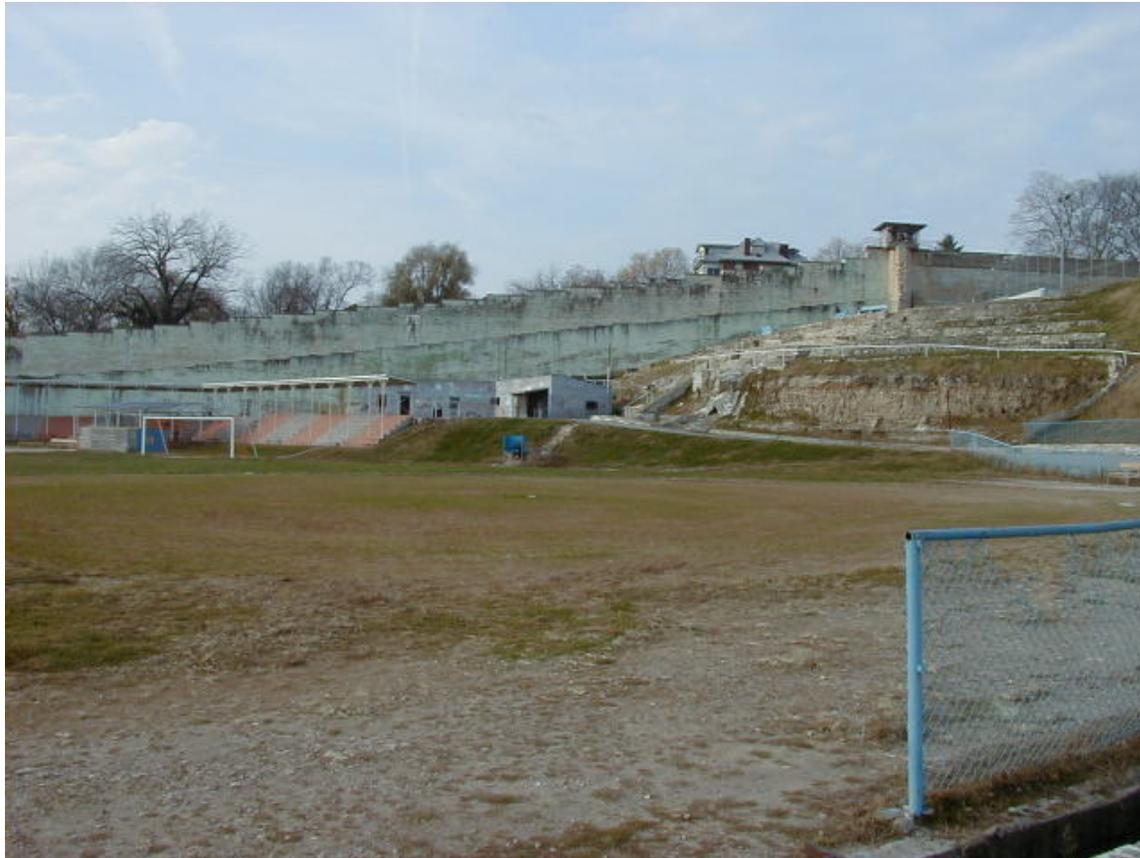
Lower Recreational yard Facing South

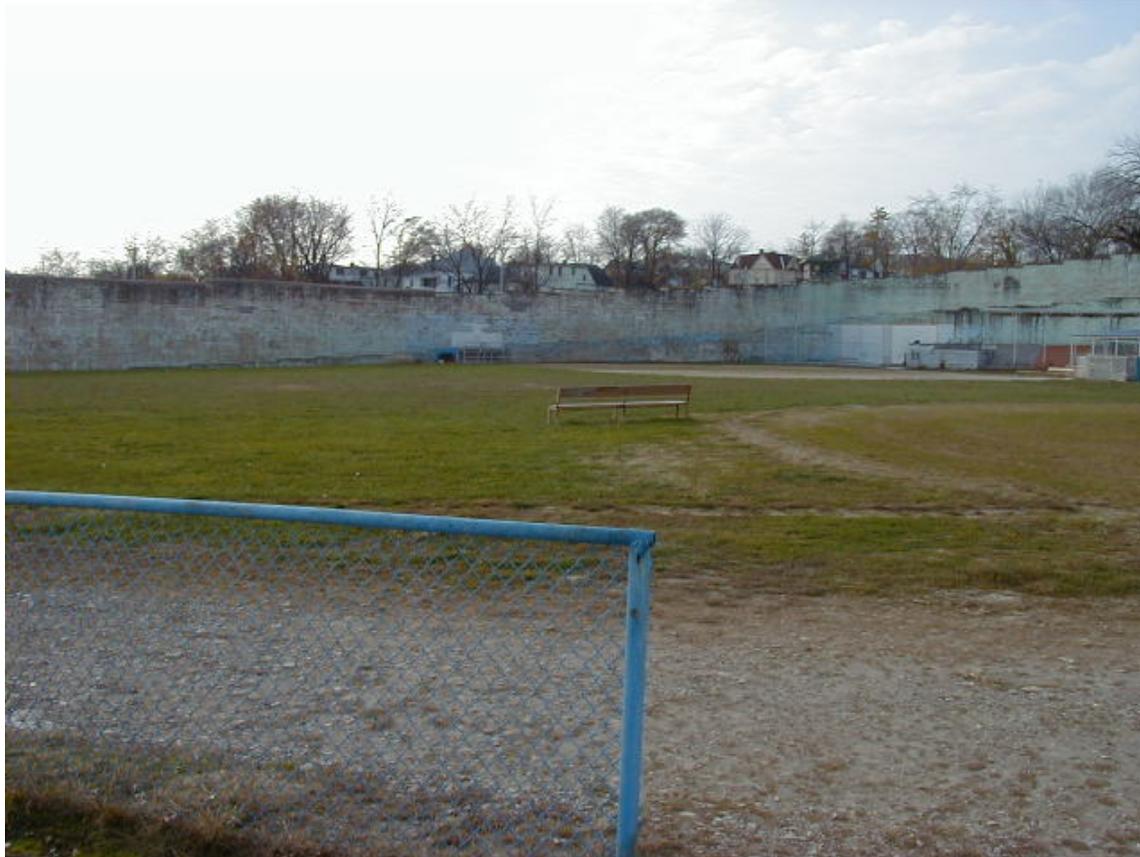
Lower Recreational yard Facing SouthEast

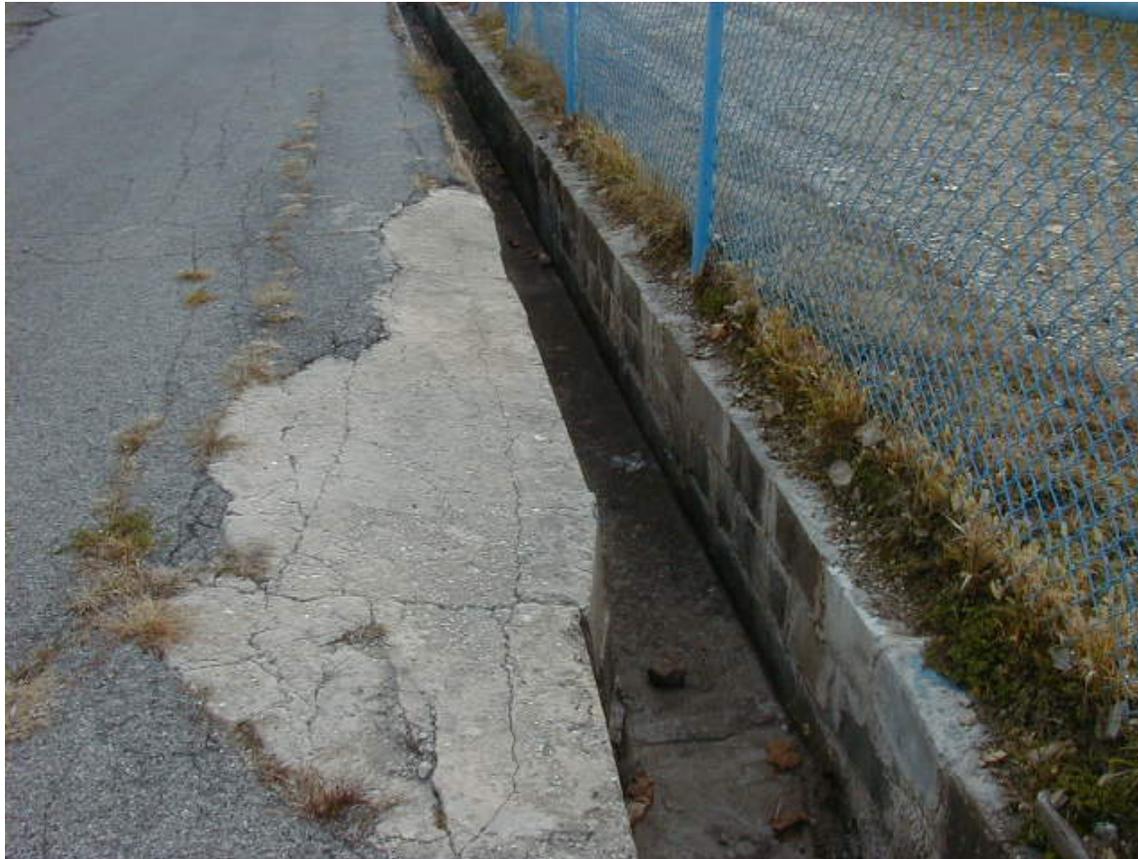
Drainage culvert along Lower recreation yard

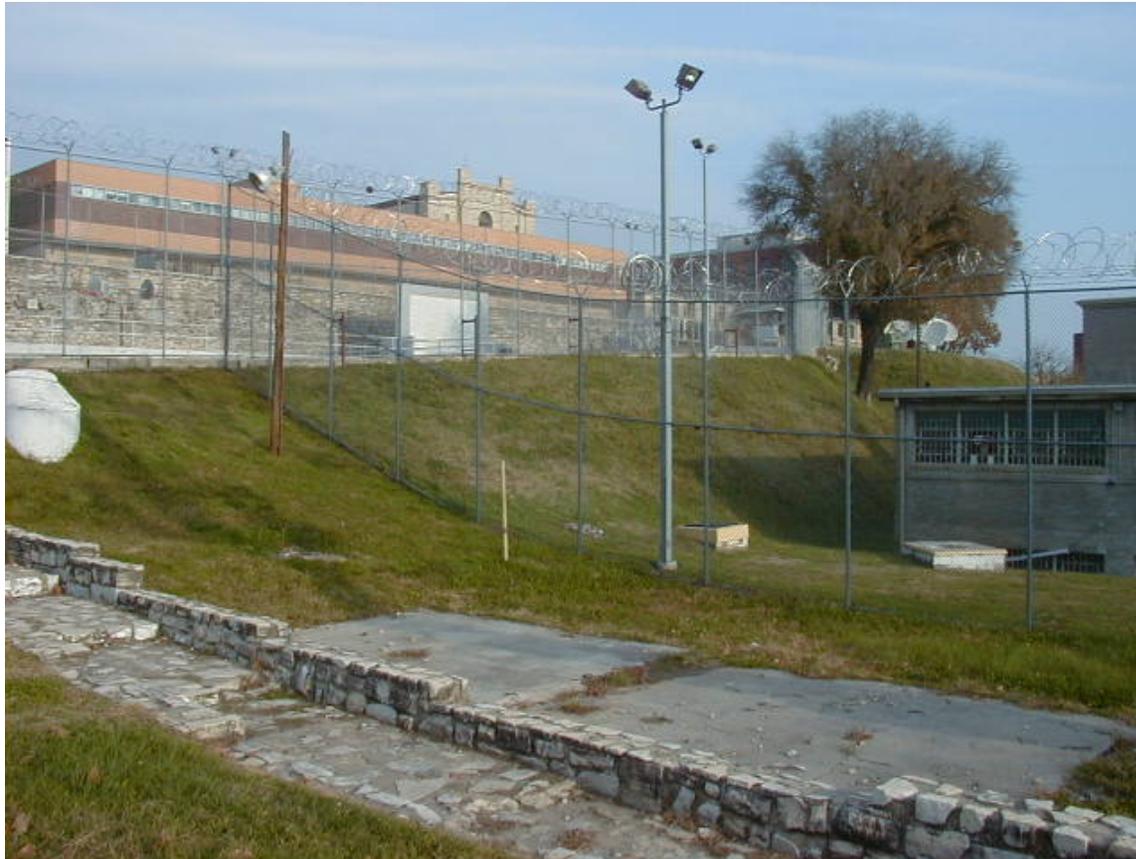
Soil bank between partition factory and school facing North

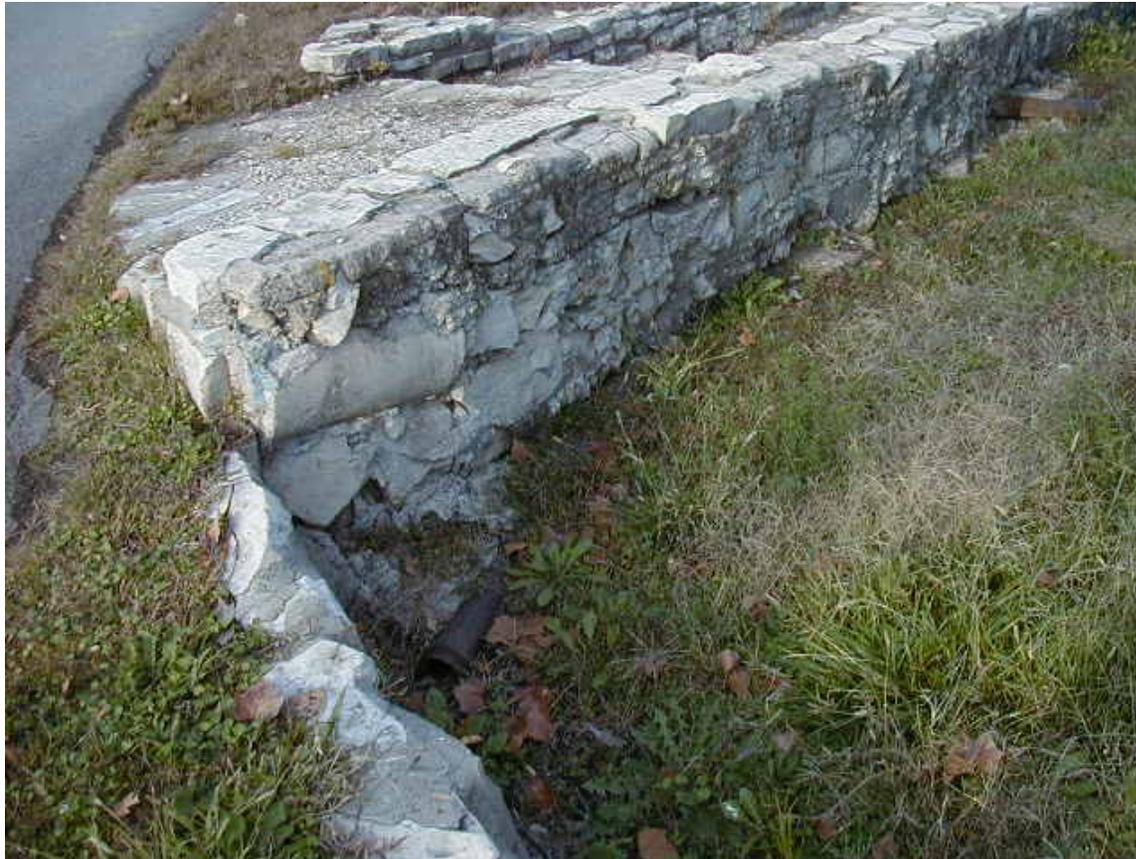
Drainage South side of partition factory

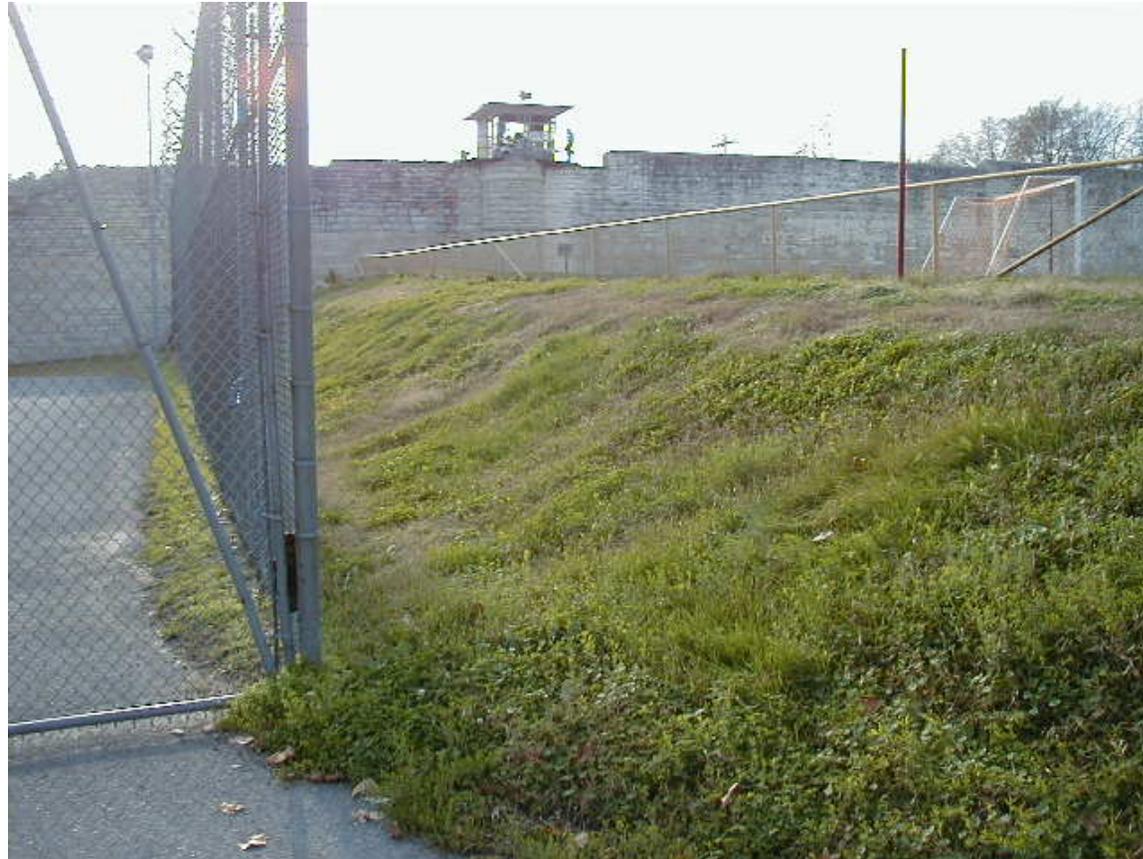
Soil bank between lower recreation yard and partition factory facing East

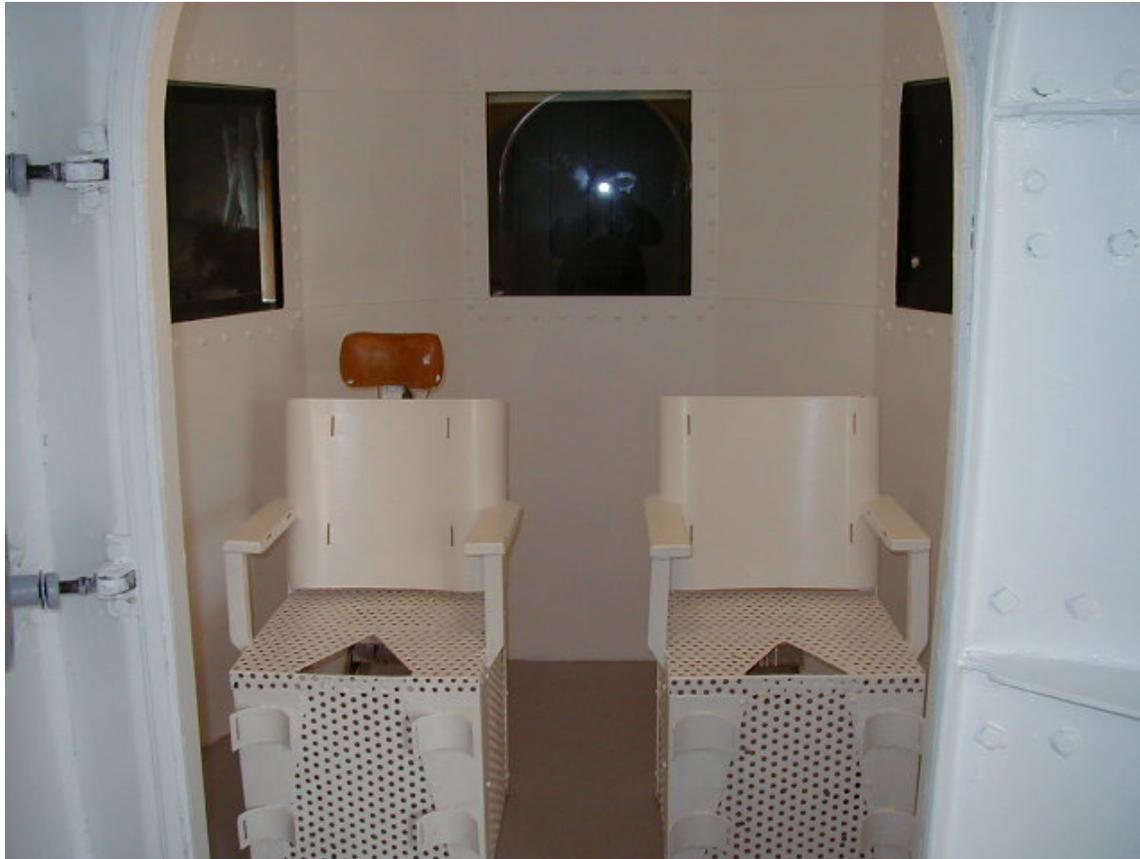
Inside gas chamber

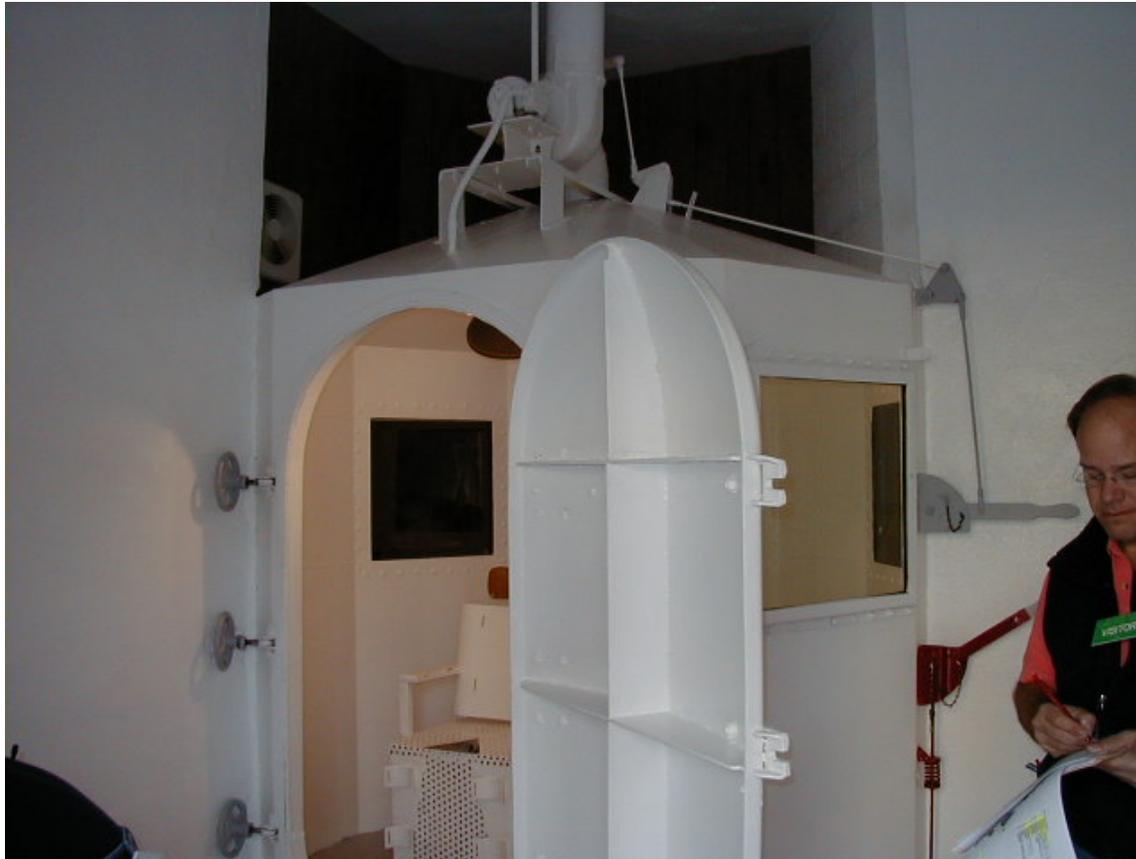
Gas chamber vent system

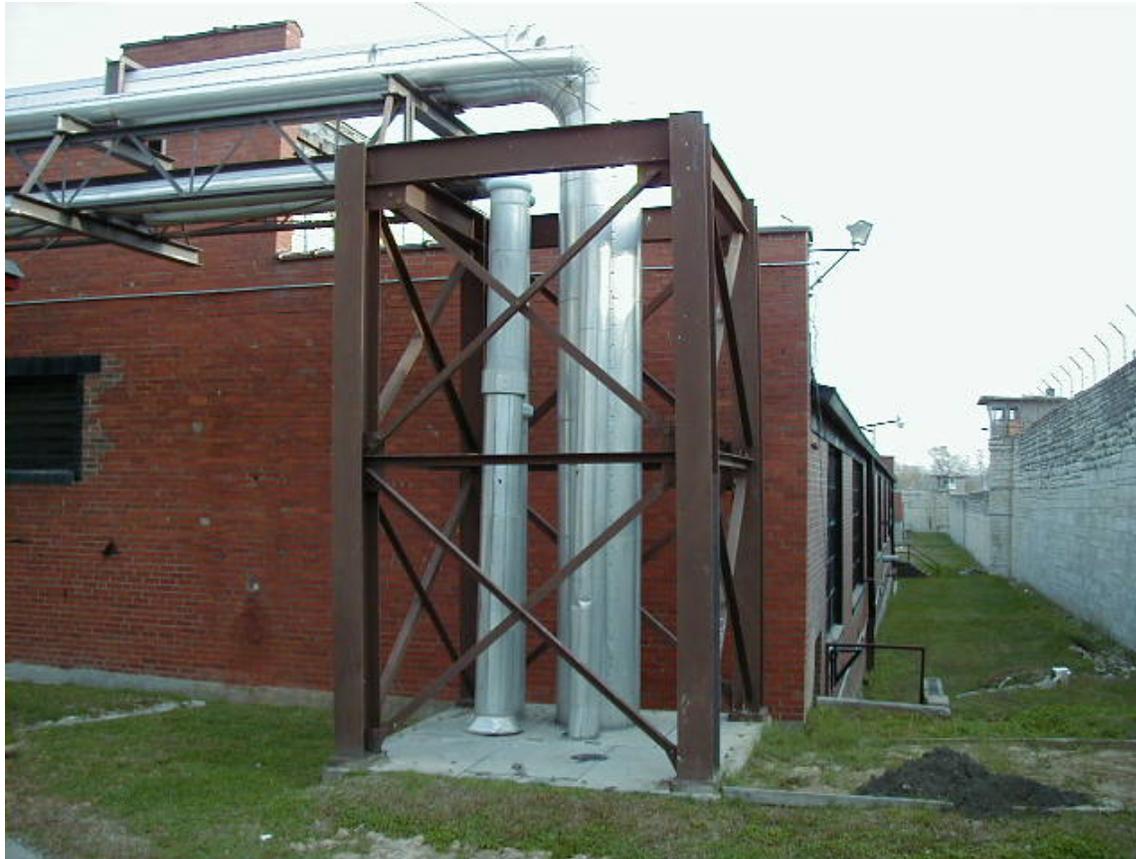
Steam lines between partition factory and metal plant facing North

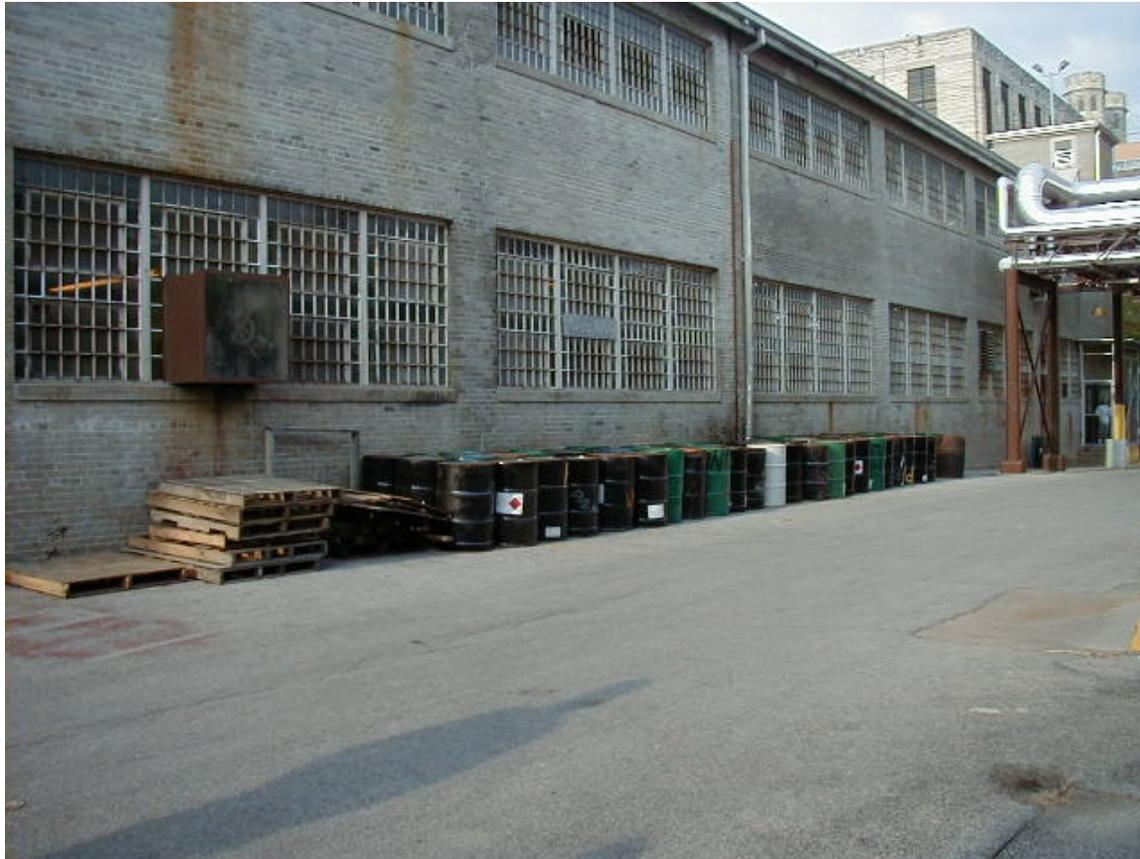
Empty drum storage behind partition factory facing West

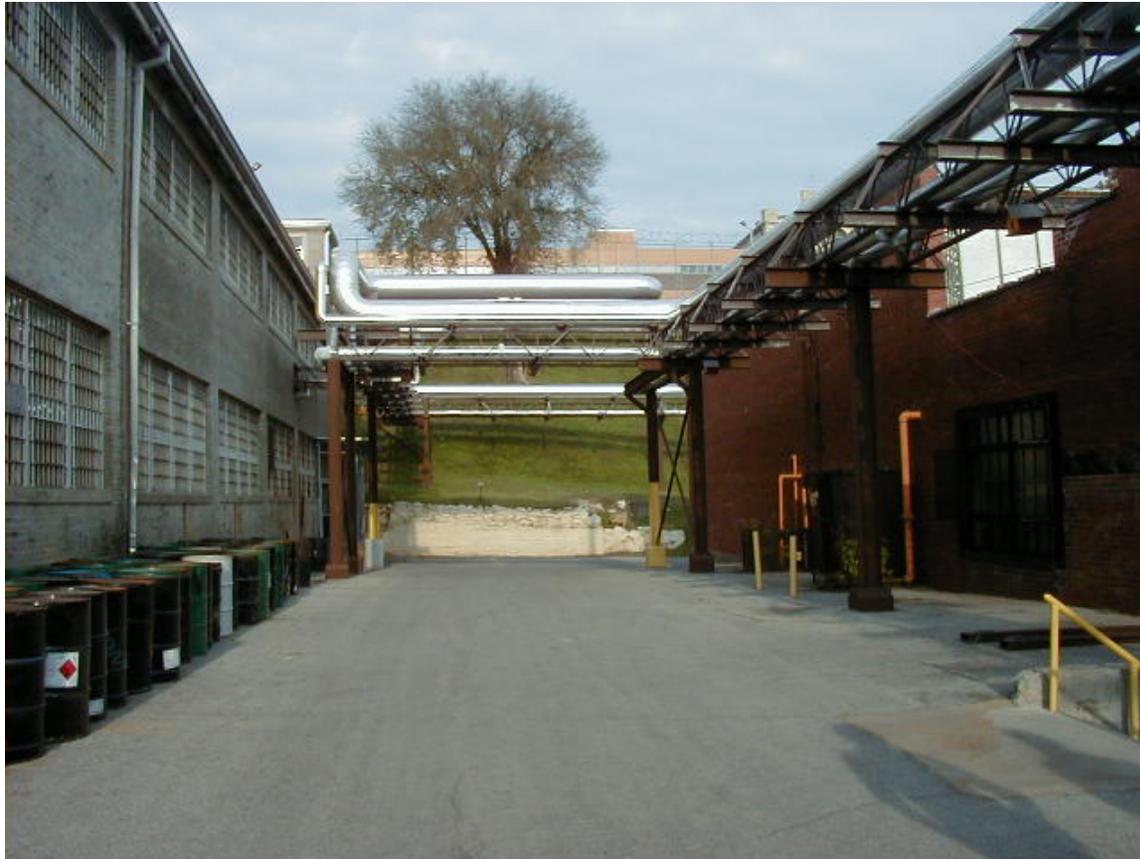
Steam lines between partition factory and metal plant facing West

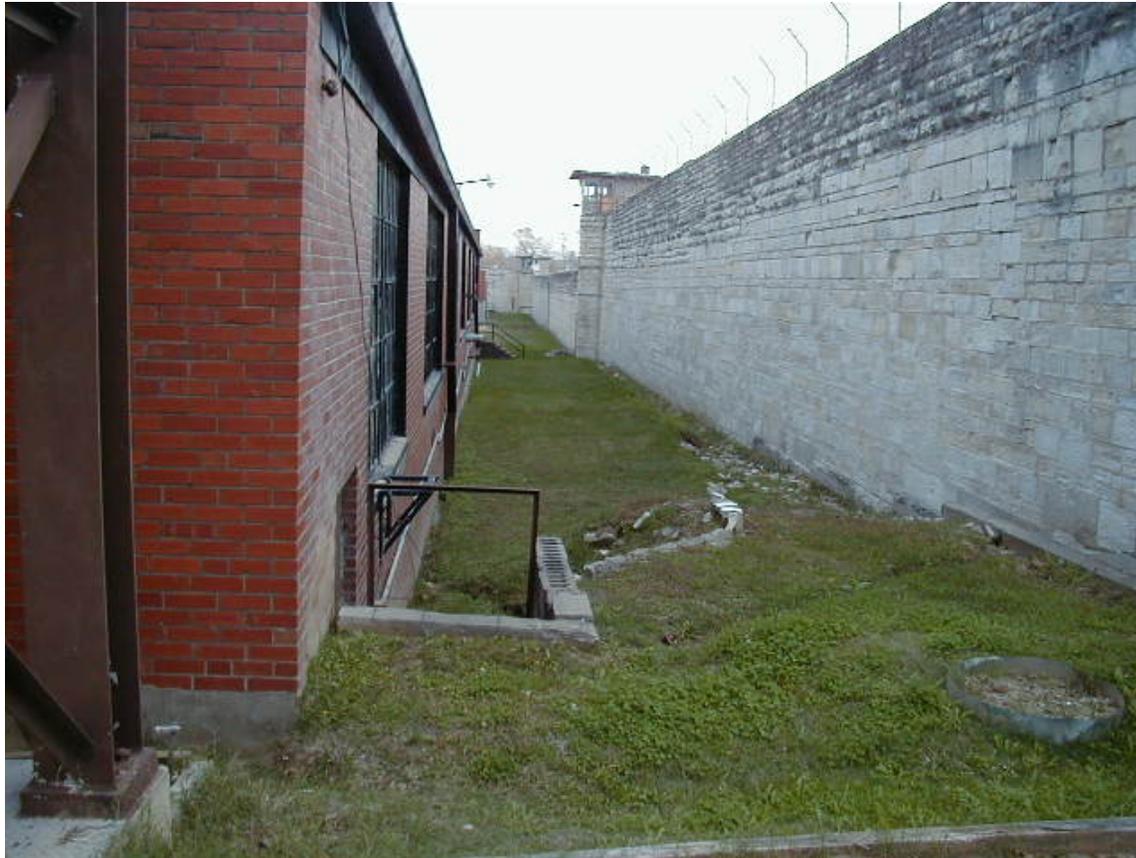
Area between metal Factory and East wall facing North
