Framework Plan

The MSP Redevelopment Project

Appendices A, B, C, & D

Observations of the Enclosure Walls

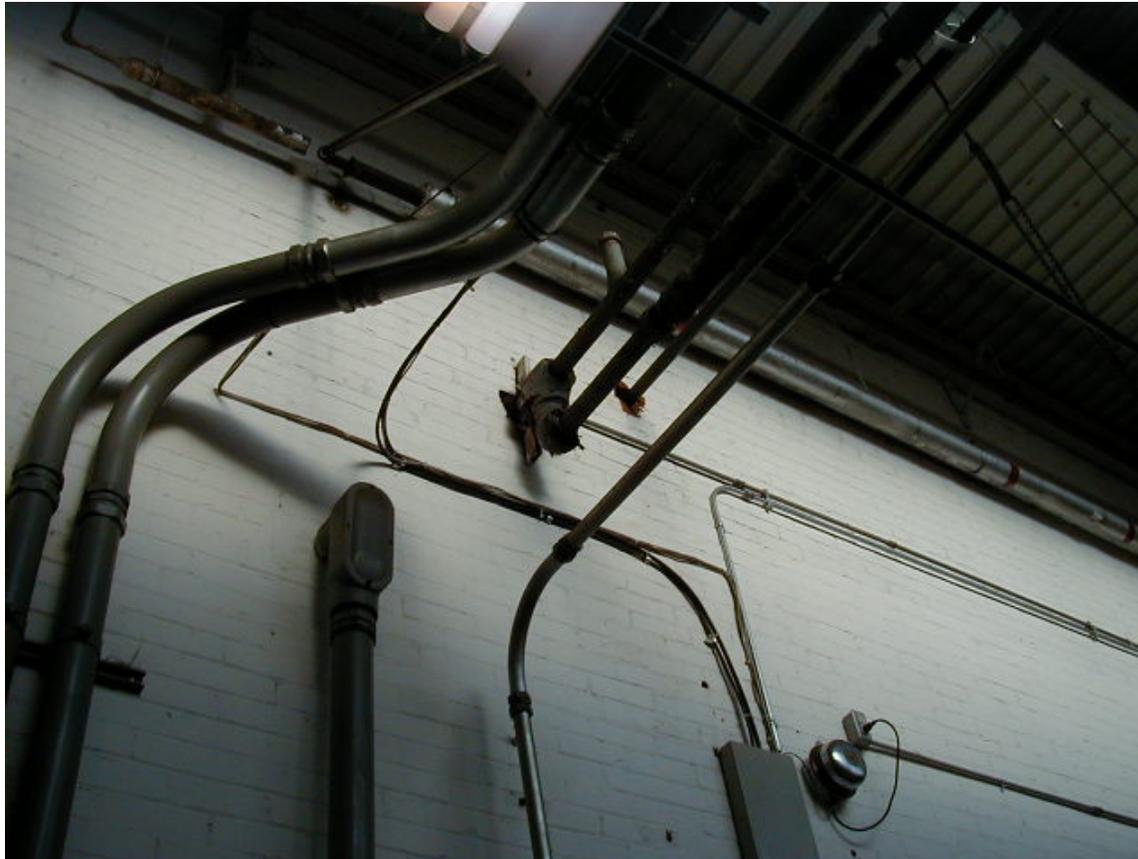
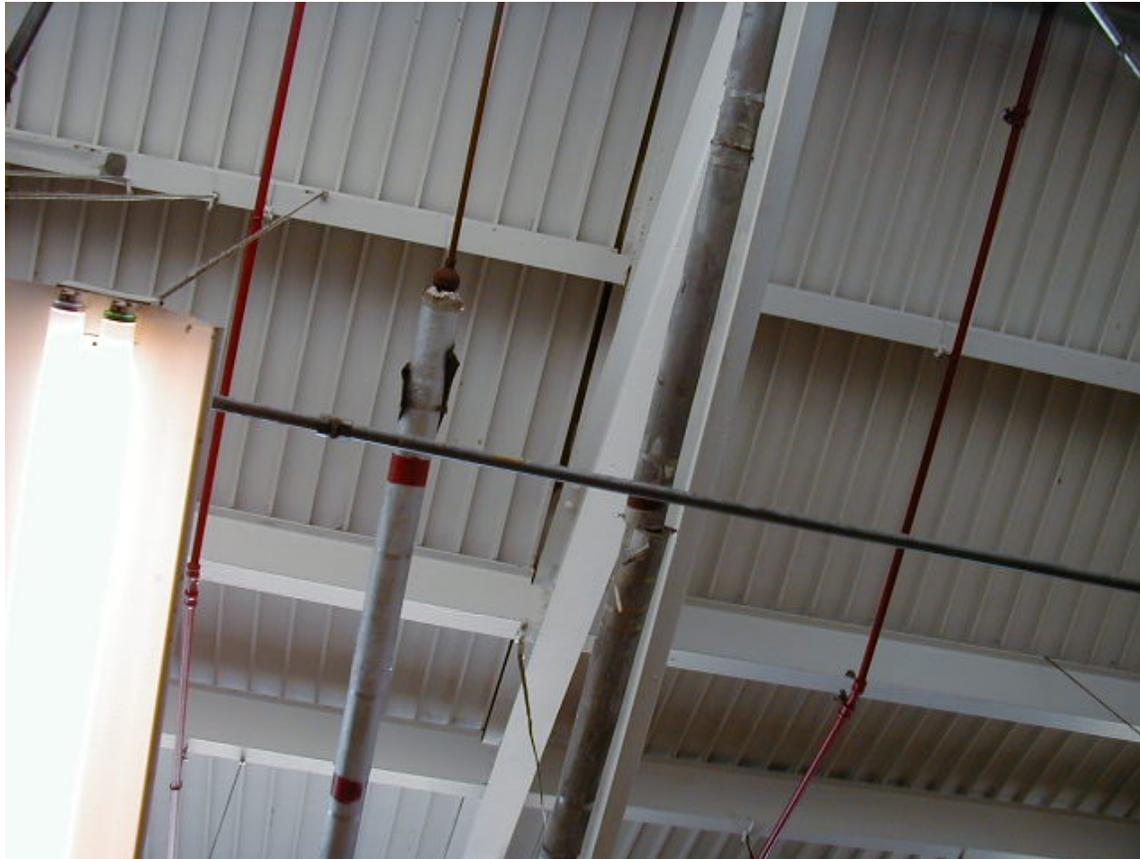
Pipe insulation Metal Factory

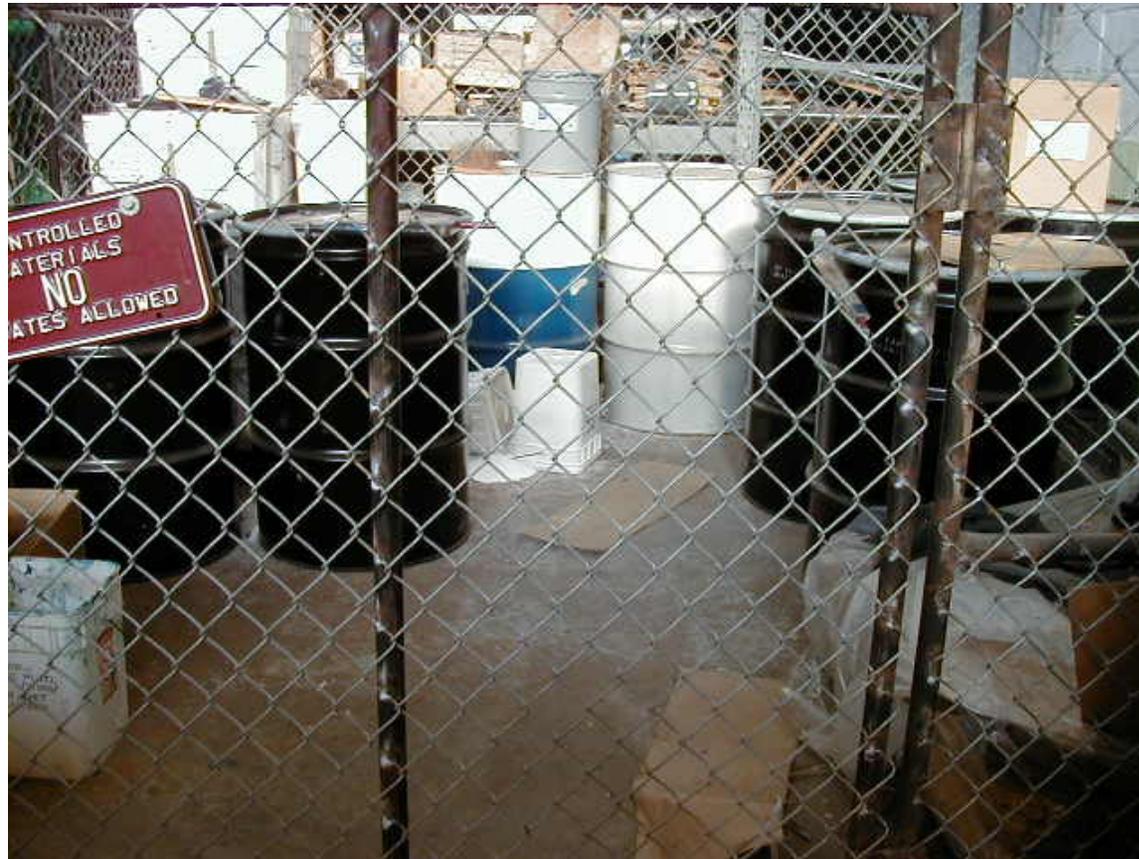
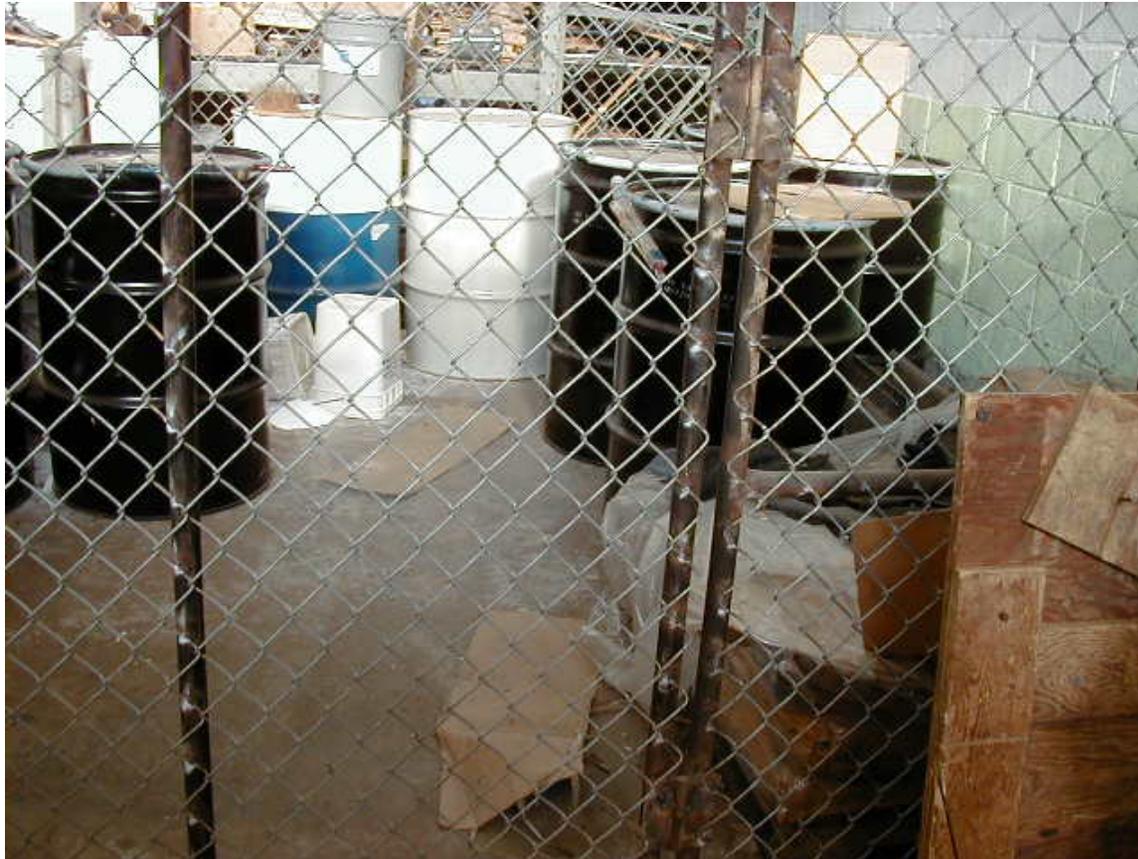
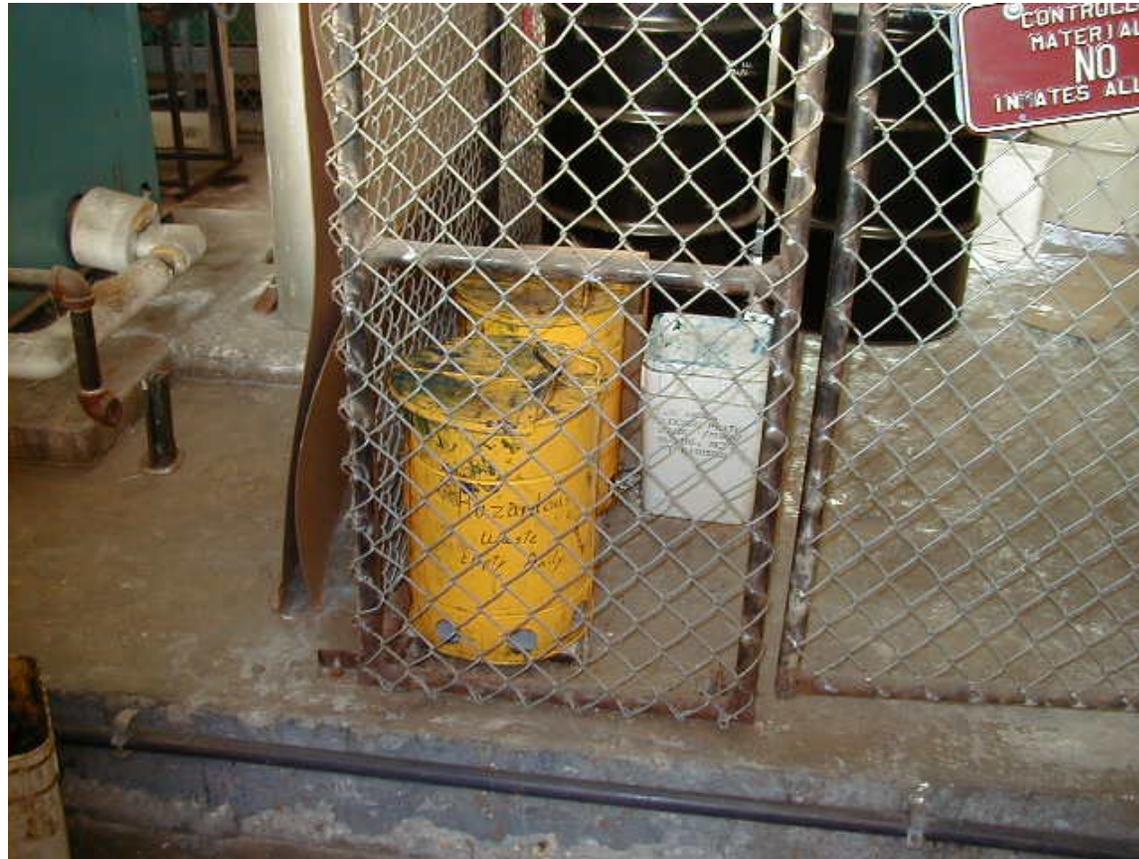
The Partition Factory stores paints and associated chemicals throughout the plant in 55 gallon drums. The Metal Working Factory stores oils and hydraulic fluids in designated areas throughout the plant in 55 gallon drums. The drums were undamaged and not leaking. The Furniture Factory stores paints and varnishes in 5 to 10 gallon containers primarily in the paint booth. Several flammable liquid cabinets are located throughout the plant. The containers were undamaged and not leaking. The Soap Factory stores dry cleaning fluid and caustics in 55-gallon drums throughout the plant. None of the containers or drums were damaged or leaking. The Shoe Factory has bulk storage in

Drum storage Metal Factory

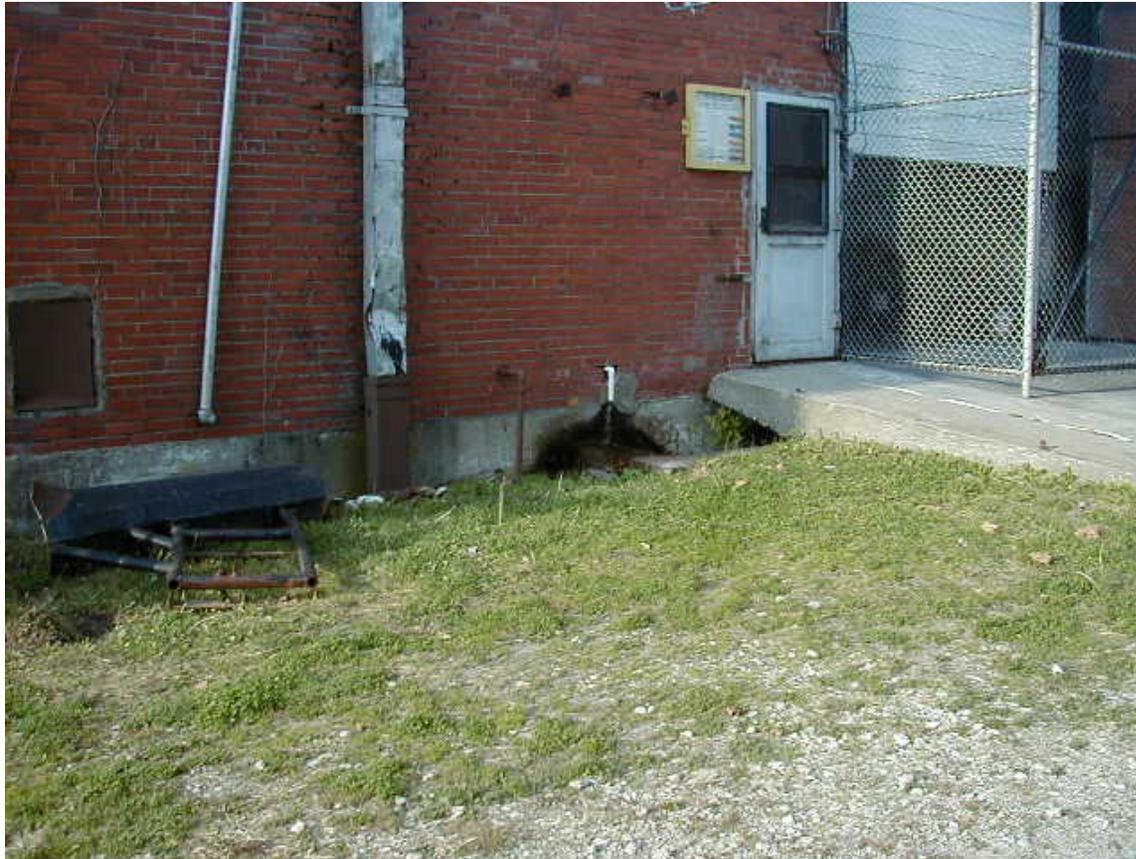
Metal Factory water discharge between Metal Factory and I-Hall facing SouthWest

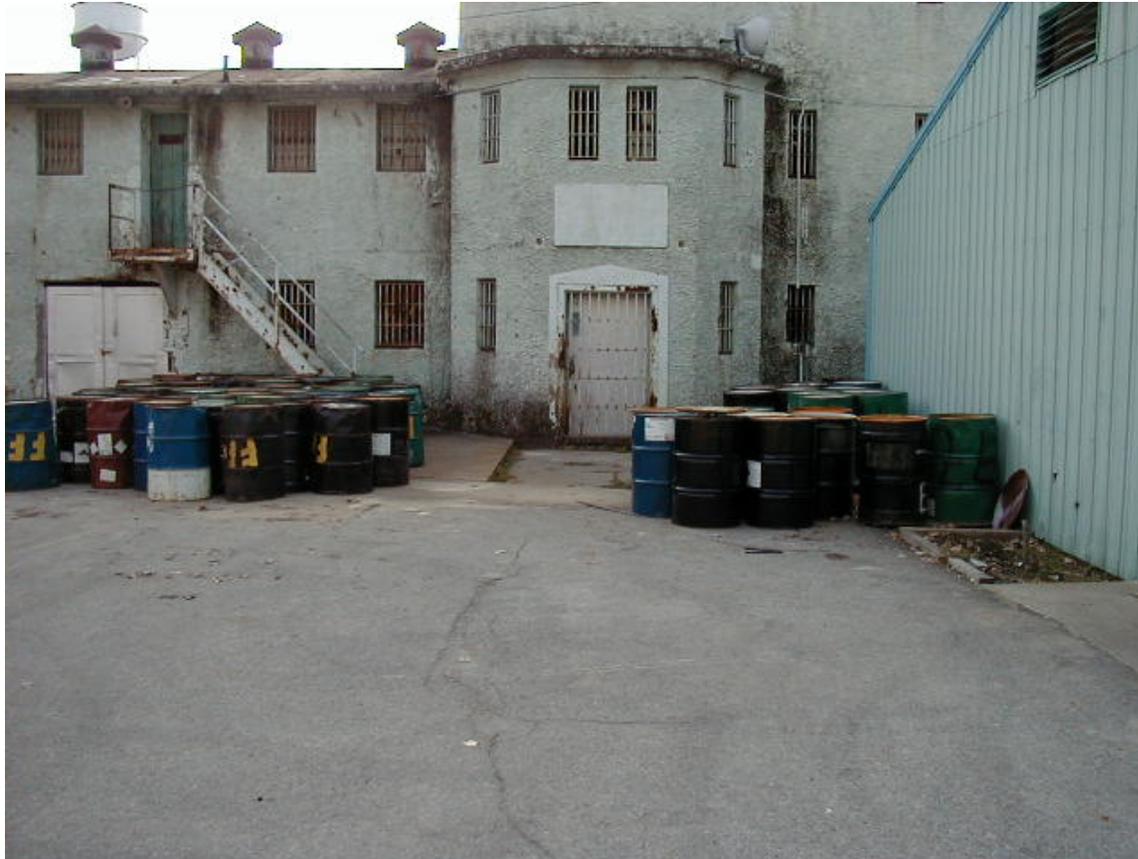
Empty drum storage behind warehouse facing East

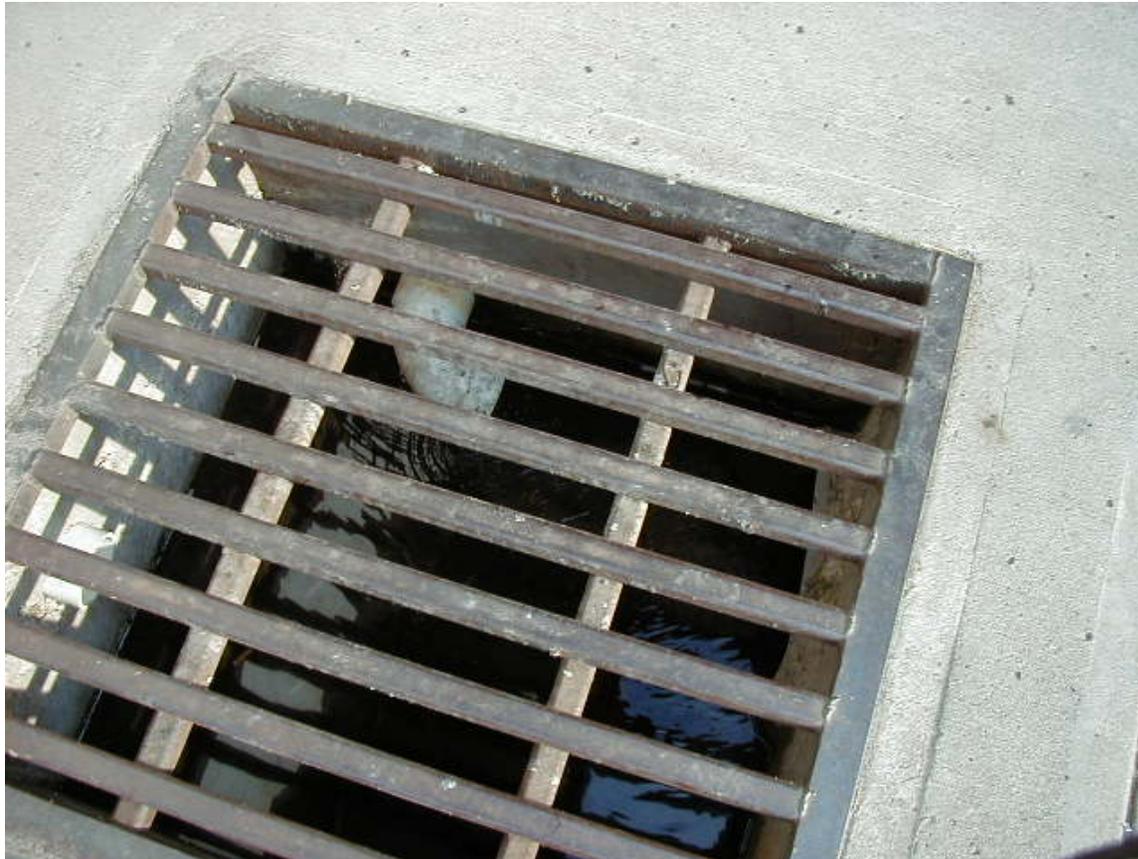
Furniture Factory water discharge on South side of building

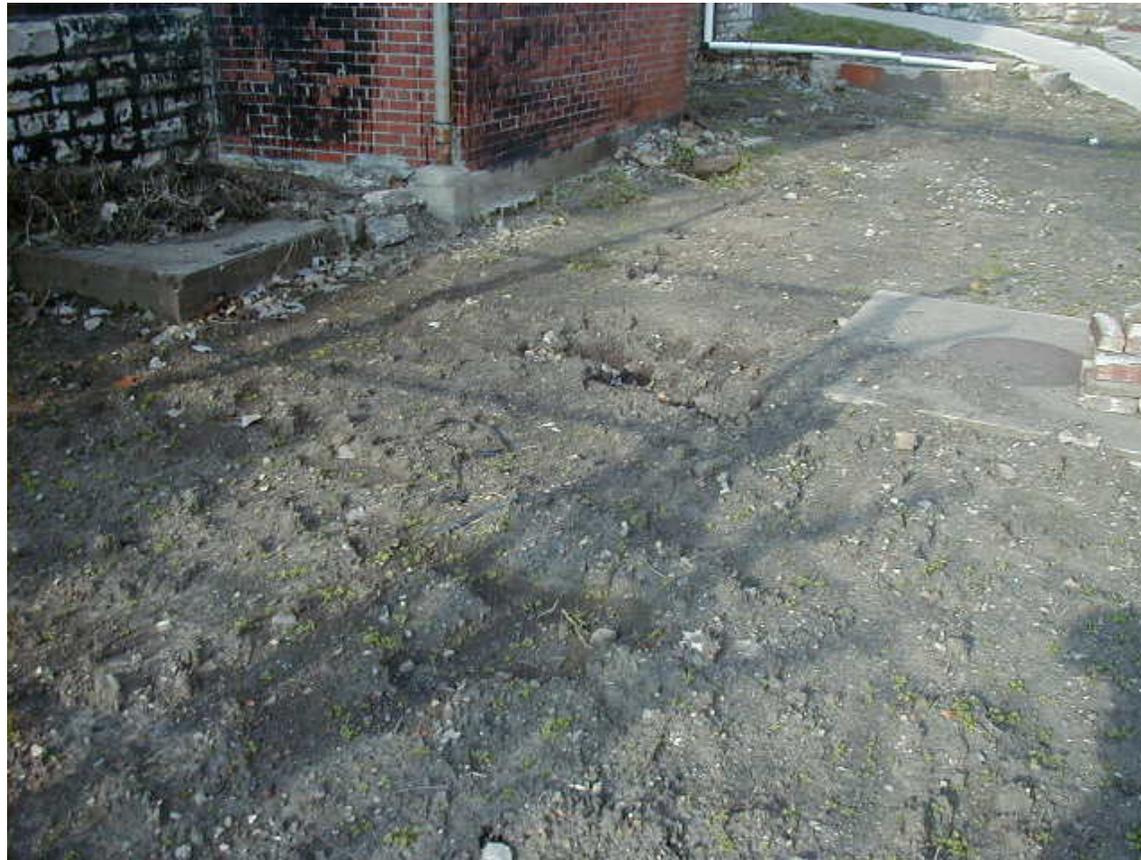
Soil along North side old boiler house facing South west

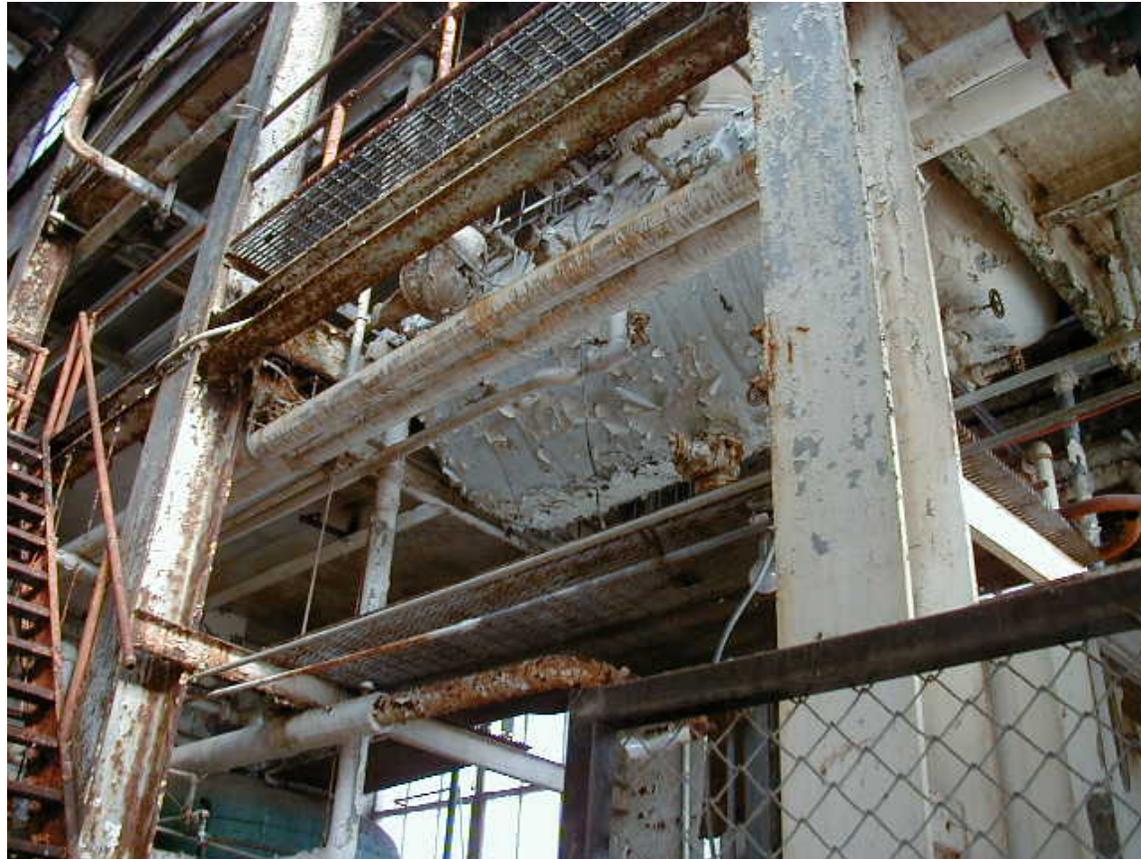
Inside old boiler house

Finding: *Old Boiler house has asbestos + Lead Paint. No evidence of debris, trash or open burning*

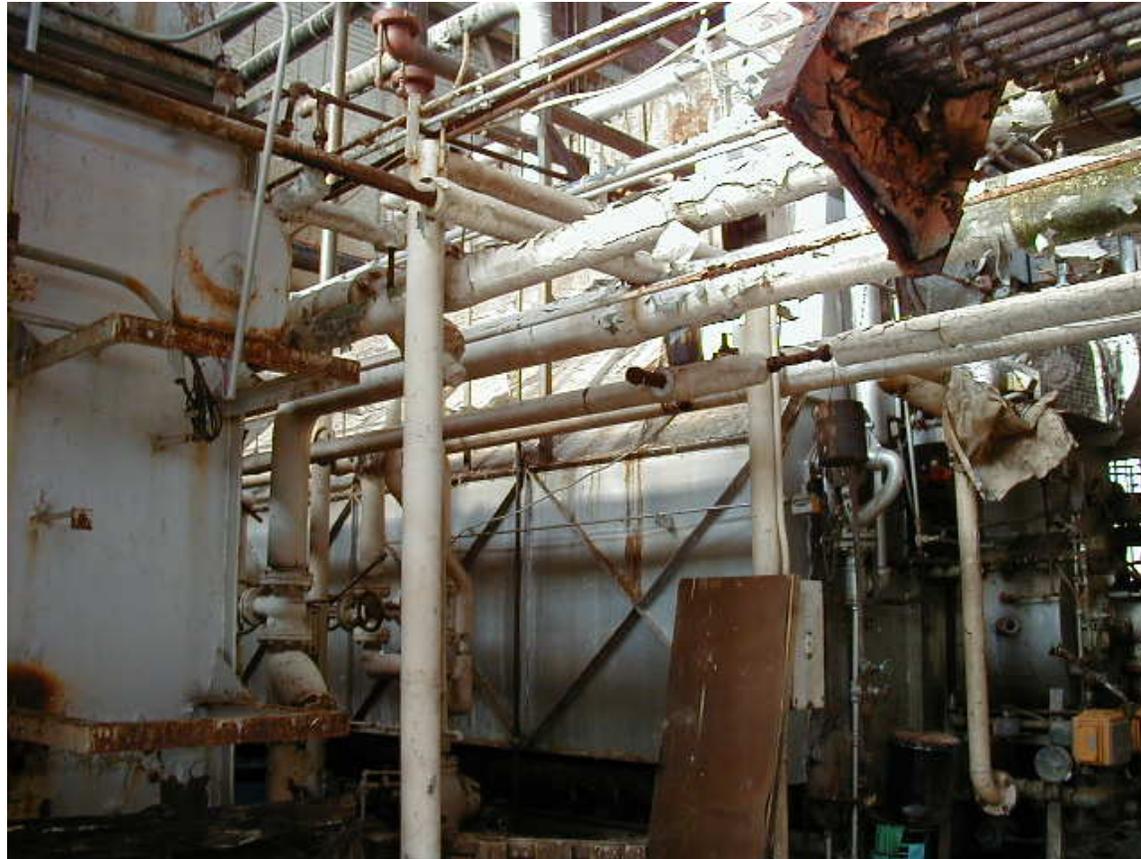
Inside old boiler house

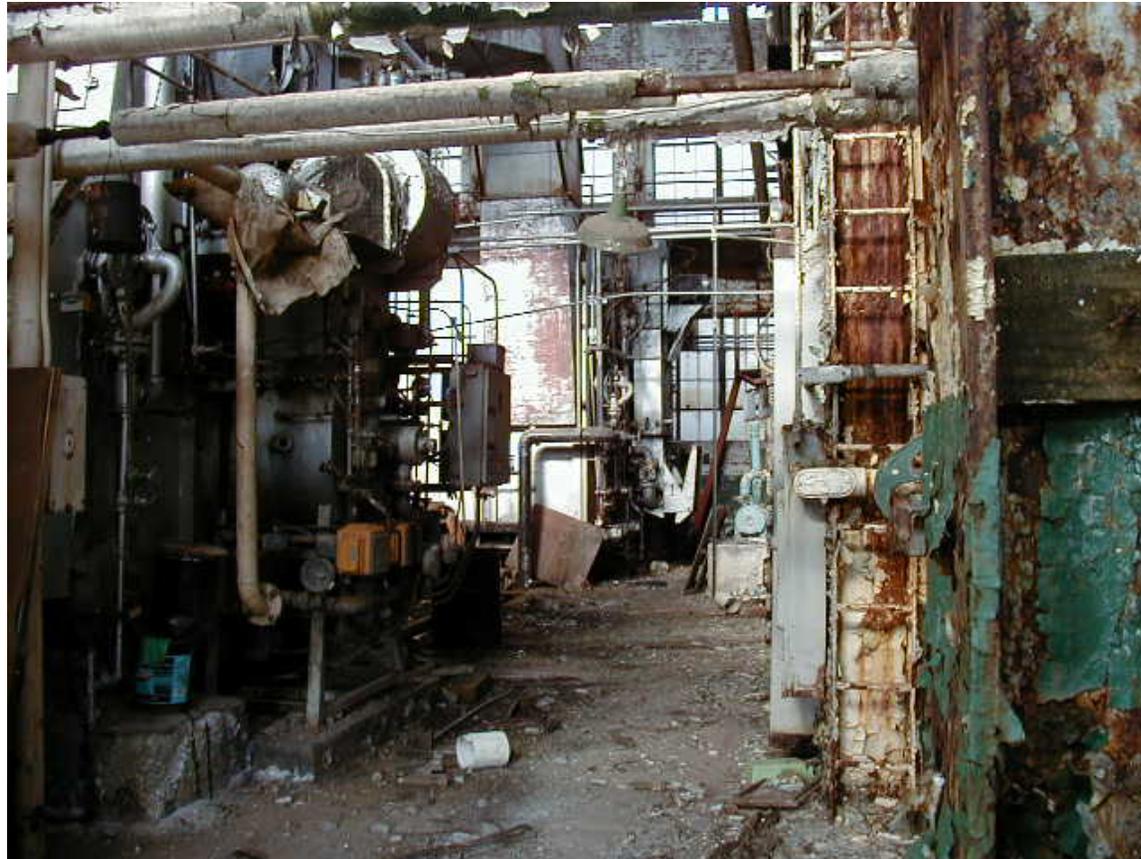
Inside old boiler house

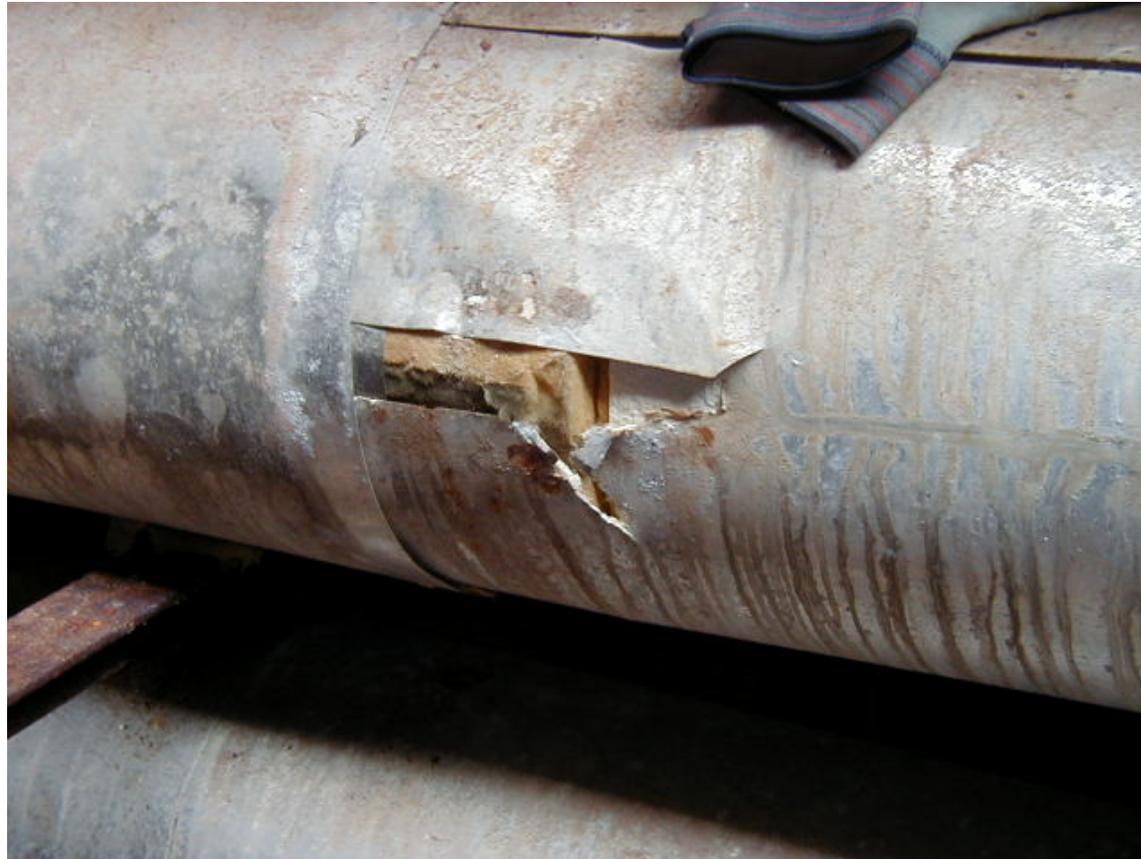
Tunnel next to H.U.3 piping

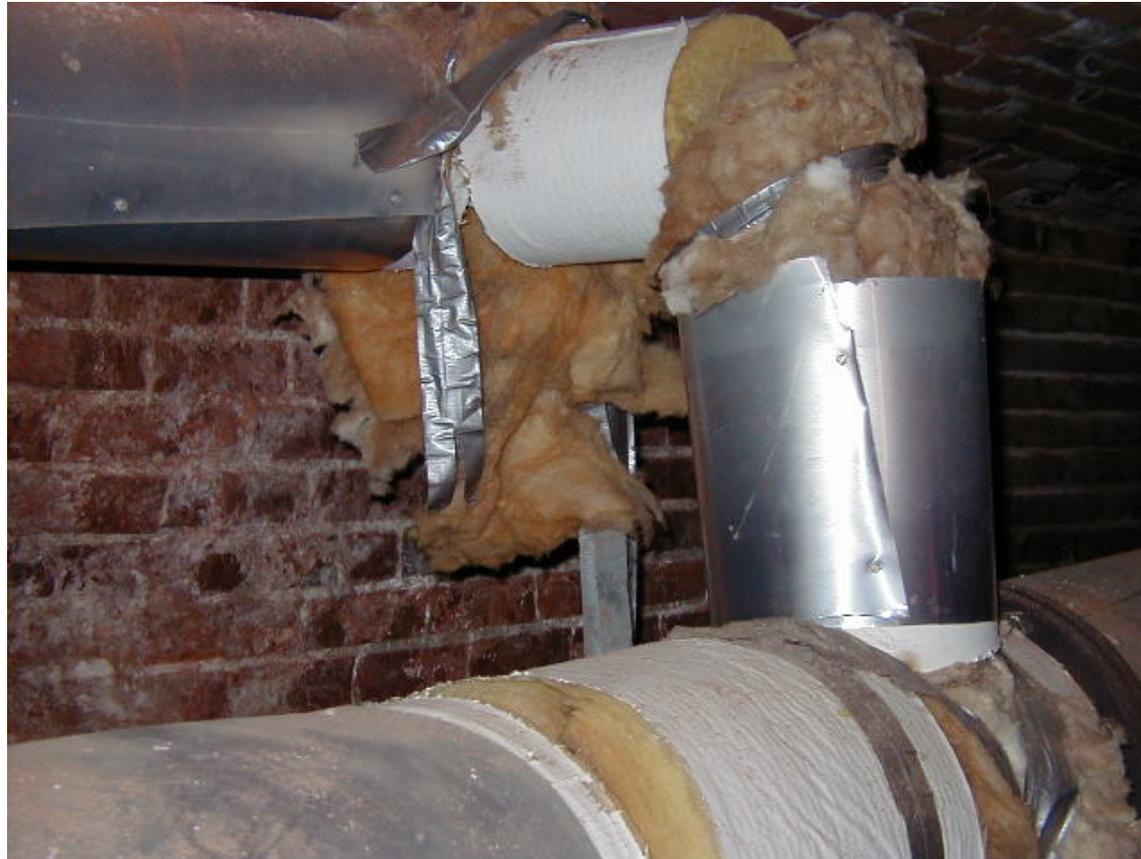
Tunnel next to H.U.3 piping insulation

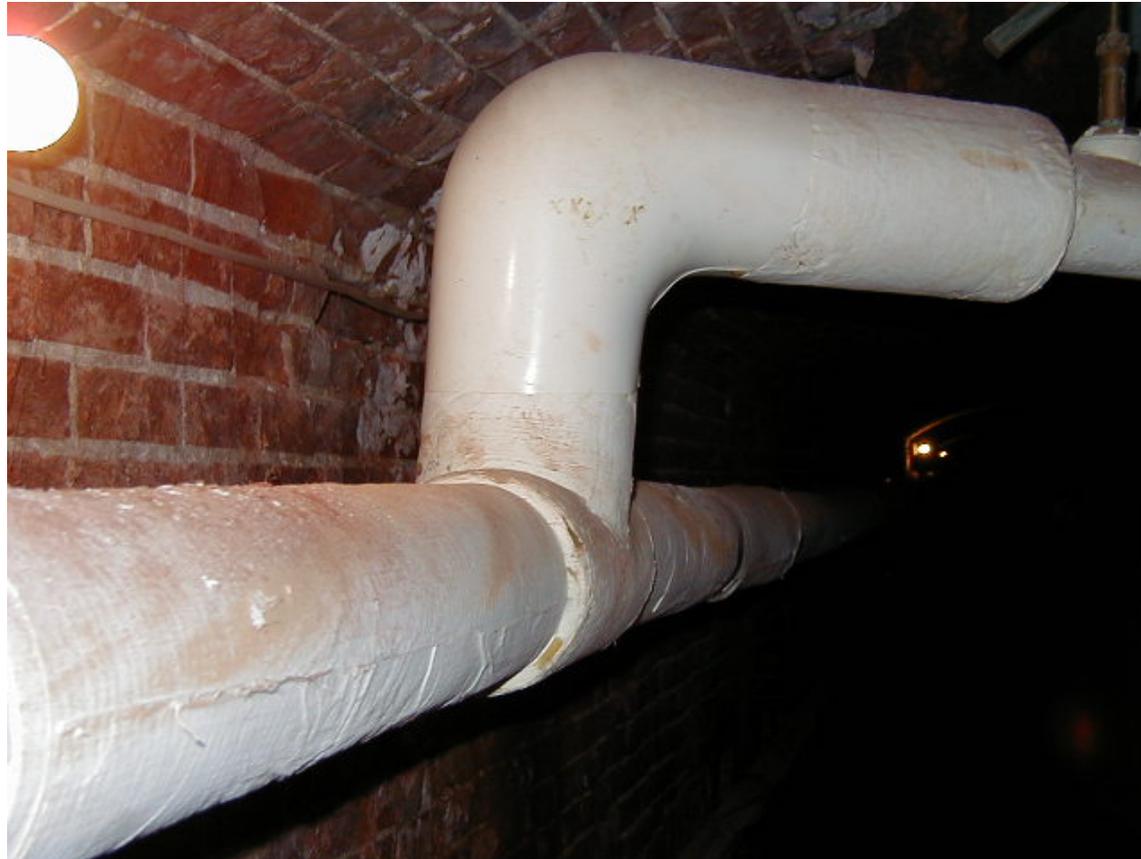
Tunnel next to M&M piping insulation

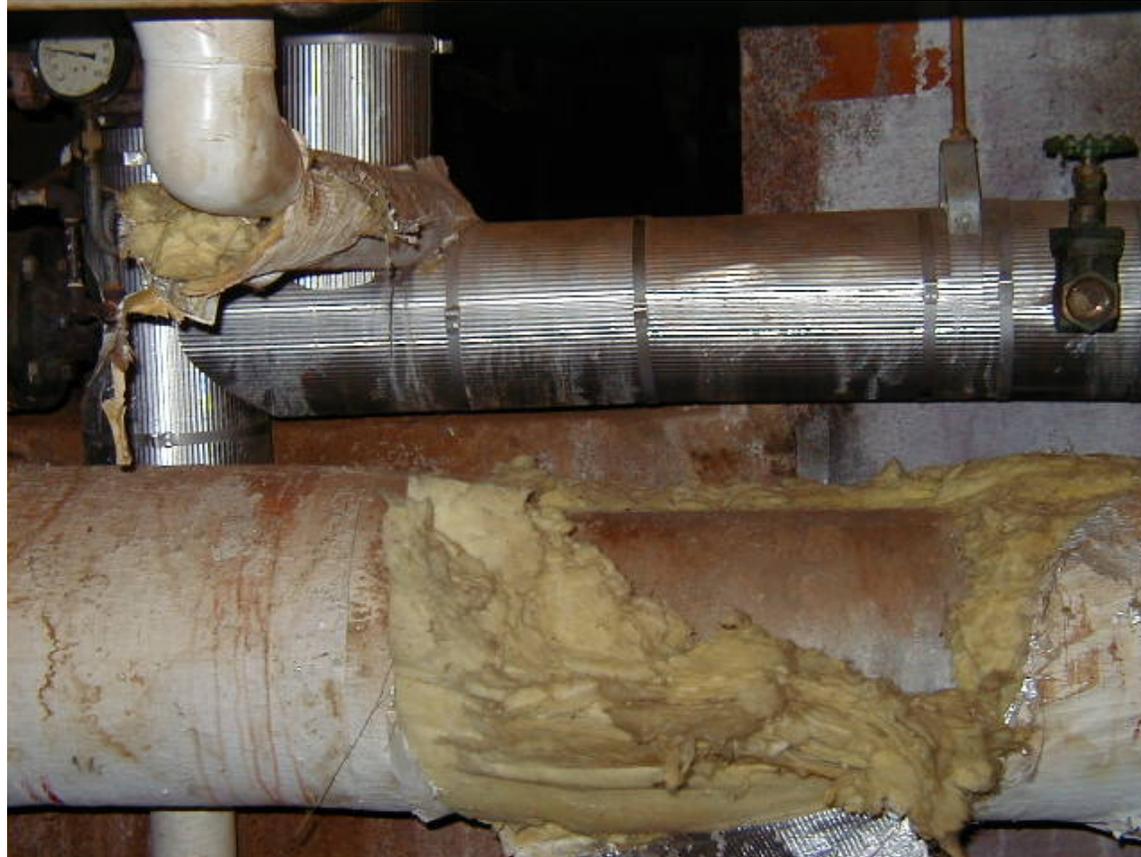
Tunnel next to M&M piping insulation

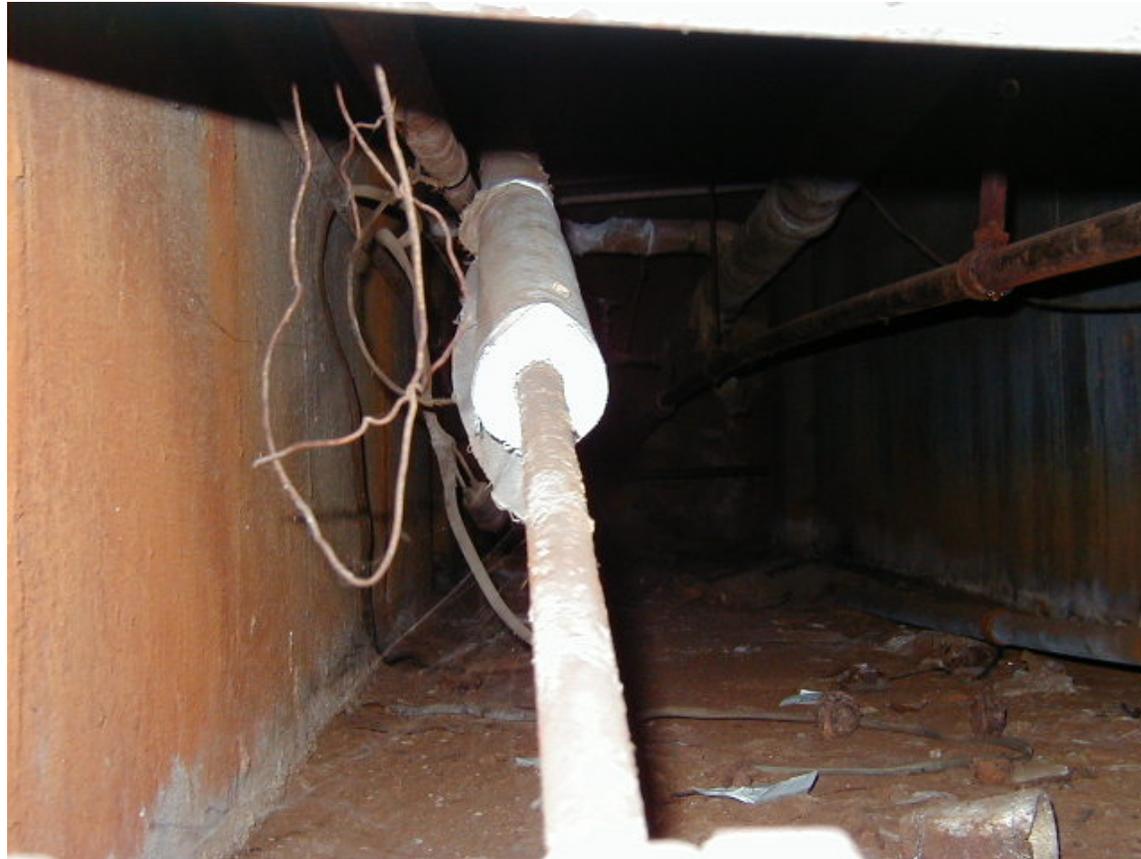
Tunnel next to H.U.1 piping insulation

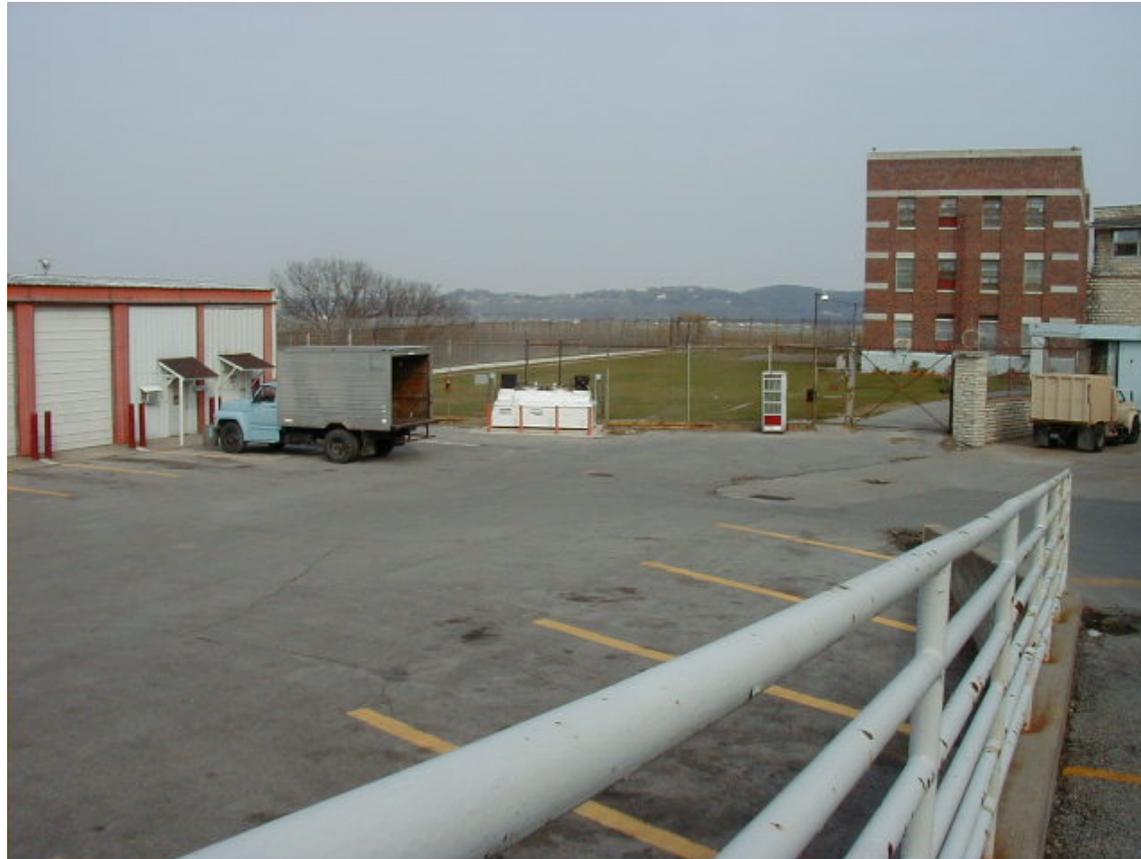
AST at Garage facing West

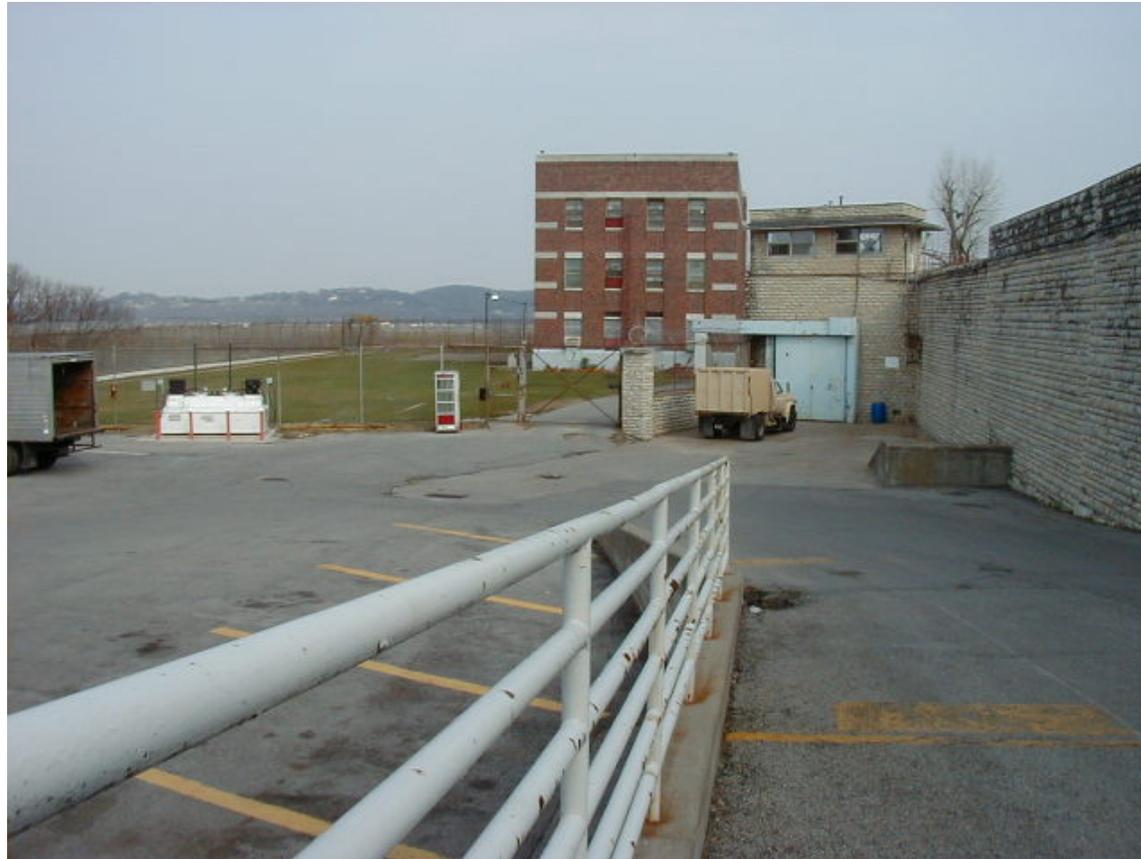
AST at Garage lower area facing North

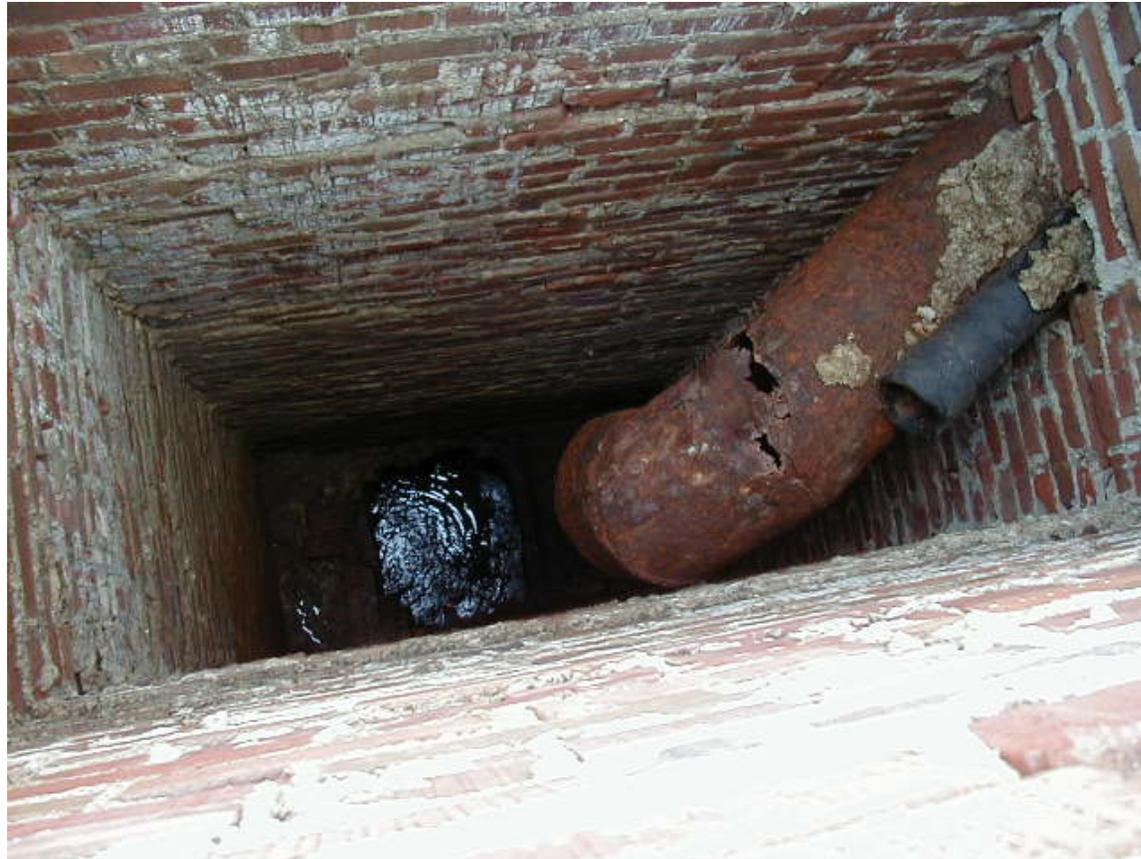
Manhole water discharge (unknown source) East of New Boiler Plant

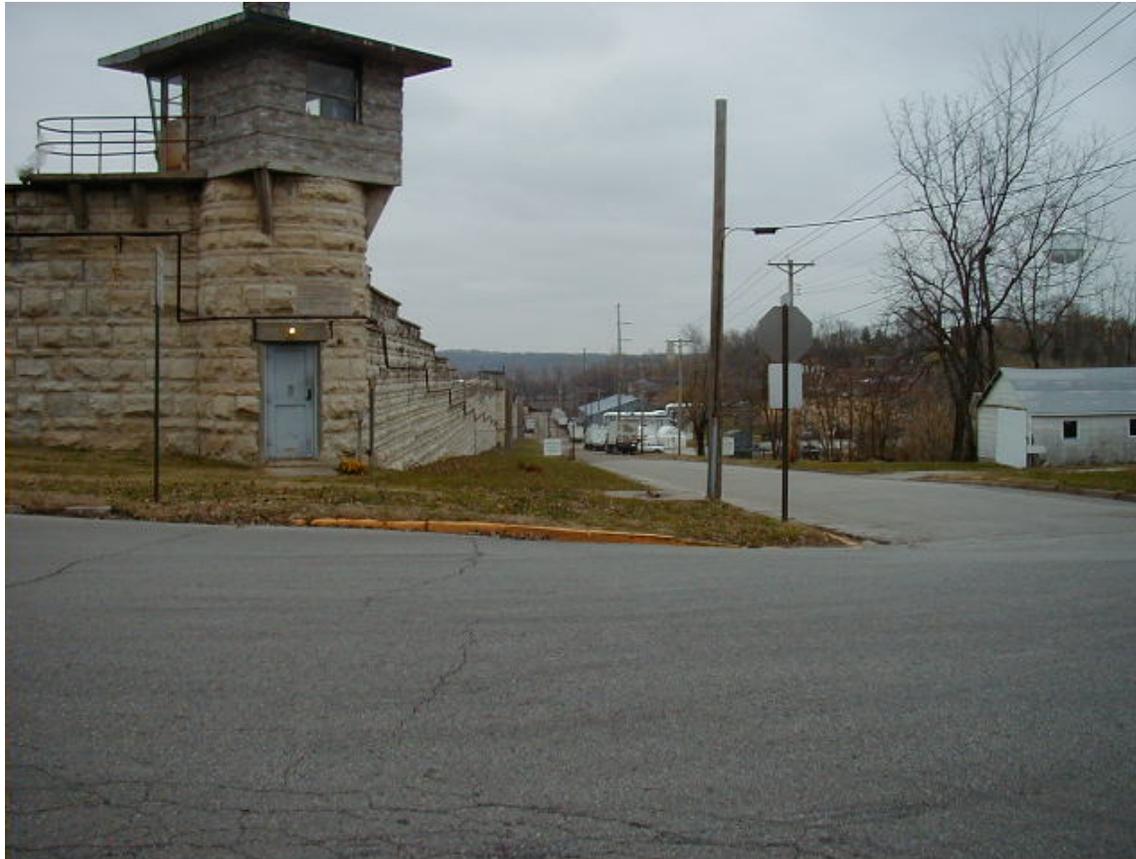
Low area behind 200 Chestnut Street facing West

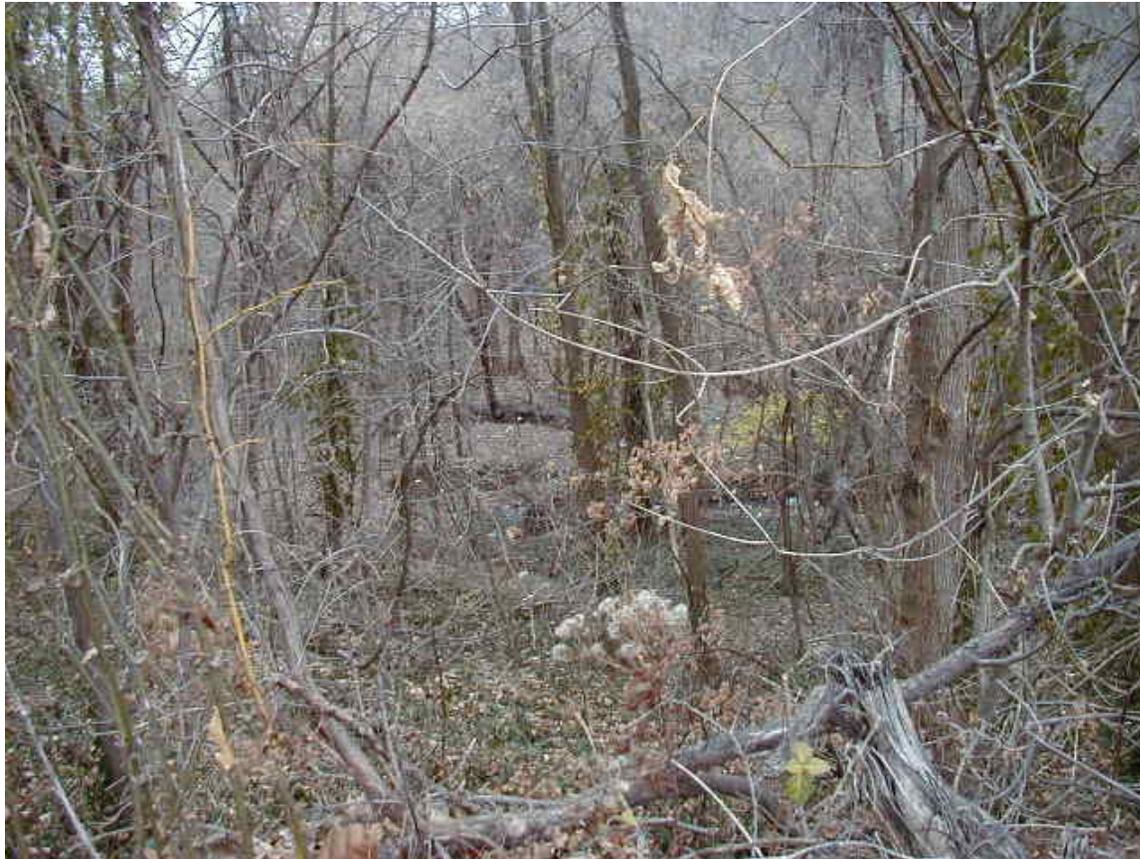
Drainage area West of former International Shoe Factory facing NorthEast

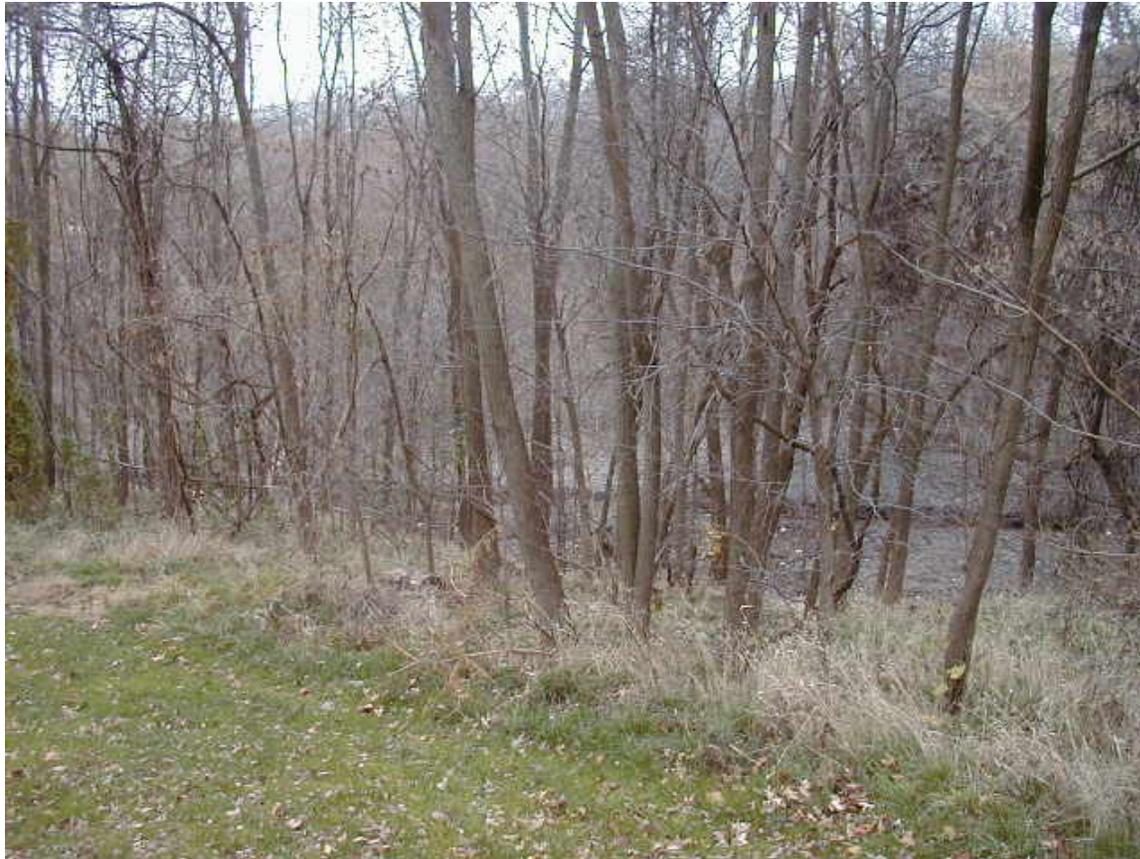
Drainage area behind 1003 and 1005 East Capitol facing East
