Framework Plan

The MSP Redevelopment Project

Appendices A, B, C, & D

Observations of the Enclosure Walls

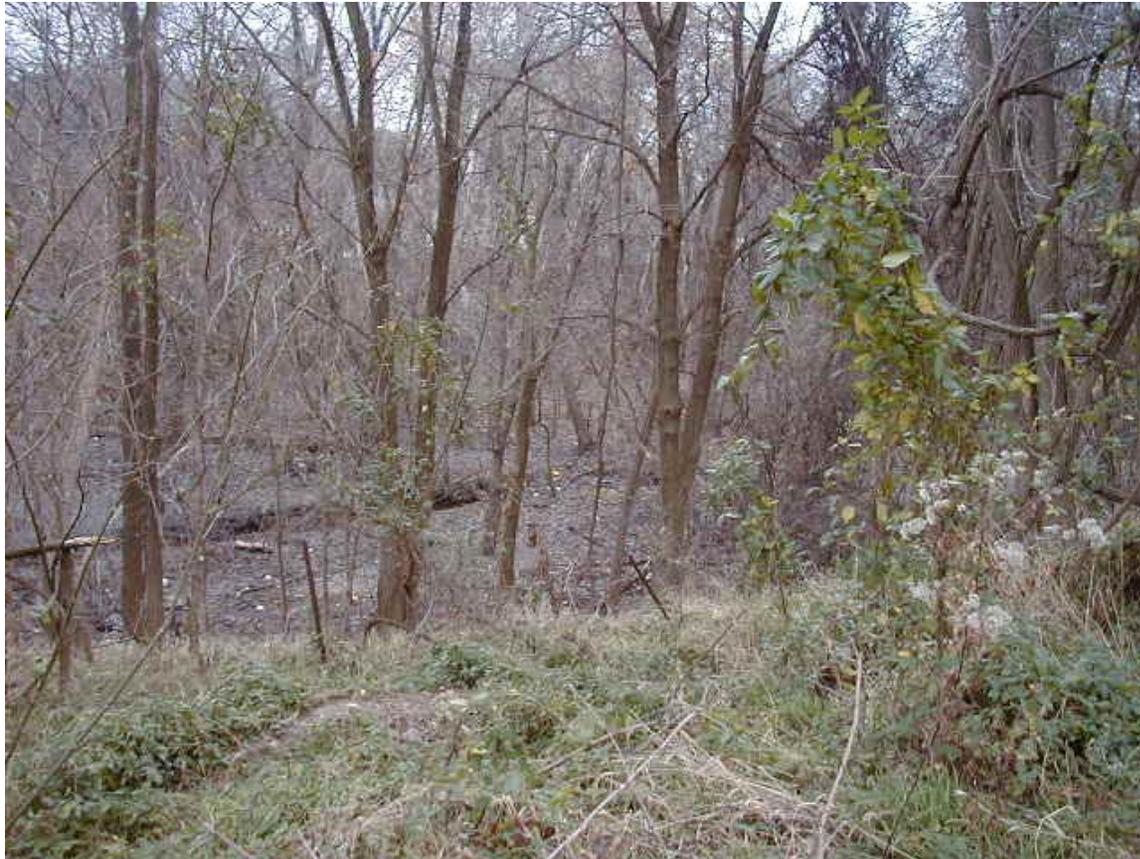
Drainage area behind 1003 and 1005 East Capitol facing NorthEast

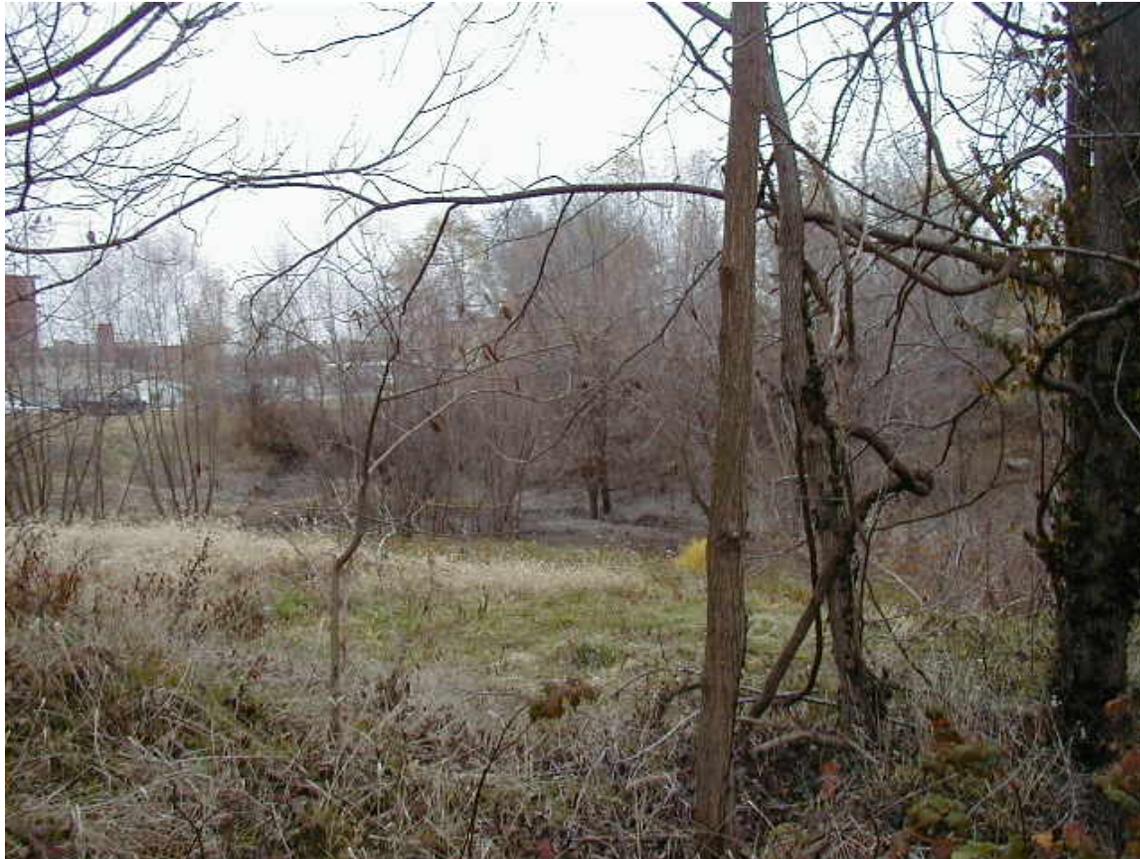
Drainage area behind 1003 and 1005 East Capitol facing North

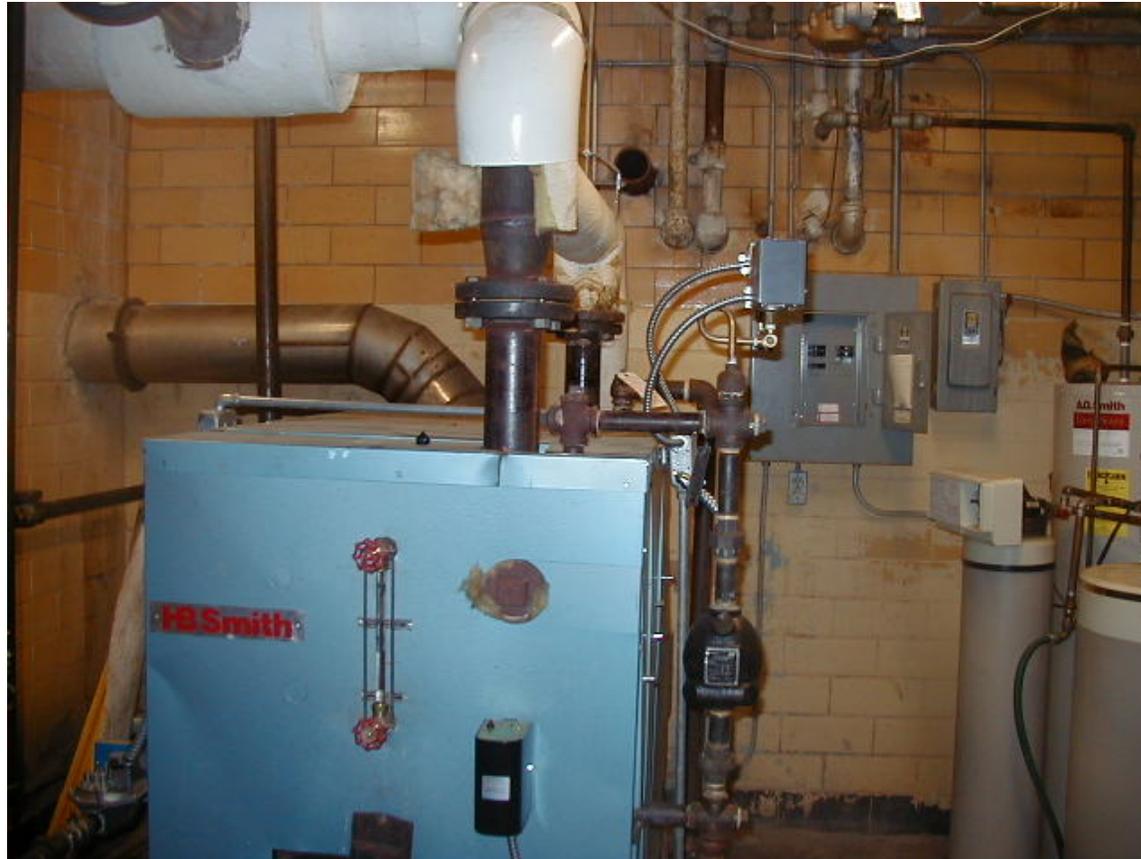
P1010001 – Boiler room – Old Training Academy

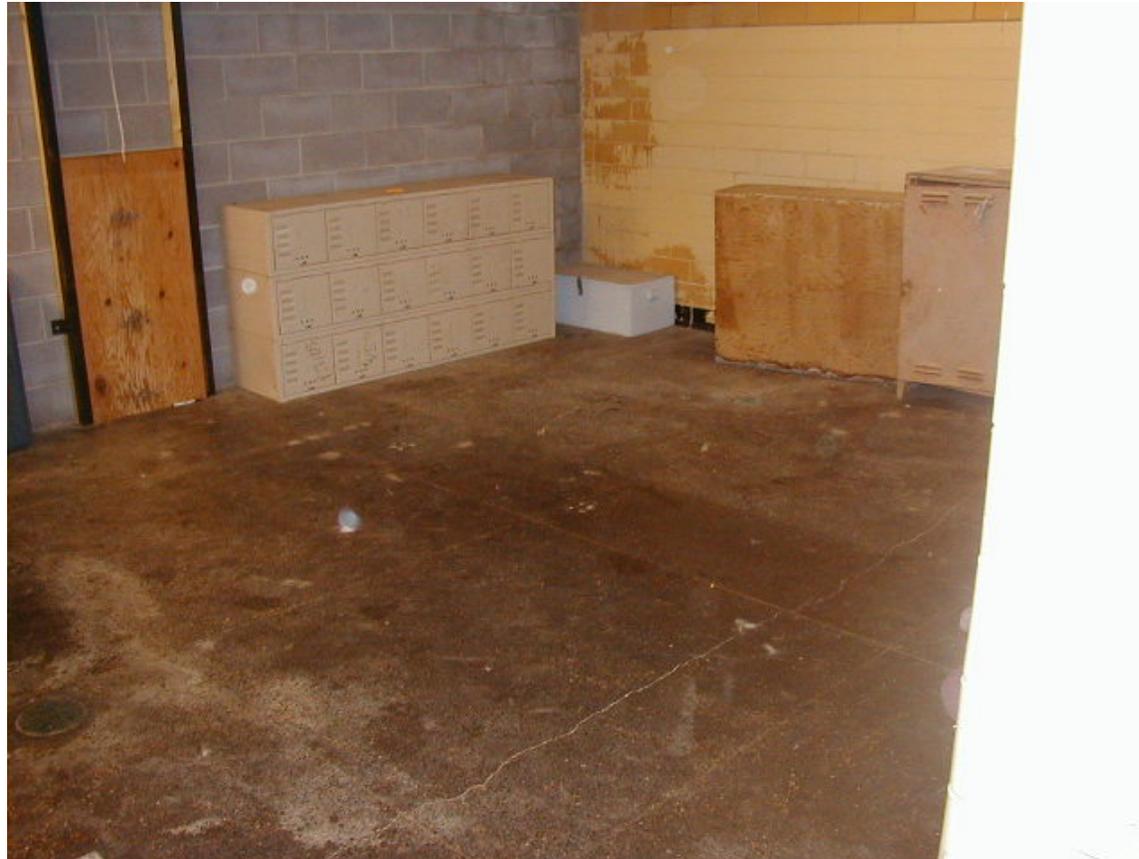
P1010002 – Basement floor and drains – Old Training Academy

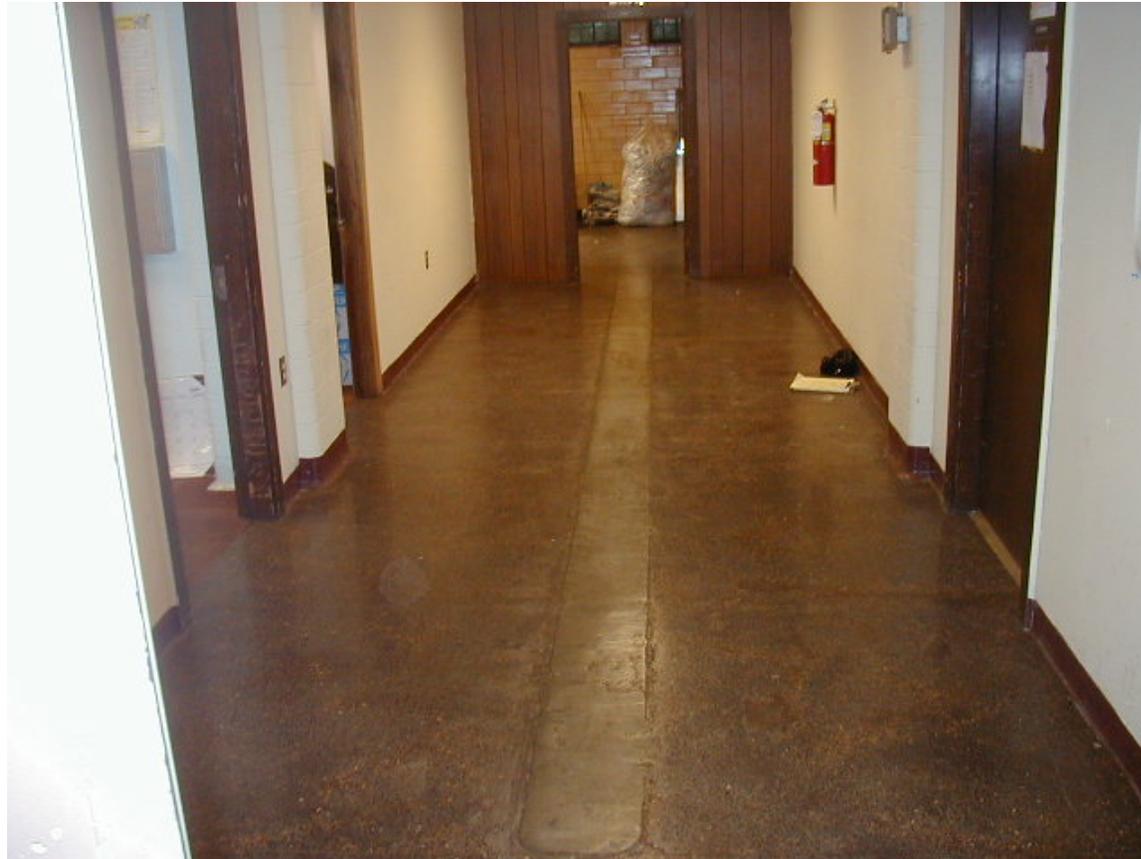
P1010003 – Basement floor – filled floor drains

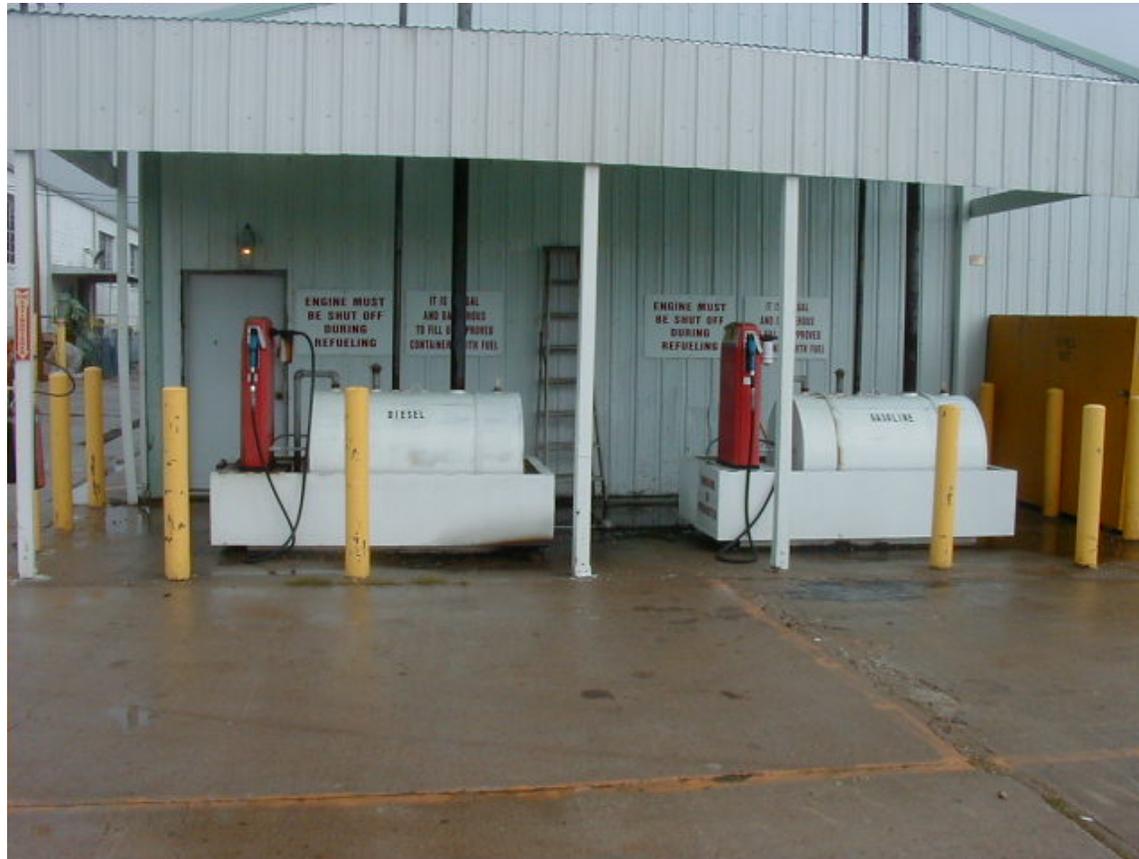
P1010025 – AST fuel storage

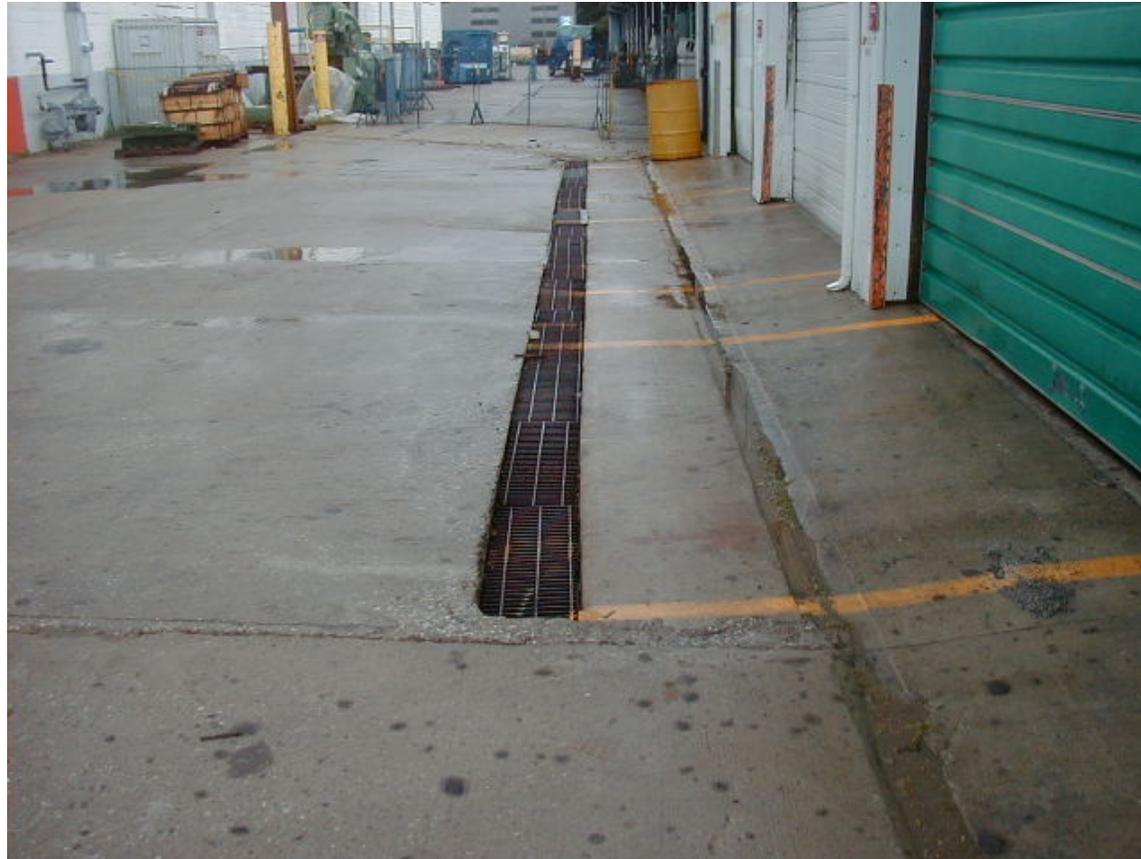
P1010026 – Drain in front of garage next to building #3

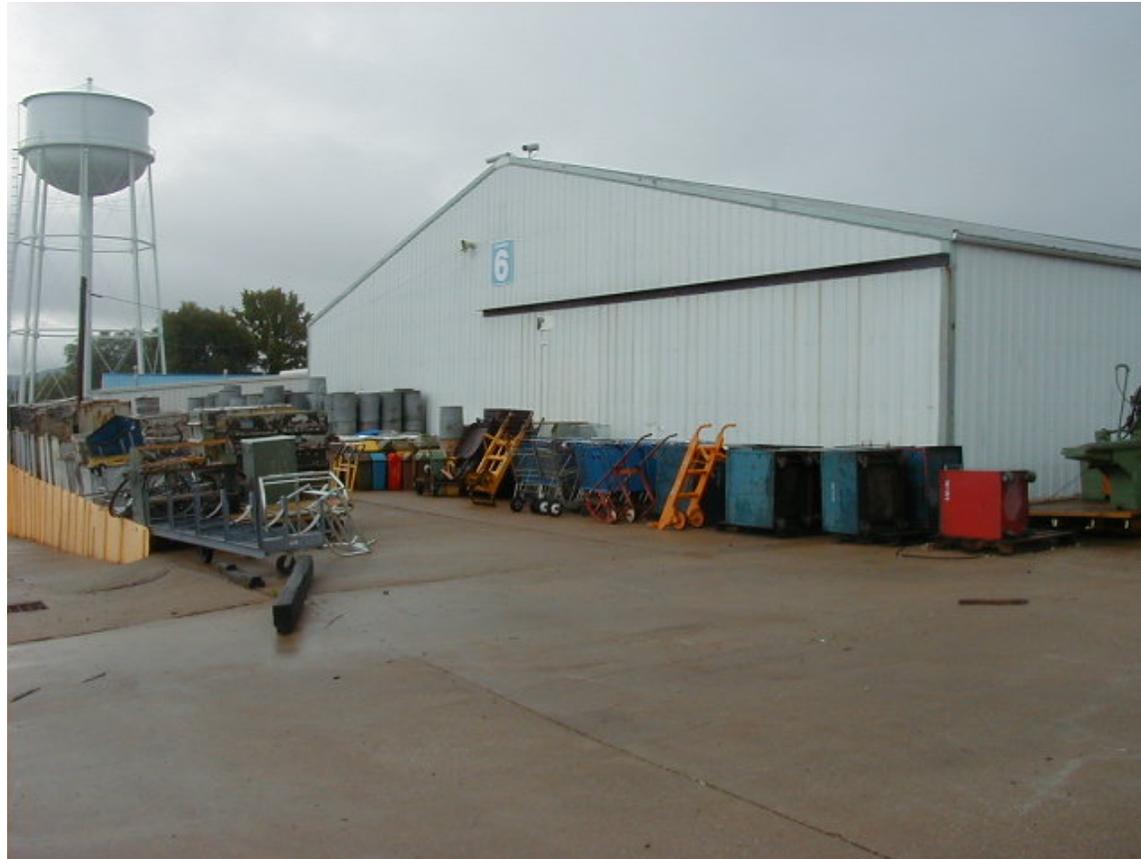
P1010029 – West side Building #6

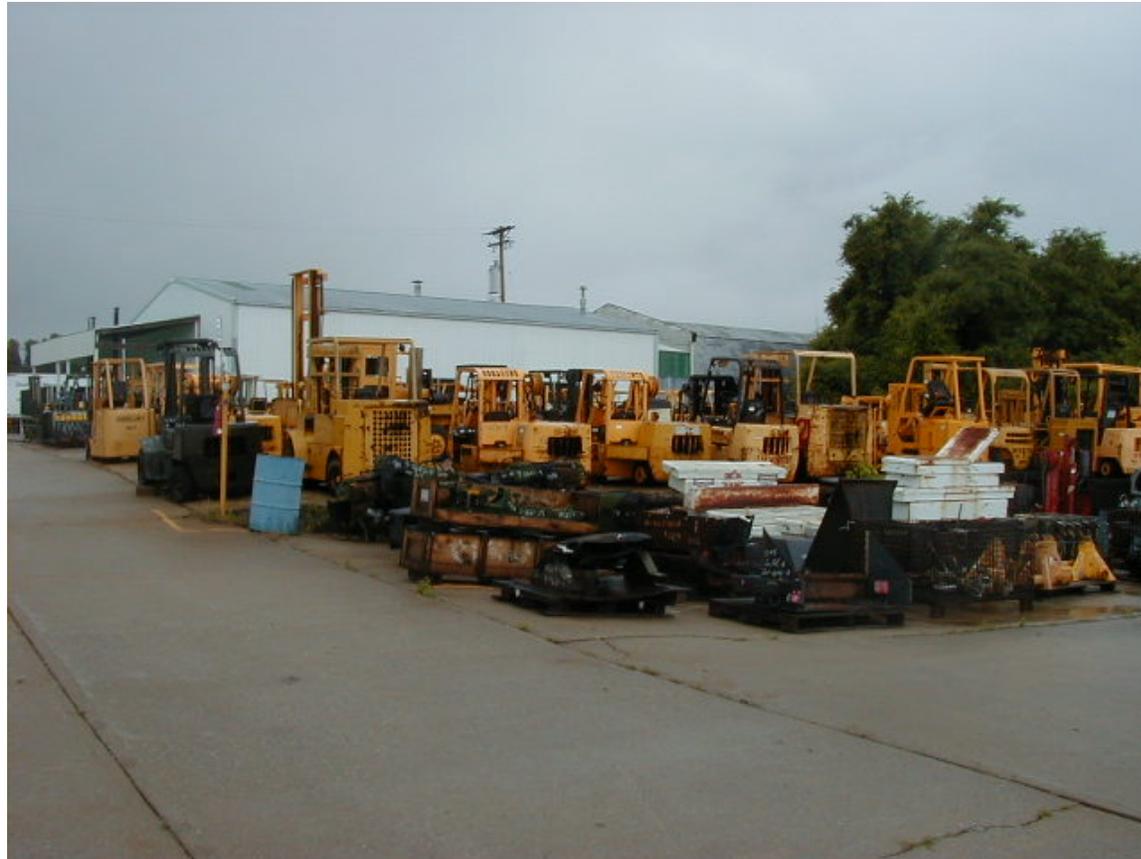
P1010030 – Forklift in Lay Down Yard

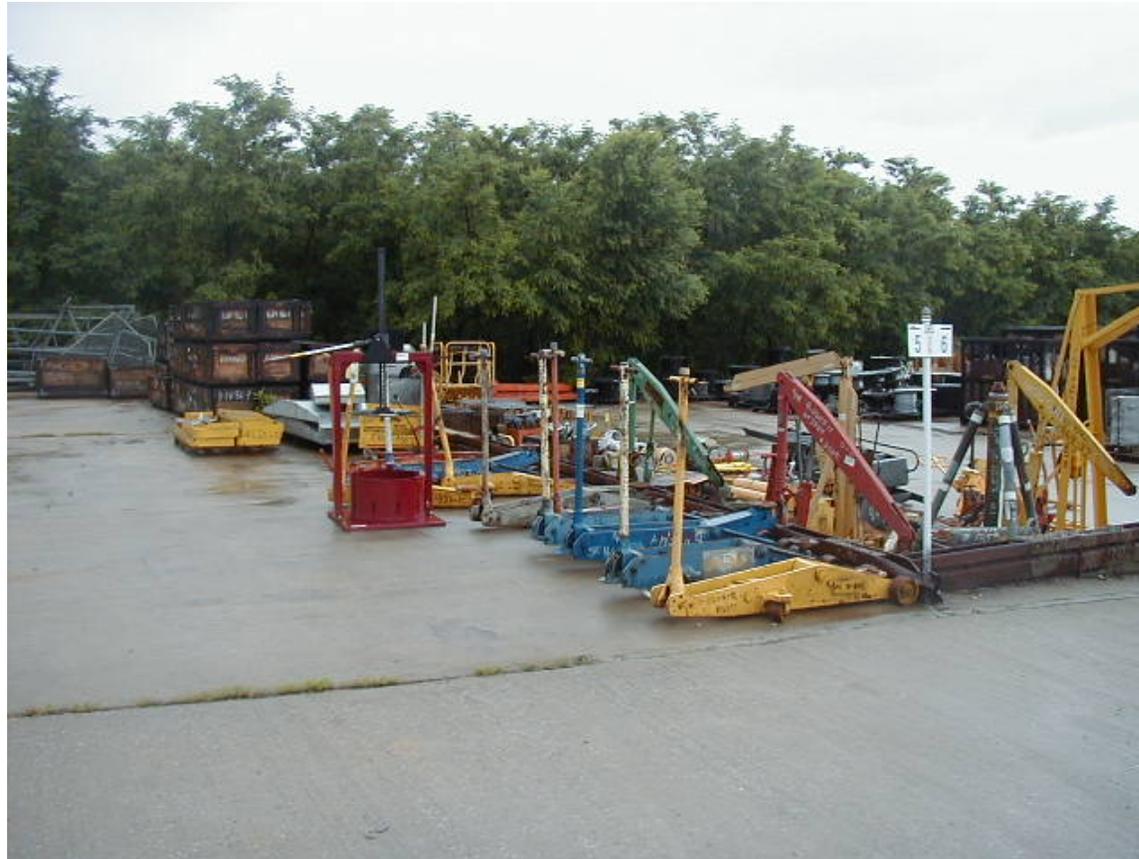
P1010031 – Hydraulic lifts in Lay Down Yard

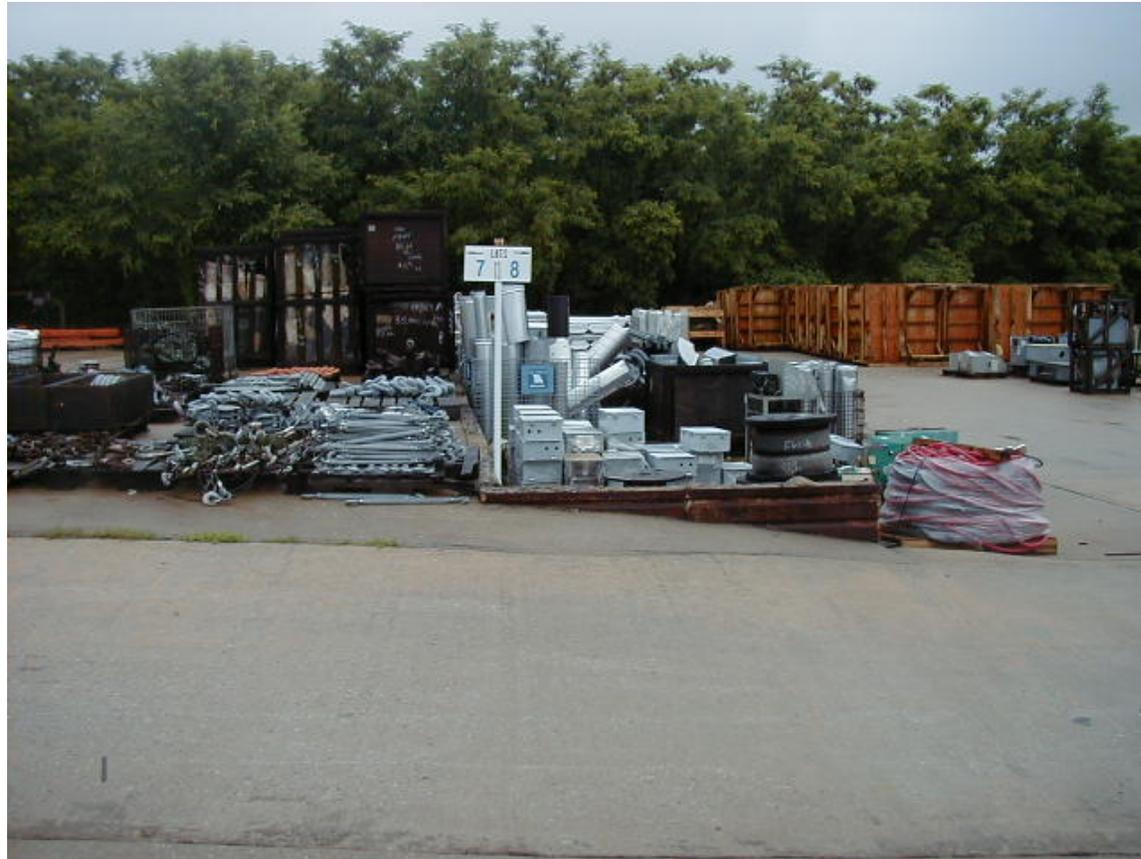
P1010032 – Storage in Lay Down Yard

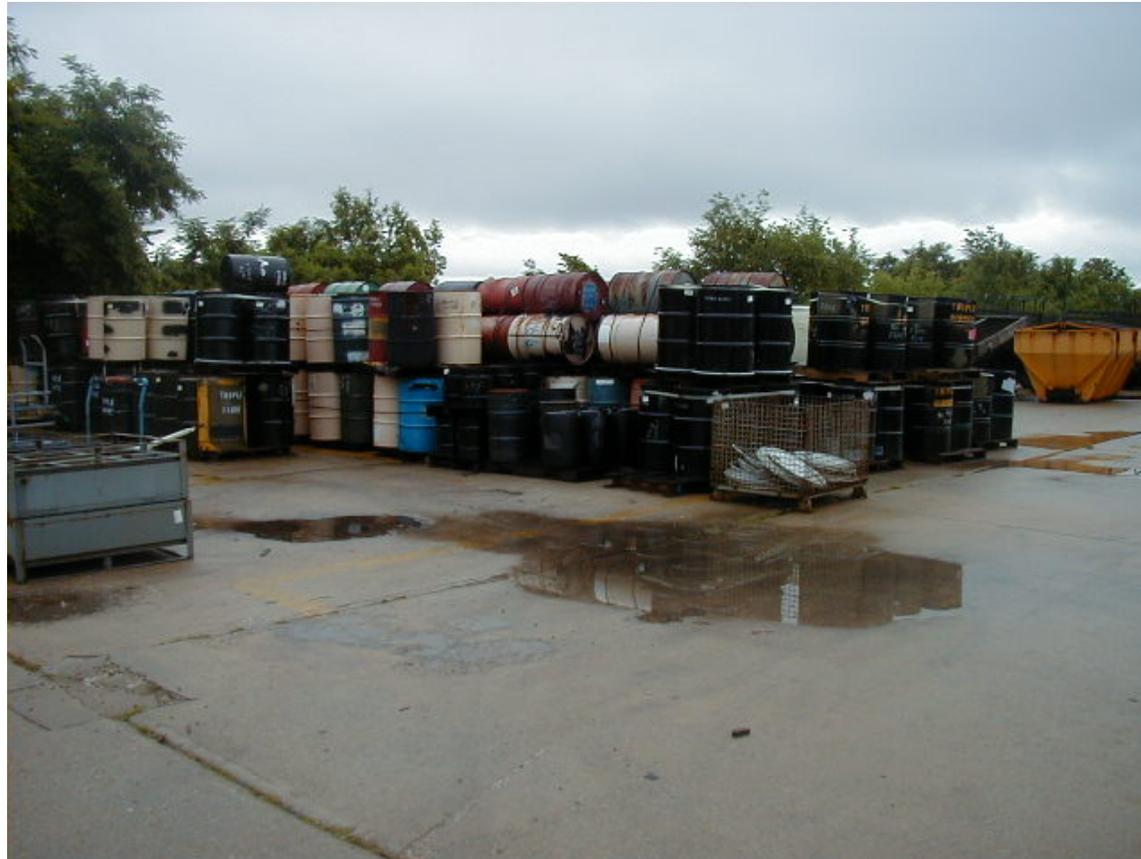
P1010035 – Empty drums storage west end of Lay Down Yard

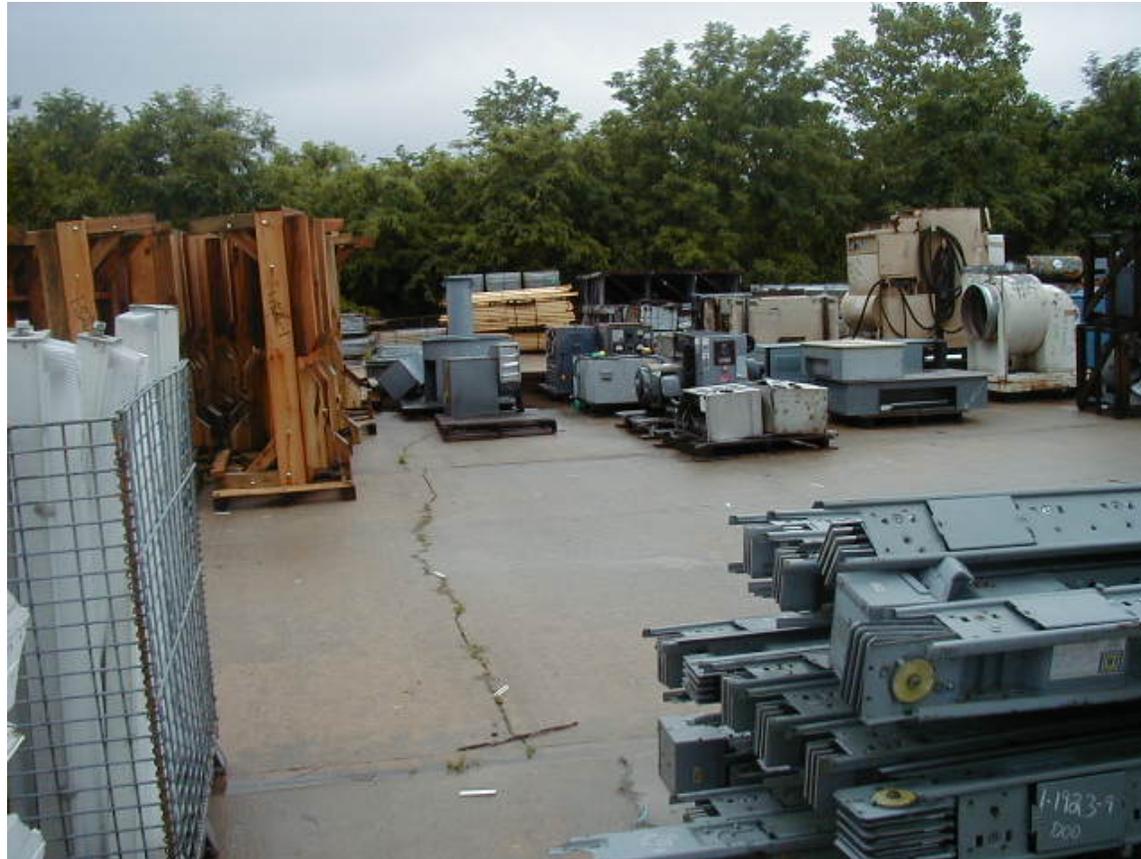
P1010036 – Generator Storage Lay Down Yard

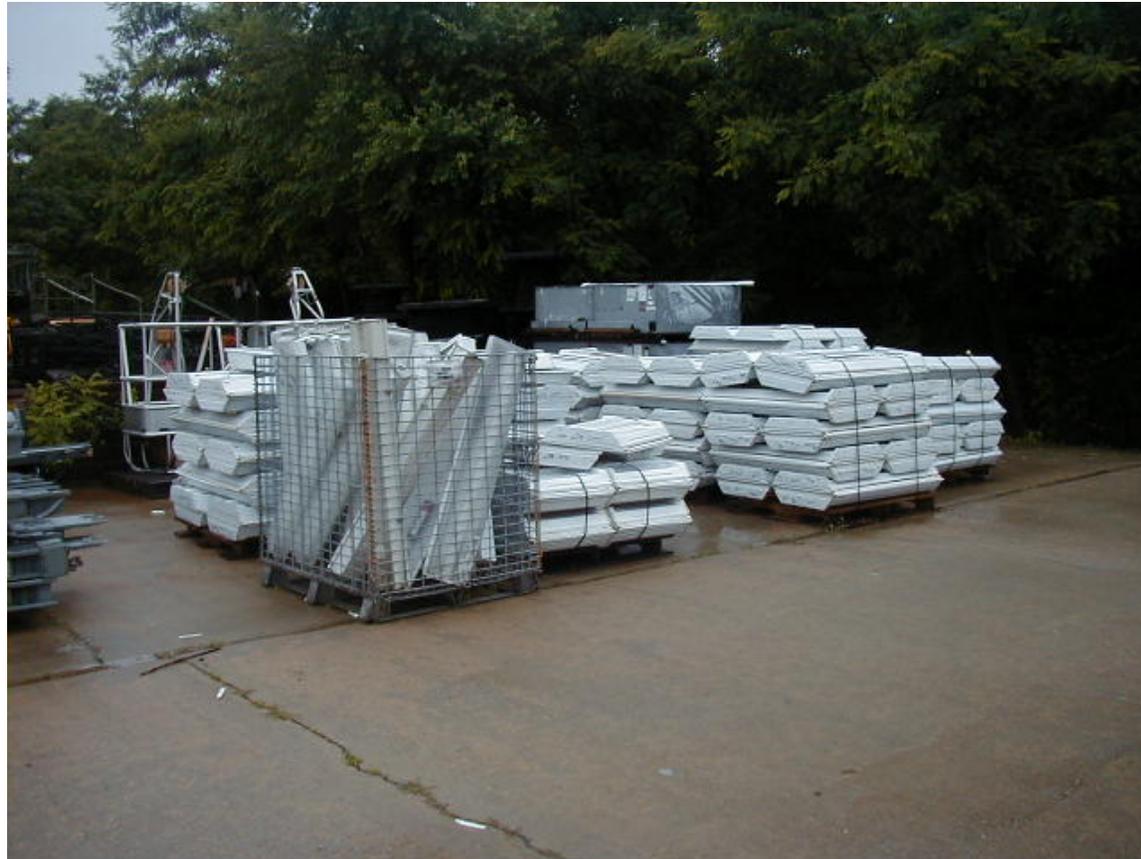
P1010037 – Fluorescent light fixtures Lay Down Yard

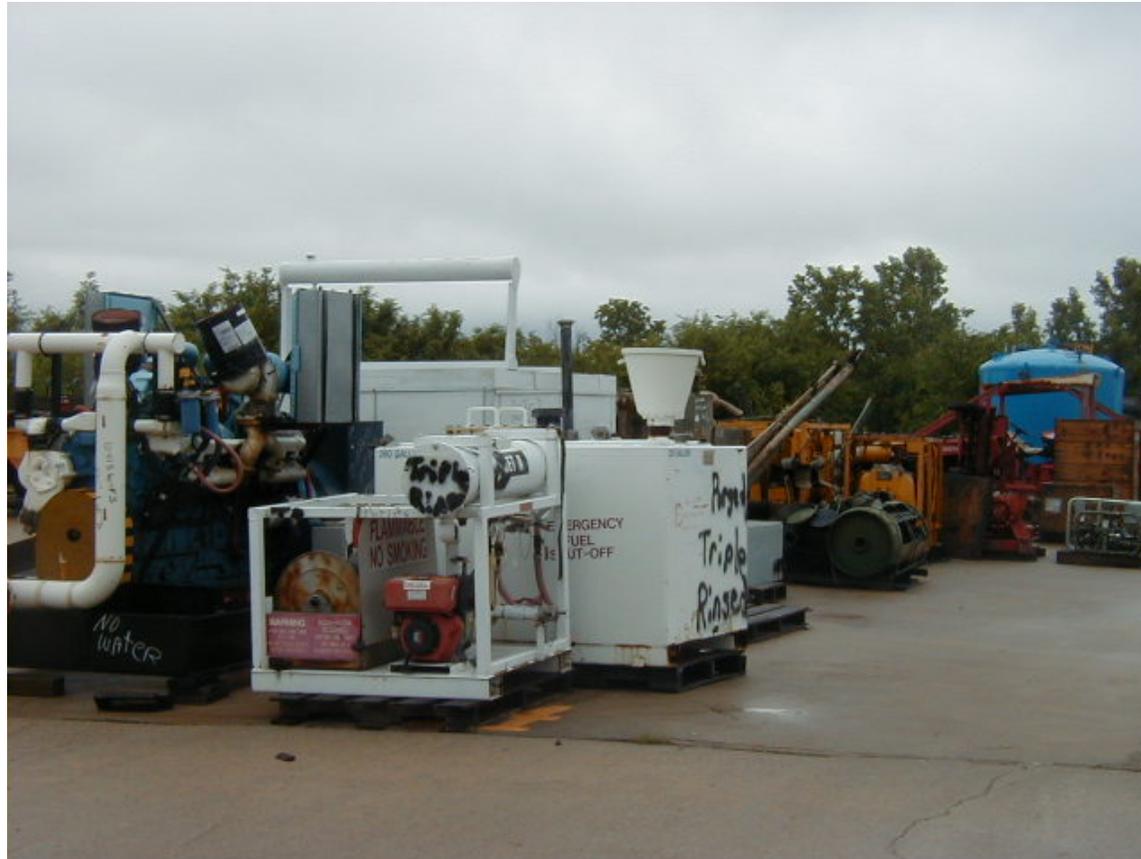
P1010040 – Pumps in Lay Down Yard

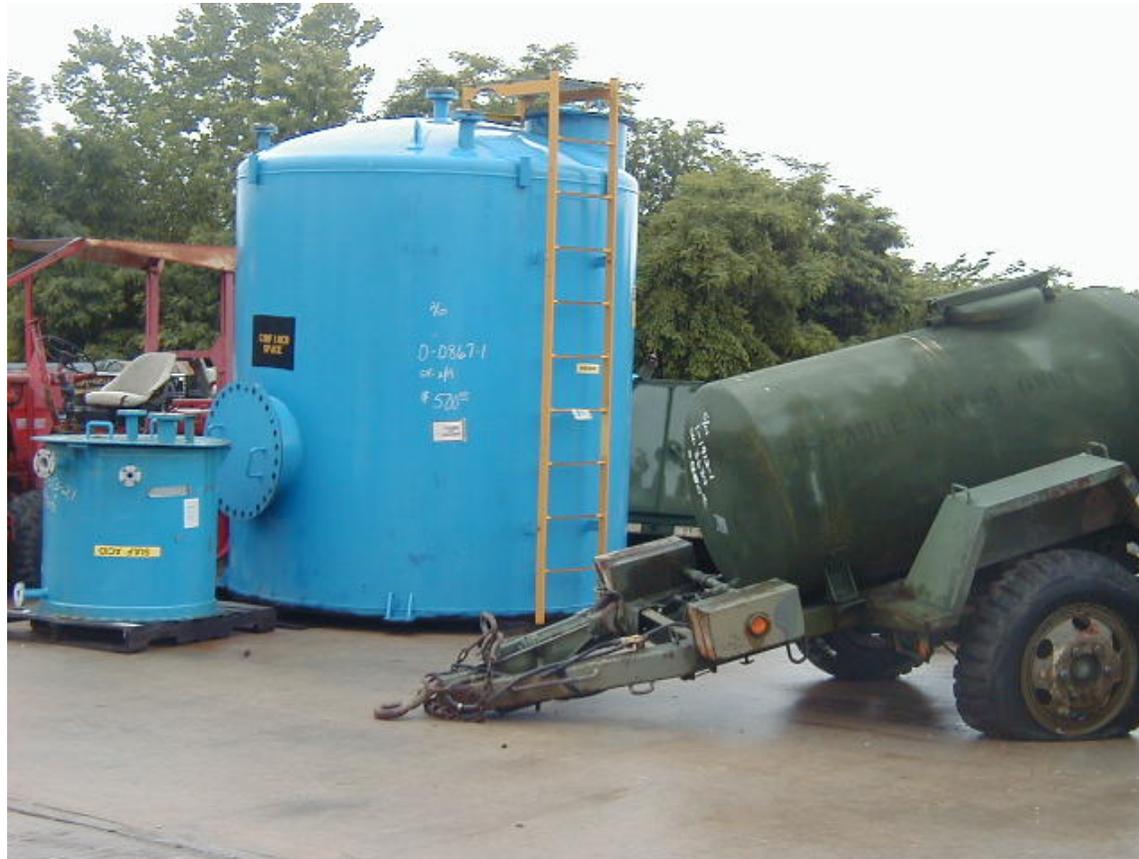
P1010042 – Empty tanks in Lay Down Yard

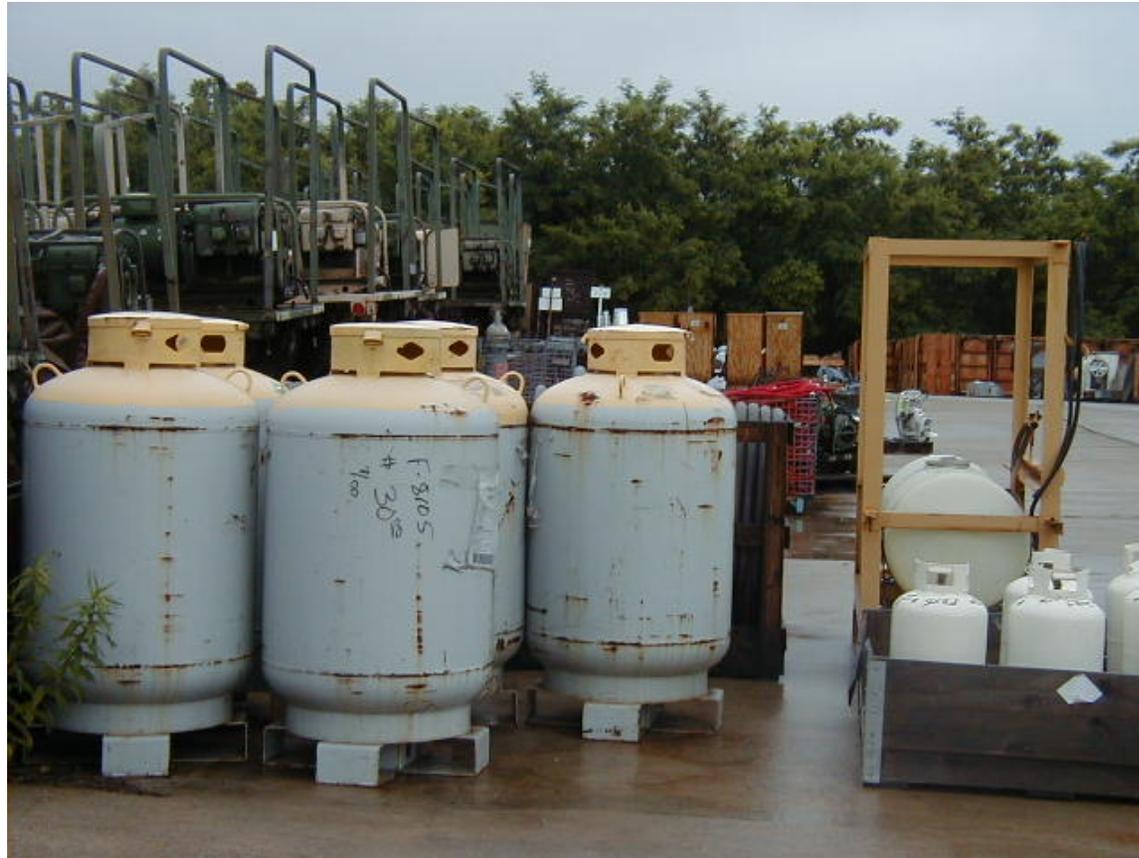
P1010043 – Empty cylinders in Lay Down Yard

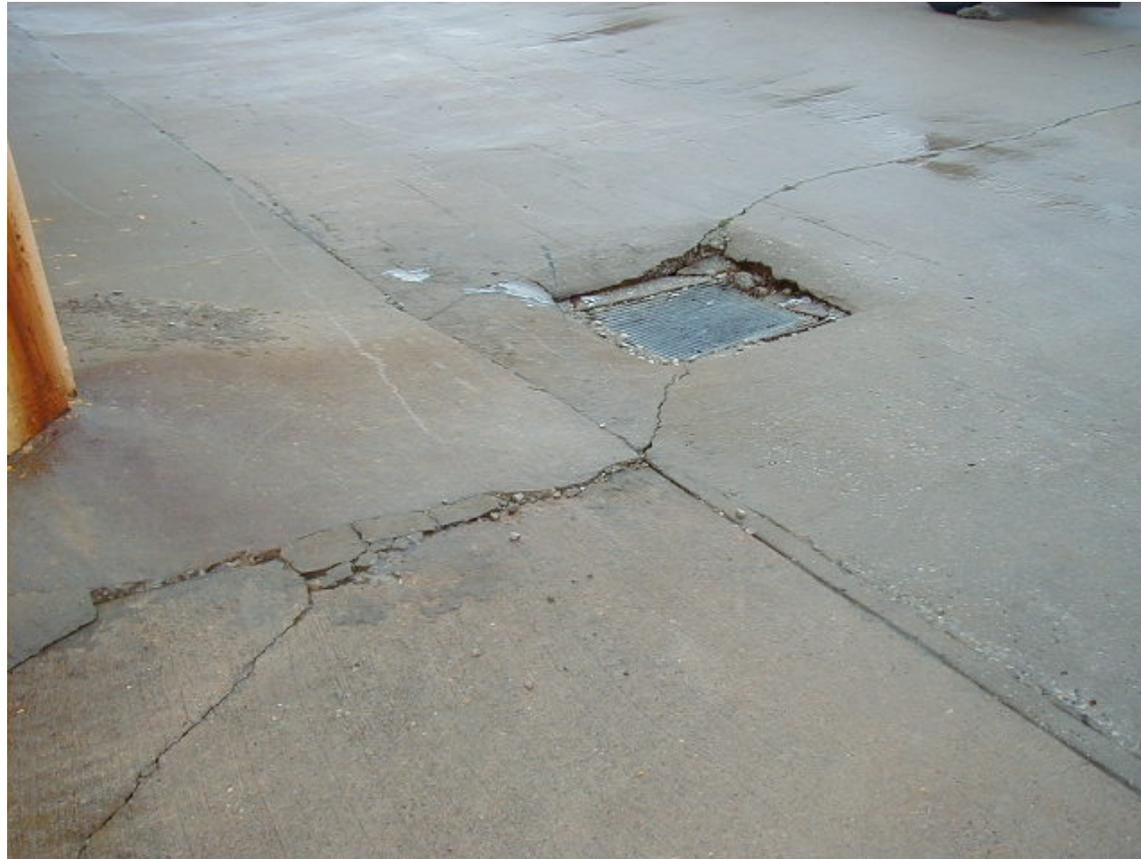
P1010050 – Storm drain west of building #6

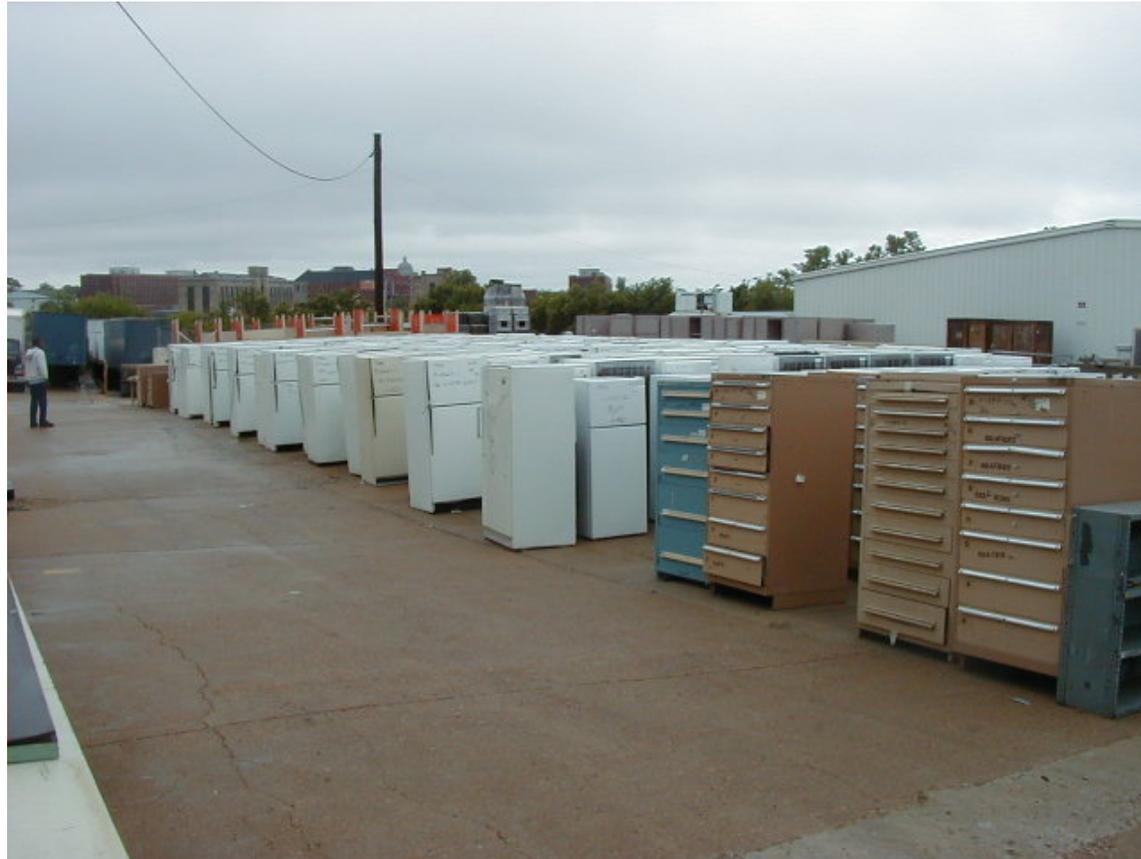
P1010053 – Surplus refrigerators between building #6 and #8

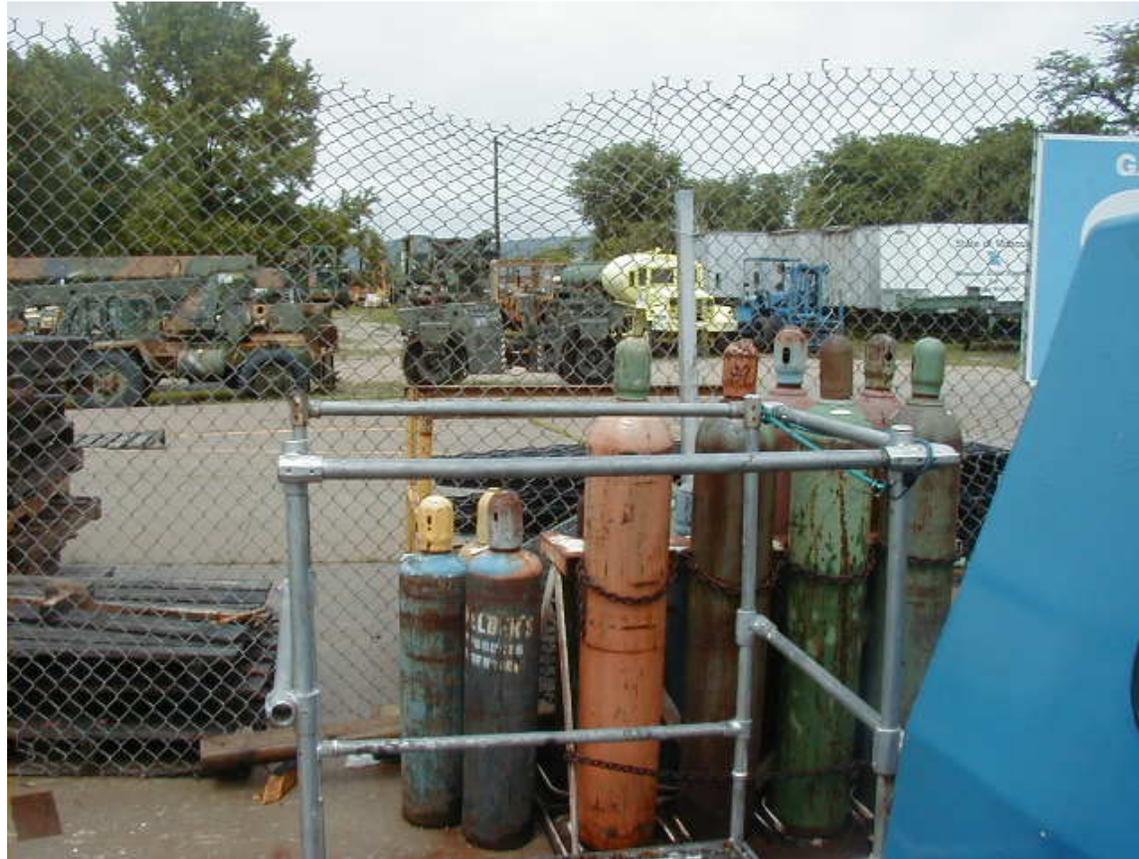
P1010057 – Empty cylinders east of garage

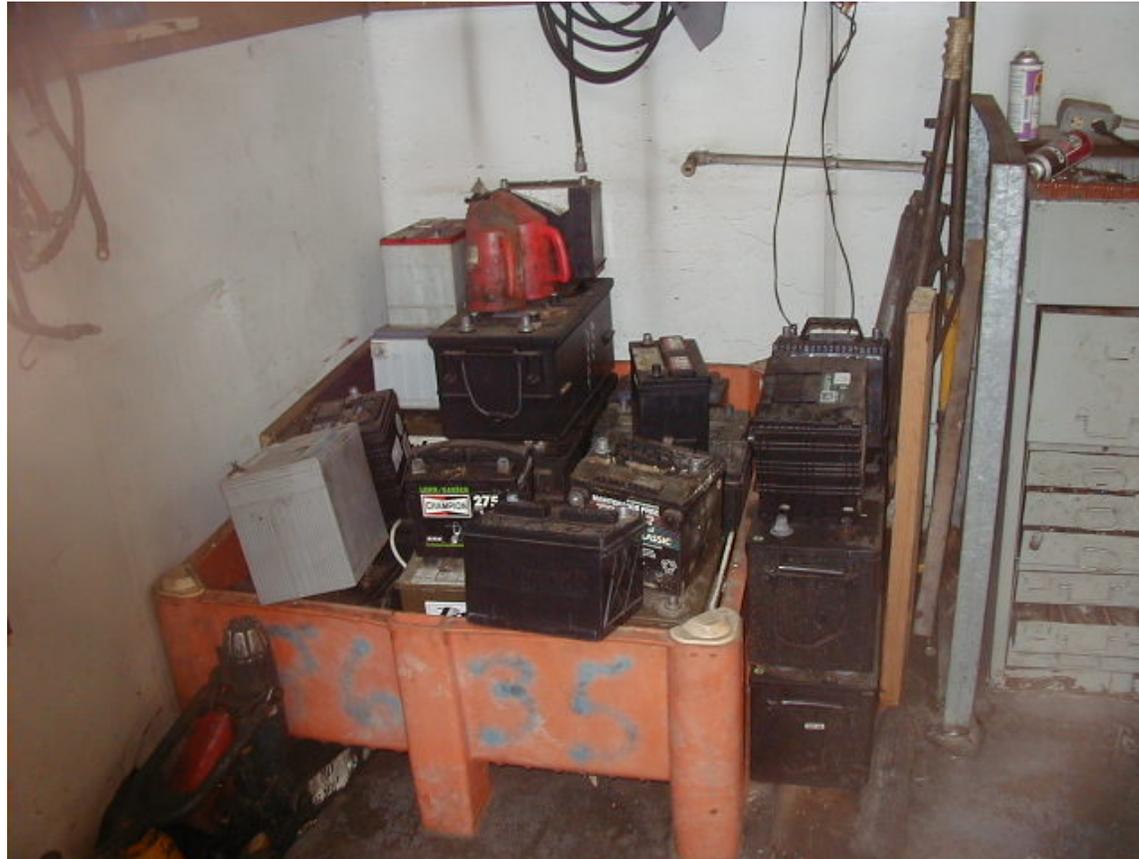
P1010060 – Battery storage

Finding: Batteries, lubricants, solvents found in garage maintenance areas, MSDS sheets available. These are in small single can quantities to large 55 gallon drums. Antifreeze

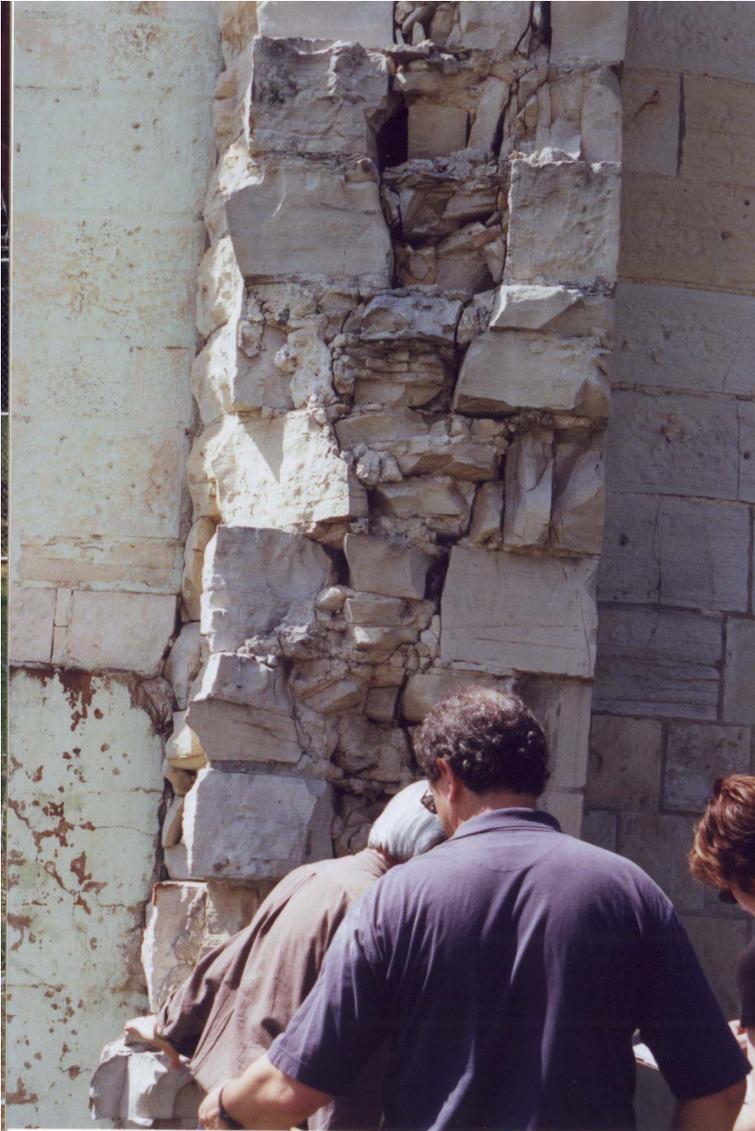
Cross Section of Wall Showing Construction

The wall on the south side of the facility has a large area of localized collapse. The collapse is only of the inner wythe of the stone wall. In this area the wall shows both rotation about the axis of the wall footing and a horizontal displacement between the two guard towers in the southwest corner of the facility. The wall is failing in overturning as well as possibly horizontal sliding. The damage appears to have been ongoing for many years. There are cracks associated with this movement which have been tuckpointed several years ago. The wall in this area retains 6 – 8 feet of soil; the grade being higher on the exterior side. There have been several types of utility work on the outside of the wall, which are in the influence zone of the backfill. It is possible that this utility work could have increased horizontal earth pressure on the wall, due to backfill compaction or water entering an open excavation. The wall is currently stable and is being restrained by the reinforced concrete band on the top acting as a tension strut. The portion of the wall,

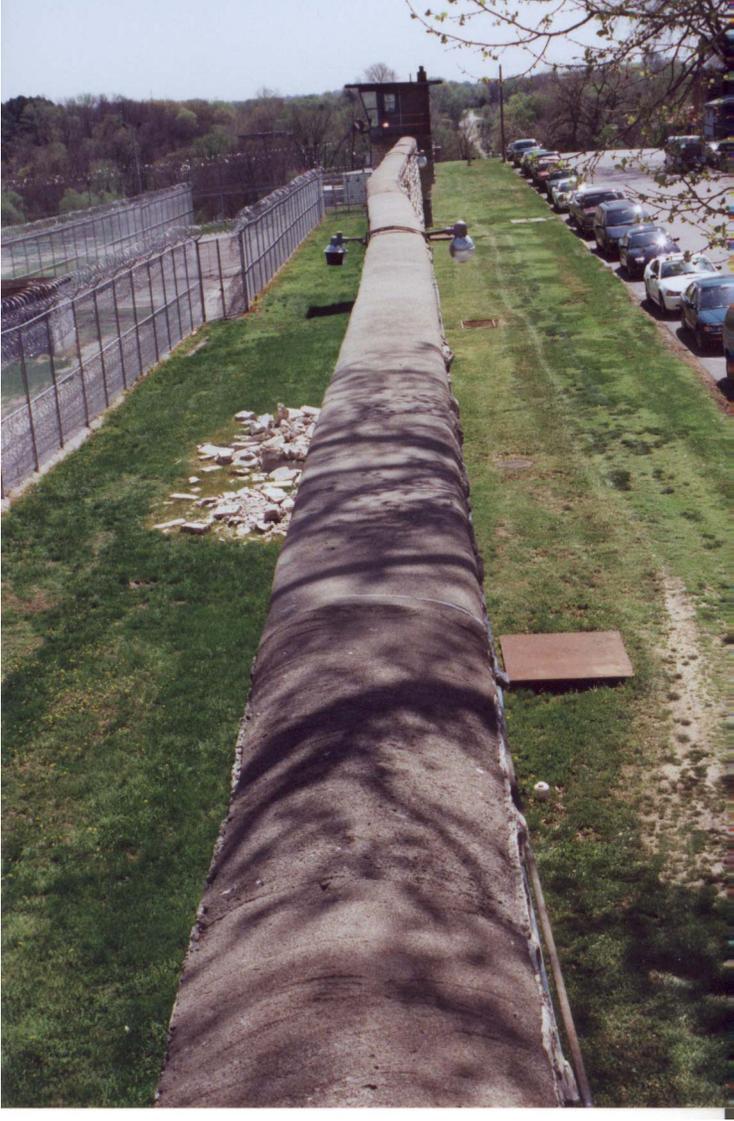
Collapsed Wall Section with Concrete on Top

Horizontal Displacement of Wall at Grade
